Summary Report

VA Medical Center
Tower
Liquid Engineering Corporation Job #55092

Tank Name:	Tower	Tank Type:	Elevated
City:	Sioux Falls	Tank Capacity:	100,000
State:	SD	Type of Construction:	Riveted Steel
Year Built:	Not Provided

Inspected By:	LEC Dive Team 14
Inspection Date:	October 5, 2020

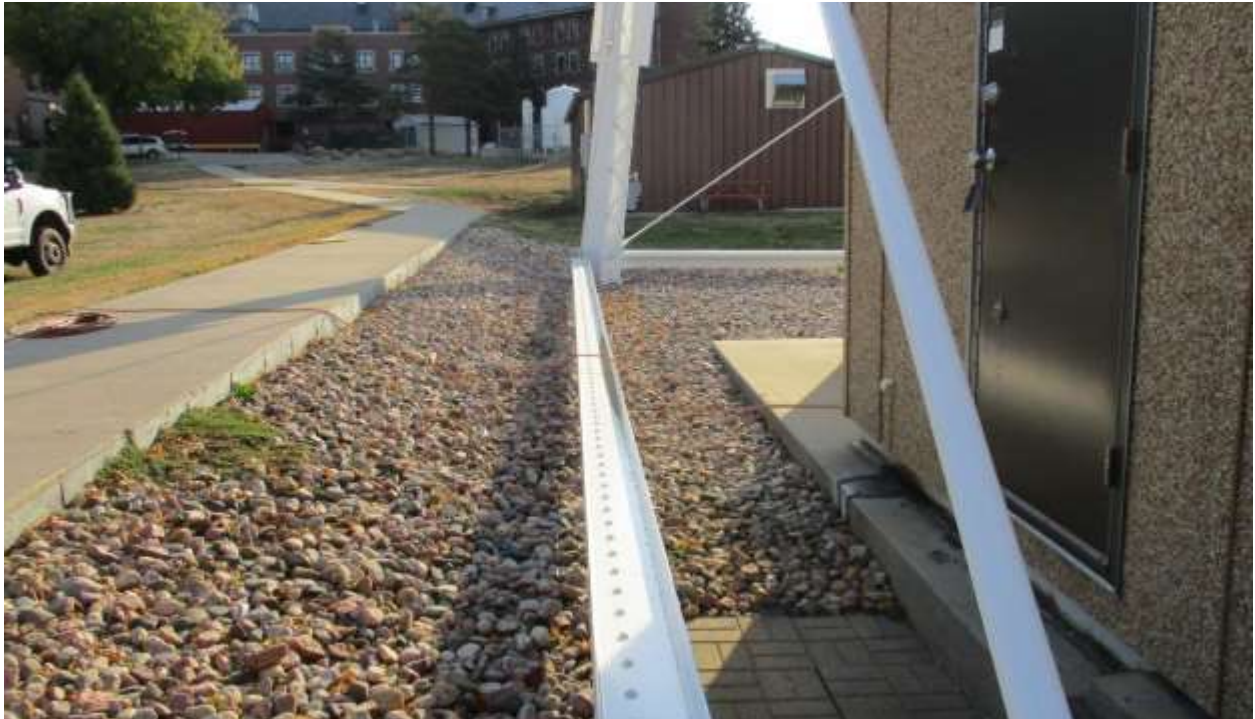
1.) Lack of Fence

- We recommend fencing the area around the tank. We further recommend posting a **No Trespassing** sign and a **Warning, Tampering With This Facility is a Federal Offense** (US code title 42, section 300i-1) sign. Fence installation to be done by others. (See photo 1)

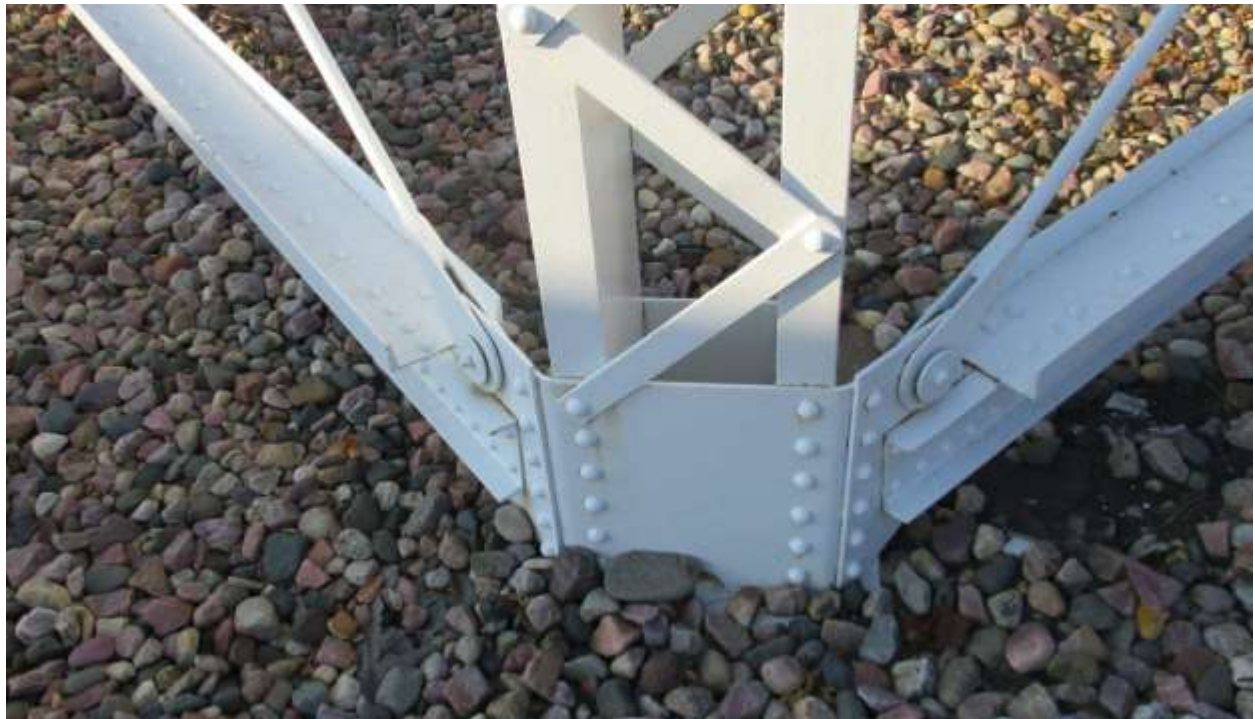
2.) Ungraded Foundations

- **AWWA D100-11; 12.7.1** states, “The tops of the concrete foundations shall be a minimum of 6 in. (152 mm) above the finished grade, unless otherwise specified.” We recommend clearing any dirt, debris and other loose gravel away from the tank foundations, down to a minimum 6” below top of foundations. This should be done by a local excavating company. (See photo 2)

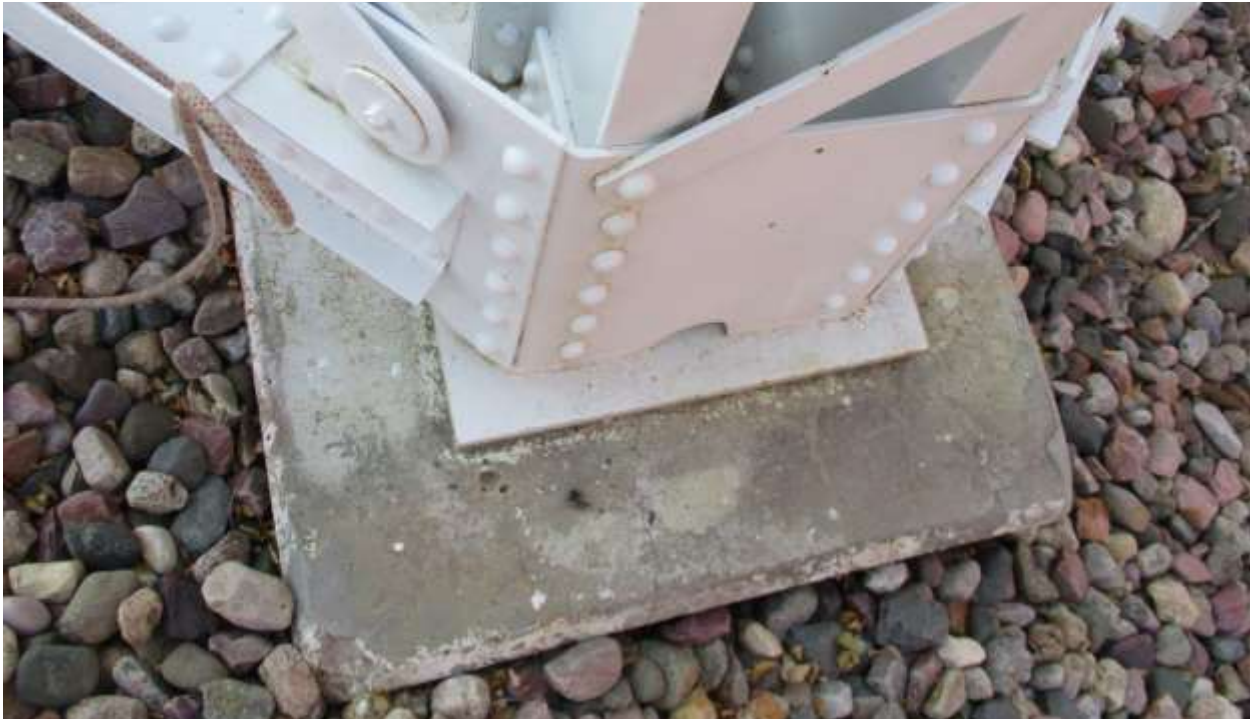
3.) Unsealed Foundations

- We recommend sealing the foundations with a sealant. (See photo 3)
- We recommend replacing the existing drain valve with a frost proof drain valve, complete with locking device to prevent unauthorized draining of the tank and a splash pad to direct water away from the foundation. **Splash pad to be installed by owner.* (See photo 5)

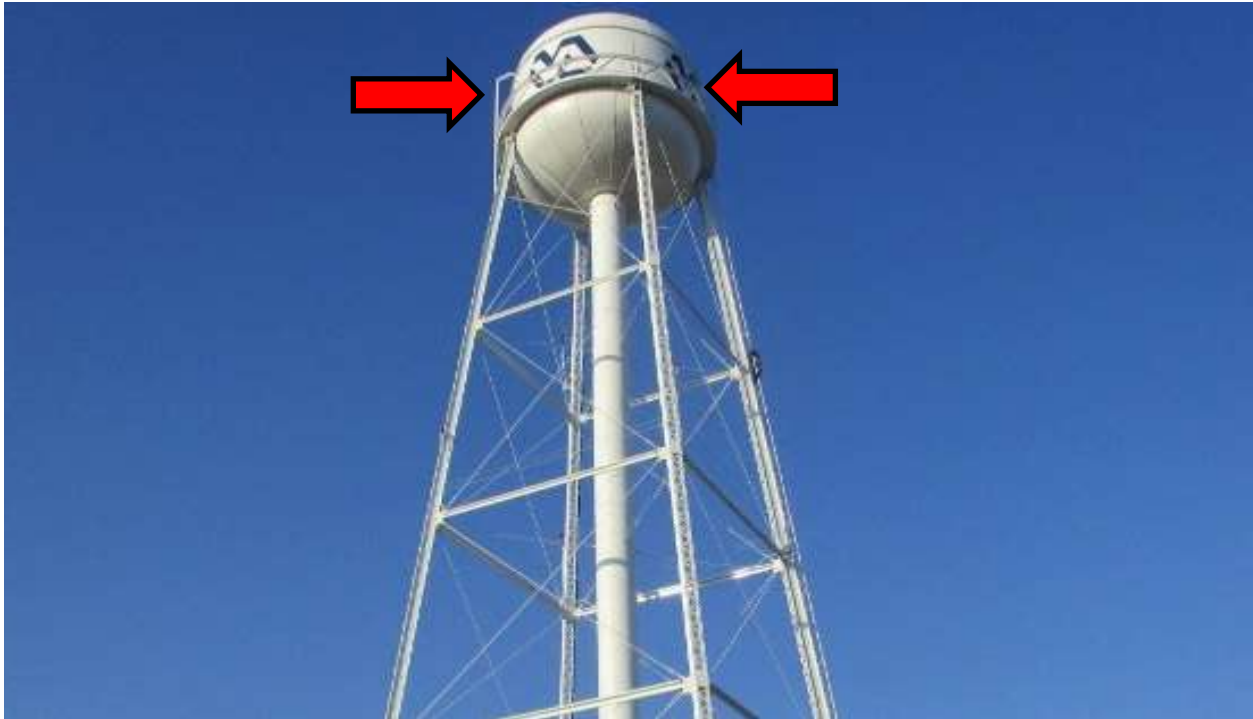
11.) Lack of Shell Manways

- We recommend installing two (2) 30" shell manways 180° apart and posting **Confined Space Entry** signs to adhere with **OSHA 1910.146(c)(2) Confined spaces**. We further recommend installing **OSHA** compliant interior bowl access ladders complete with standoffs every 10' on center, and cable type ladder safety devices at the suggested primary and secondary shell manways. **In cold climates it's up to the owner's discretion on placement of internal ladders.* (See photo 11)

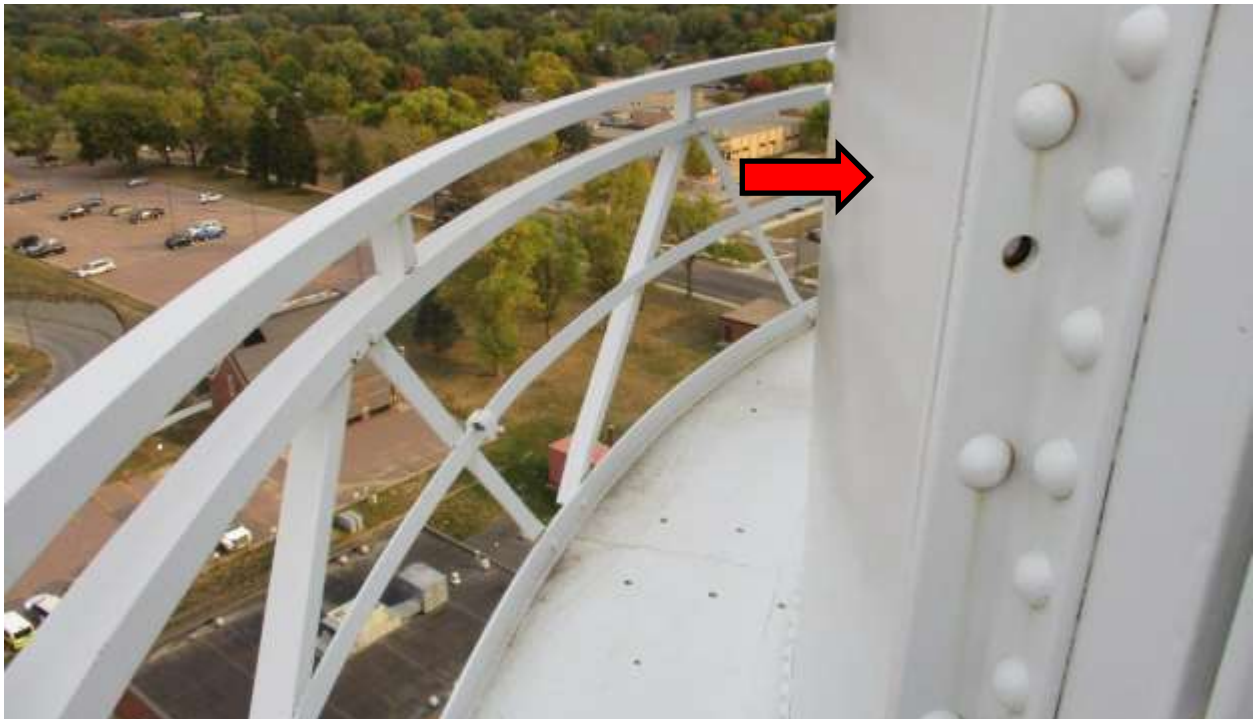
12.) Lack of Liquid Level Indicator

- We recommend installing a float-type liquid level indicator. (See photo 12)
- **AWWA D100-11; 5.5** states, “When the vent is provided with screening against insects, a pressure-vacuum-screened vent or a separate pressure-vacuum relief mechanism shall be provided that will operate in the event that the screens frost over or become clogged.” We recommend replacing the existing roof vent with a vacuum-pressure, frost proof vent and screen. **This work should be performed on an emergency basis**. (See photo 15)

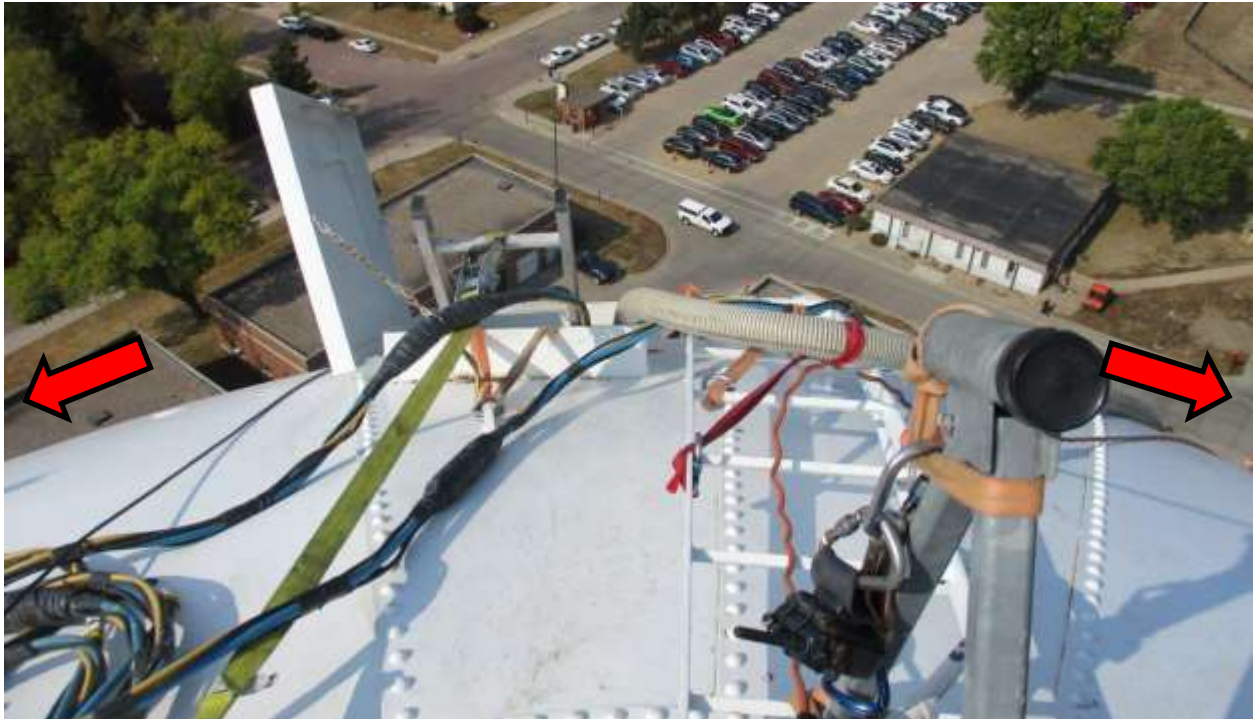
13.) Lack of Roof Handrails

- **OSHA 1910.28(b)(1)(i)** states, "...the employer must ensure that each employee on a walking-working surface with an unprotected side or edge that is 4 feet (1.2 m) or more above a lower level is protected from falling by one or more of the following: 1910.28(b)(1)(i)(A) Guardrail systems." **OSHA 1910.29(b)(1)** states, "The top edge height of top rails, or equivalent guardrail system members, are 42 inches (107 cm), plus or minus 3 inches (8 cm), above the walking-working surface." **OSHA 1910.29(b)(2)(i)** states, "Midrails are installed at a height midway between the top edge of the guardrail system and the walking-working surface;..." **OSHA 1910.29(k)(1)** states, "The employers must ensure toeboards used for falling object protection:..." We recommend installing an **OSHA** compliant 42" high handrail system around the circumference of the tank roof, complete with an intermediate rail, a toeboard, and a swing gate at the junction of the shell-to-knuckle roof access ladder and tank roof. (See photo 13)

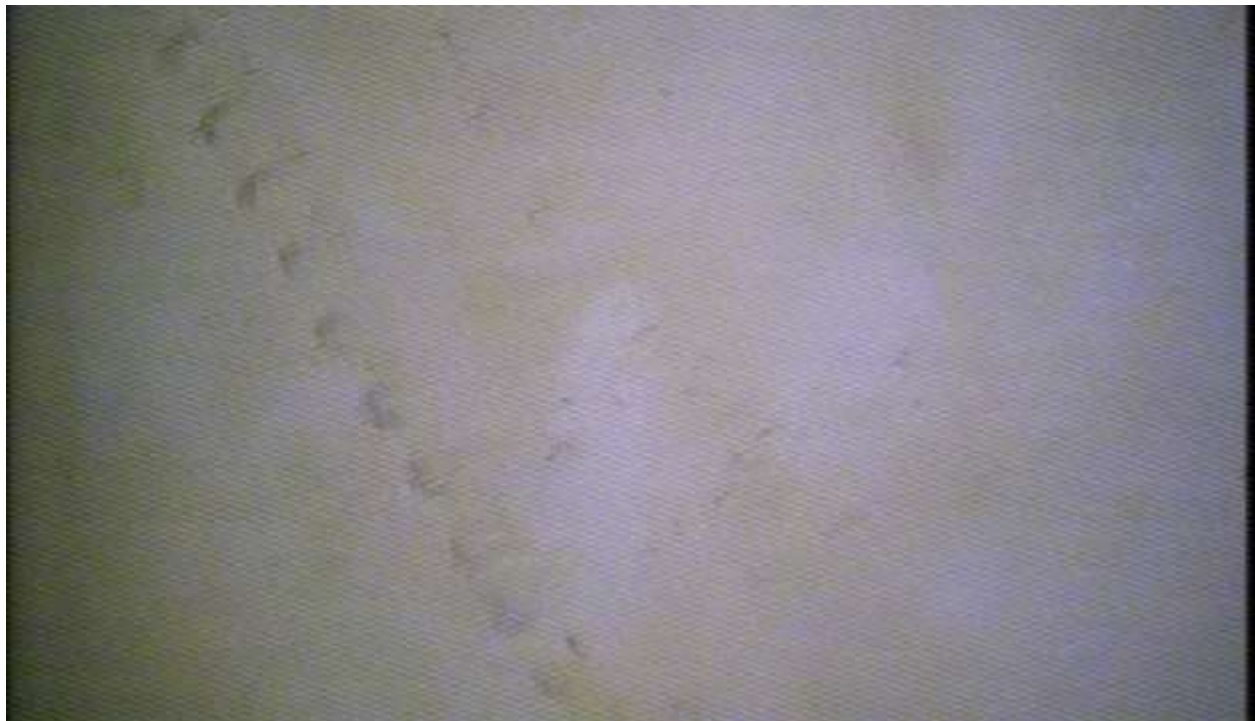
18.) Lack of Mixing System

- We recommend installing a mixing system. Electrical work to be done by others if required. (See photo 18)
- We recommend replacing the existing cathodic protection system with a new active cathodic protection system. (See photos 19 & 20)
