# ASBESTOS REINSPECTION REPORT 2019

LOCATION:  
**ST. CLOUD VA MEDICAL CENTER  
4801 VETERANS DRIVE  
ST. CLOUD, MN 56303**

**VA PROJECT #: 656-C90115  
SOLICITATION #: 36C26319Q0714**

INSPECTION DATES:  
**NOVEMBER 4-6, 2019  
JULY 13, 2020**

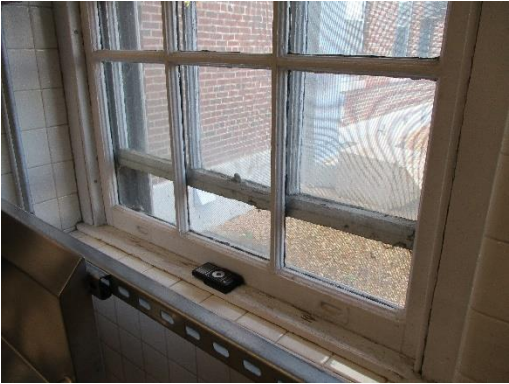
<p><b>Photo 4-5</b> Exterior window glazing &amp; caulking</p>

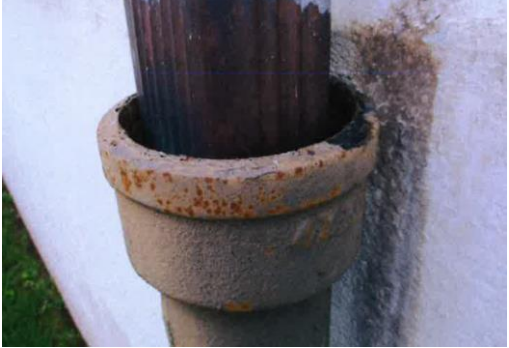
A photograph showing a multi-paned window with a white frame. The window is set into a brick wall. The caulking around the window frame appears to be in poor condition, with some missing or peeling material.
<p><b>Photo 4-6</b> Exterior tar on downspouts</p>

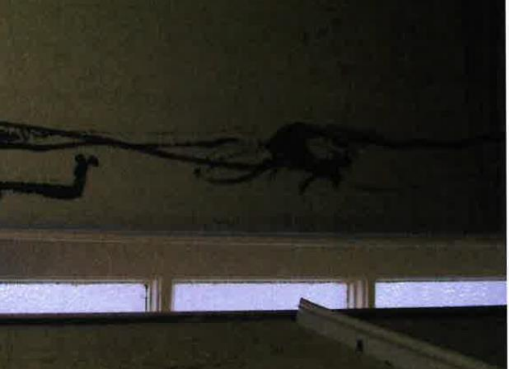
A photograph of a wall made of light-colored, fibrous panels (Transite wall sheets). The panels are separated by dark joints. A small white label is visible on one of the panels. The wall appears to be part of an interior or semi-enclosed structure.
<p><b>Photo 4-8</b> Black adhesive above windows</p>

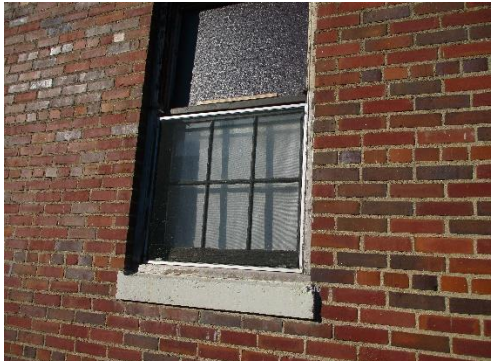
A close-up photograph showing a black electrical control box mounted on a fiberglass insulated pipe. The pipe is wrapped in white fiberglass insulation. A wooden handle is visible in the background.
<p><b>Photo 6-2</b> Exterior window glazing &amp; caulking</p>

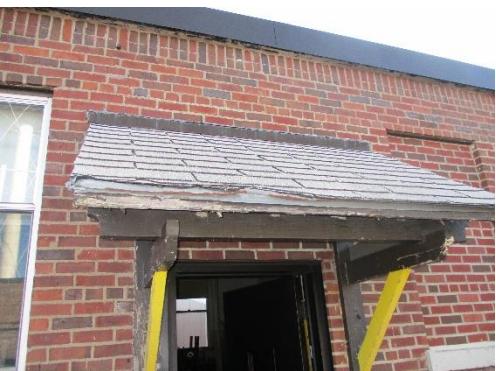
A photograph of a window set in a red brick wall. The window has a white frame and a dark screen. The caulking around the window frame appears to be in poor condition.
<p><b>Photo 6-3</b> Exterior tar roof overhang</p>

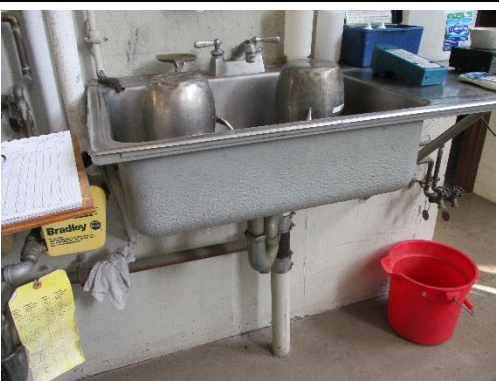
An exterior photograph of a brick building. A window is visible with a metal railing in front of it. The window frame appears to have been recently caulked.
<p><b>Photo 7-4</b> Sink undercoating</p>
