3-YEAR RE-INSPECTION REPORT

VETERANS ADMINISTRATION MEDICAL CENTER
2501 WEST 22ND STREET
SIOUX FALLS, SOUTH DAKOTA 57105

B2E Project Number: 10298.0001

December 10, 2013

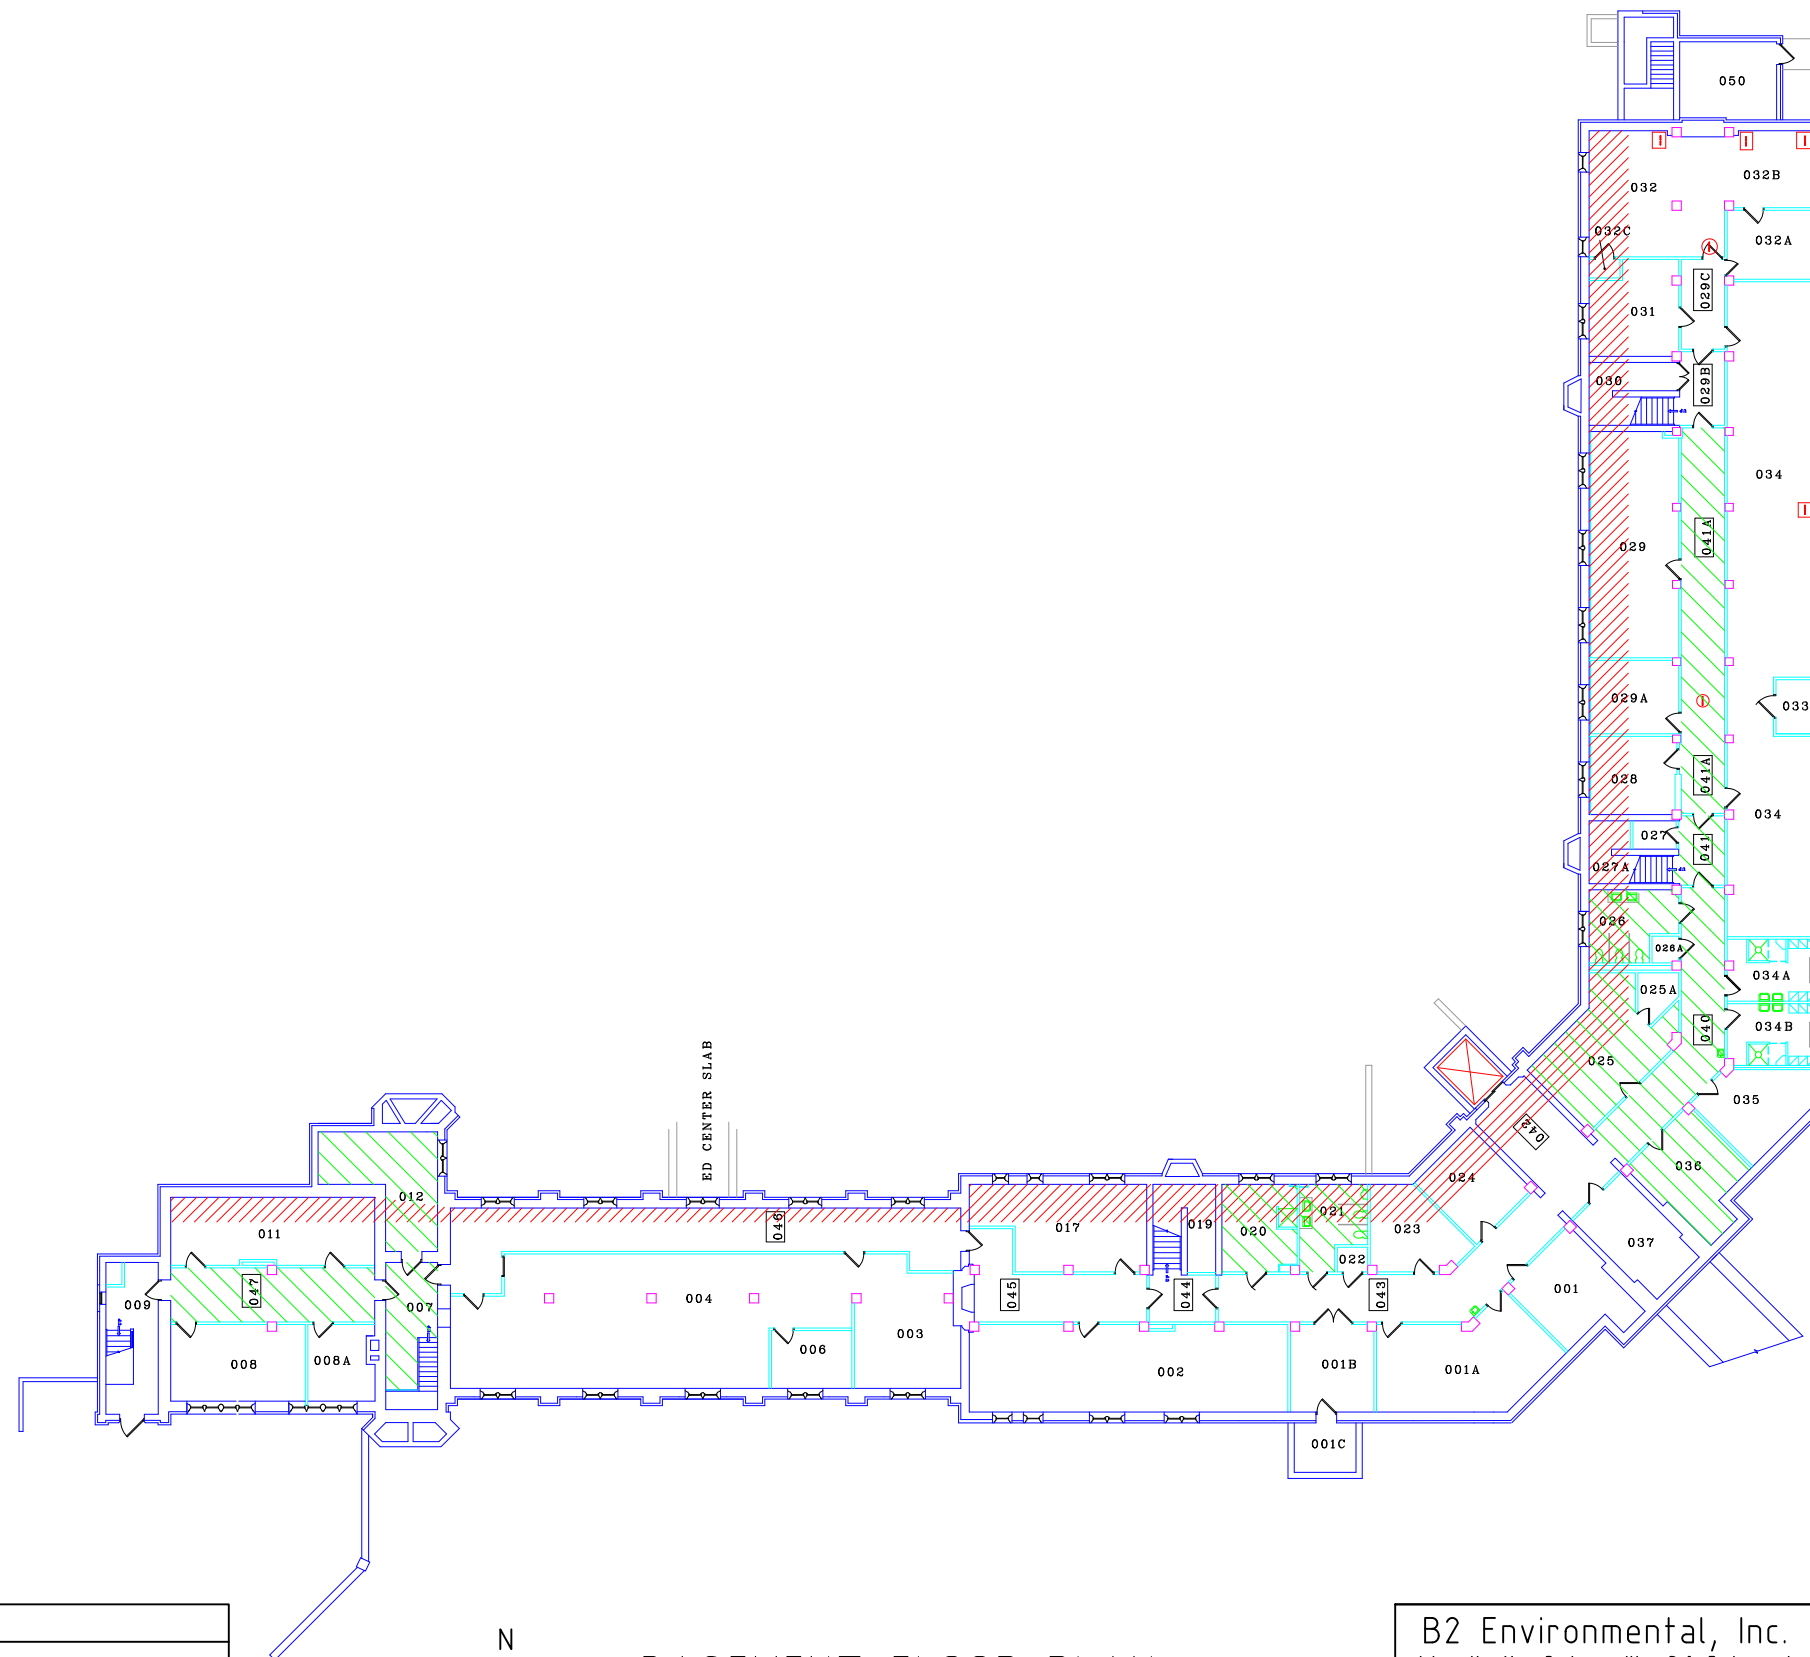
BASEMENT FLOOR PLAN
BUILDING 1

6"-10" O.D. Pipe Insulation, Mudded Fittings, & Debris (in crawlspace)

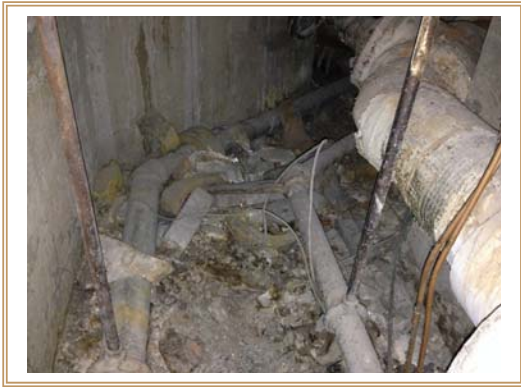
The materials were not assessed in previous reports and were assumed to be ACBM based on the results of similar materials found throughout the building. The material is currently significantly damaged with a large amount of material debris found within the space.

View of significantly damaged **asbestos-containing** pipe insulation and mudded fittings. Building 1, basement, underfloor crawlspace areas.

- Repair or remove damaged material and debris. Maintain the material using the guidelines outlined in the Operations and Maintenance (O&M) section of your Management Plan.
- Follow recommendations shown in Management Plan.

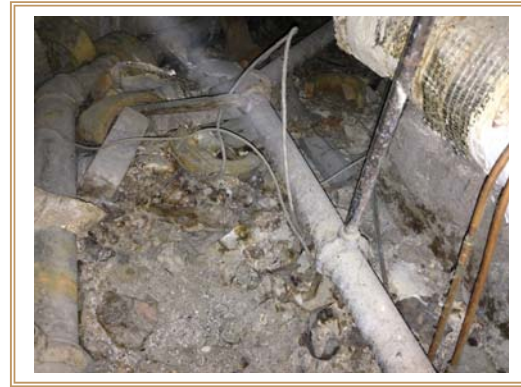
View of significantly damaged **asbestos-containing** pipe insulation and mudded fittings. Building 1, basement, underfloor crawlspace areas.

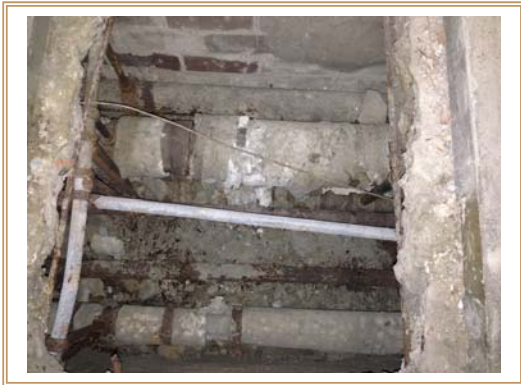
View of significantly damaged **asbestos-containing** pipe insulation and mudded fittings. Building 1, basement, underfloor crawlspace areas.

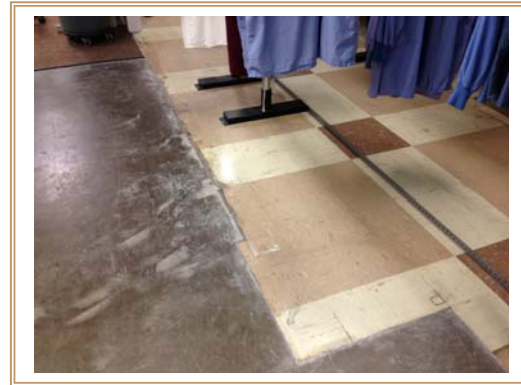
The material has been partially removed since the last re-inspection. Significantly damaged tiles that have been cut with exposed edges remain on the perimeter of the remaining area of floor tile and mastic.

BUILDING	FLOOR	ROOM	MATERIAL DESCRIPTION	QUANTITY	FRIABLE	AHERA ASSESSMENT CATEGORY	REMARKS
5	Ground Level	E 06	9" x 9" Floor Tile/Mastic	260 sf	No	4	Damaged - Cut Edge Exposed

View of significantly damaged, **asbestos-containing**, cut 9"x9" floor tiles/mastic. Building 5, ground level, room E06.

- Repair or remove damaged material. Maintain the material using the guidelines outlined in the Operations and Maintenance (O&M) section of your Management Plan.
- Follow recommendations shown in Management Plan.
