HAZARDOUS BUILDING MATERIALS INSPECTION REPORT

Correct Mechanical Deficiencies VA Medical Center Omaha, Nebraska

VA Project No: 636-19-301

August 27, 2020

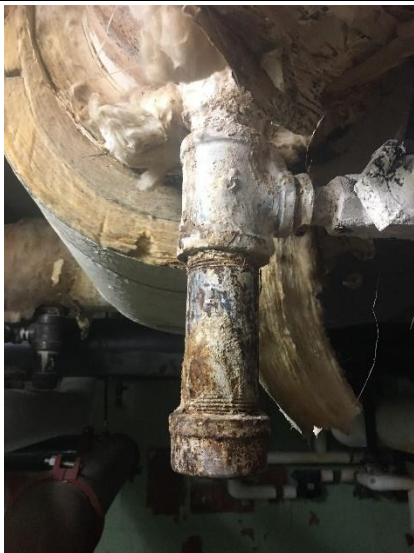
PHOTO 1 Residual TSI on Drip Leg
Non-ACM

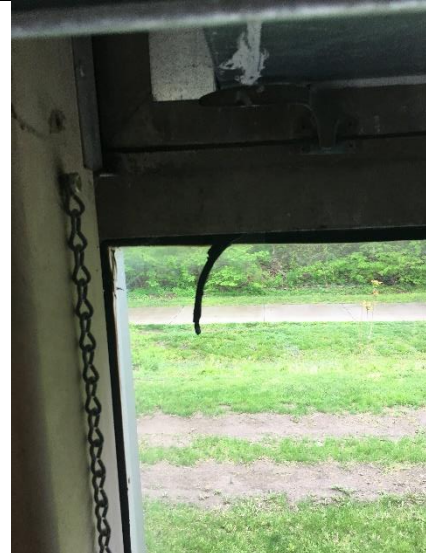
PHOTO 2 Caulk on interior side of windows
Building 2 Boiler Room 6% Chrysotile

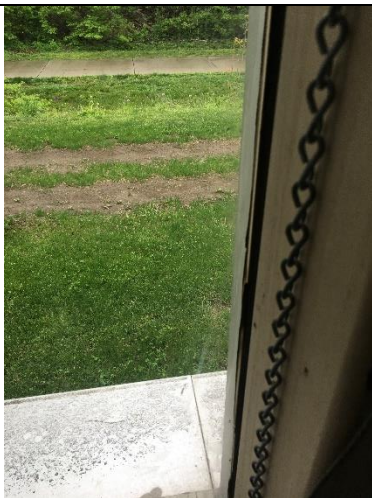
PHOTO 3 Caulk on interior side of windows
Building 2 Boiler Room Non-ACM

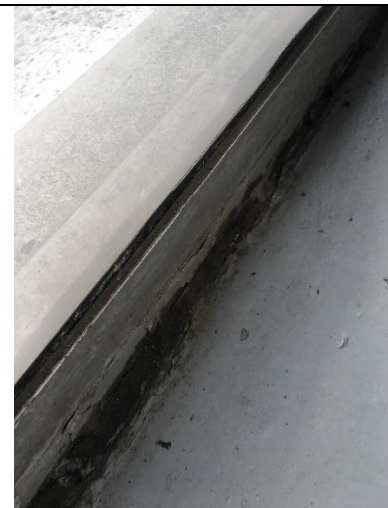
PHOTO 4 Caulk on interior side of windows
Building 2 Boiler Room 6% Chrysotile

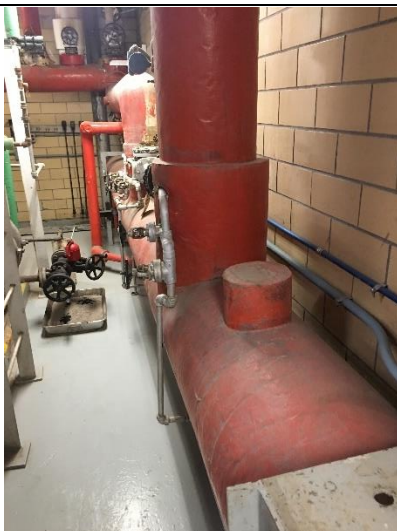
PHOTO 5 Red Jacketed TSI on Pipe
Assumed ACM

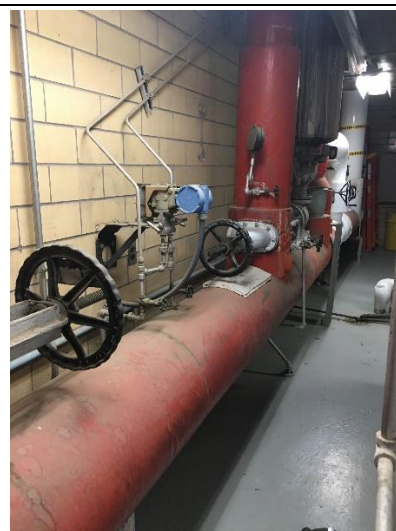
PHOTO 6 Red Jacketed TSI on Pipe
Assumed ACM

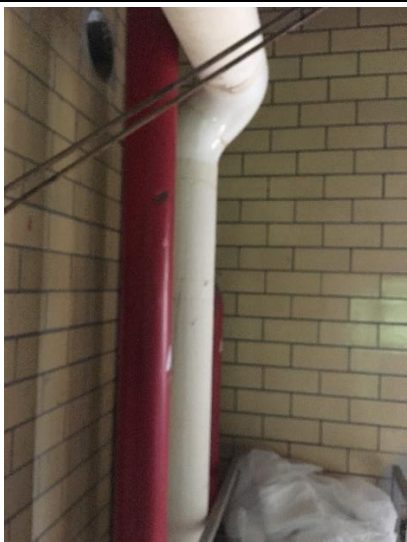
PHOTO 7 Red Jacketed TSI on Pipe
Assumed ACM

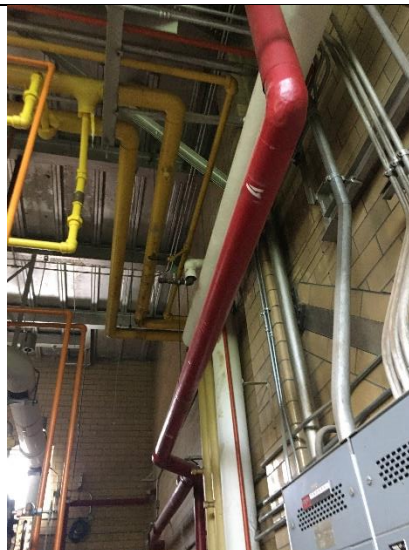
PHOTO 8 Red Jacketed TSI on Pipe
Assumed ACM

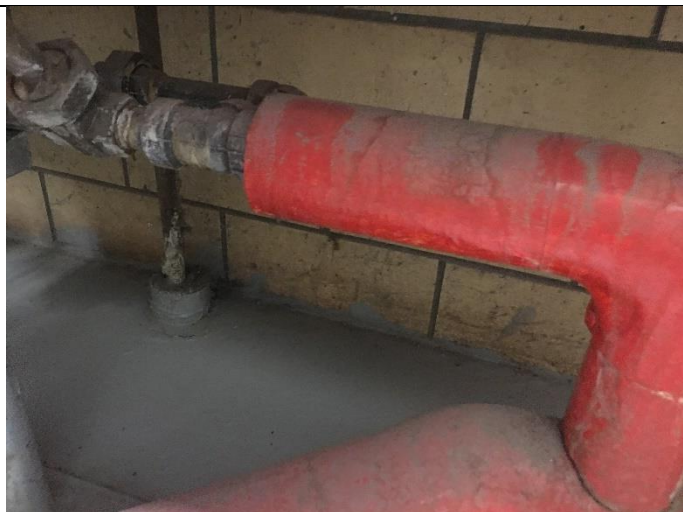
PHOTO 9 Red Jacketed TSI Fittings
Assumed ACM

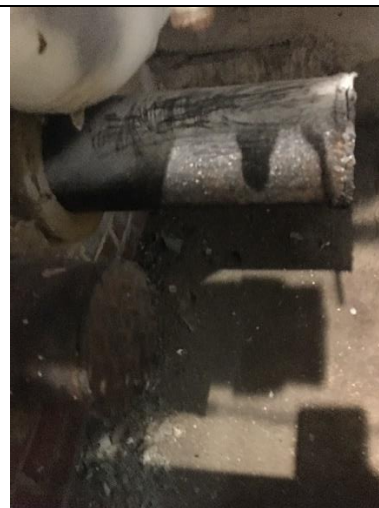
PHOTO 10 Debris on Floor under Glycol Pipes
Non-ACM

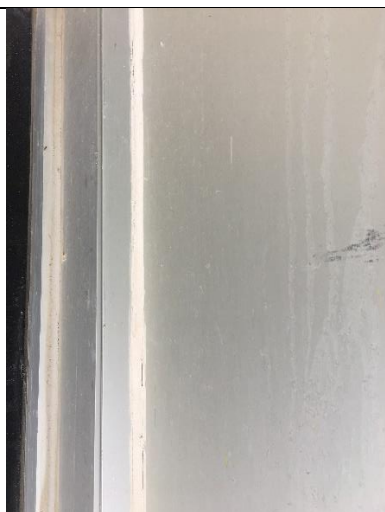
PHOTO 11 Gray Window Caulk – Exterior
Non-ACM

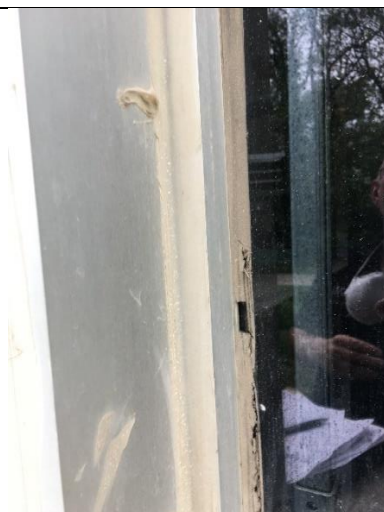
PHOTO 12 Brown Window Caulk – Exterior
Non-ACM

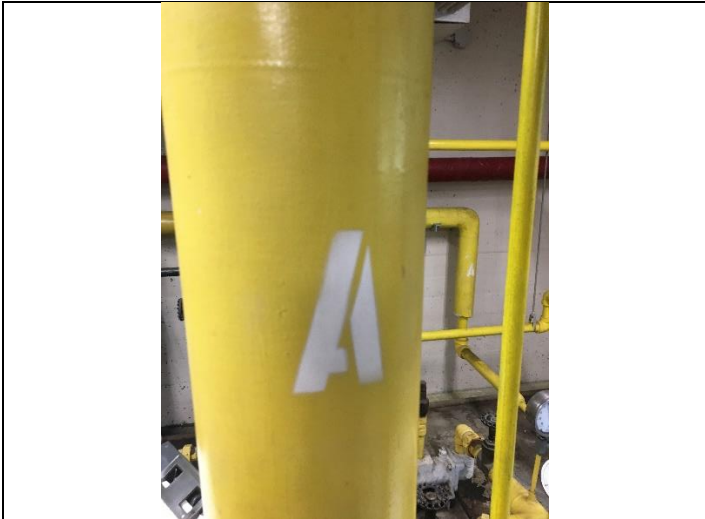
PHOTO 13 Yellow Jacketed TSI on Pipe
Assumed ACM

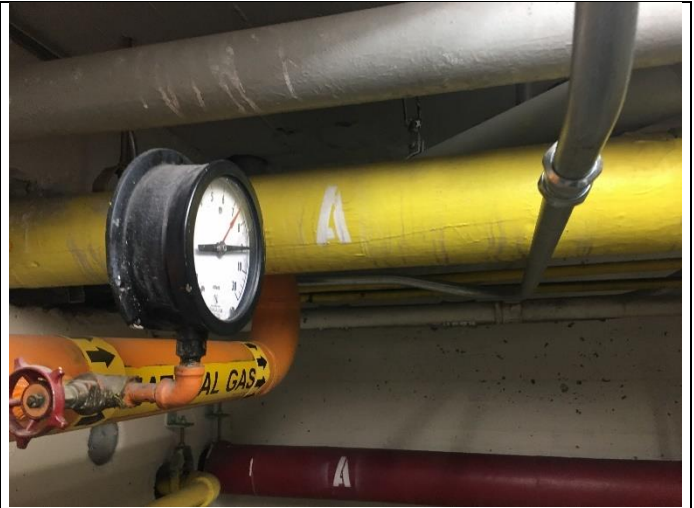
PHOTO 14 Yellow Jacketed TSI on Pipe
Assumed ACM

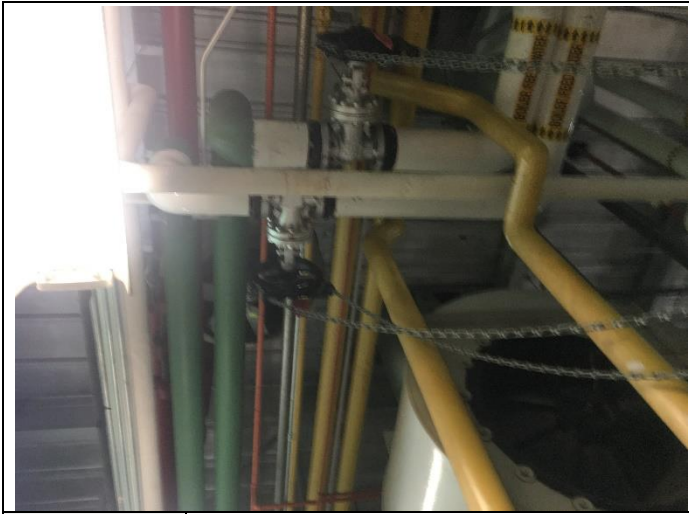
PHOTO 15 Yellow Jacketed TSI on Pipe
Assumed ACM

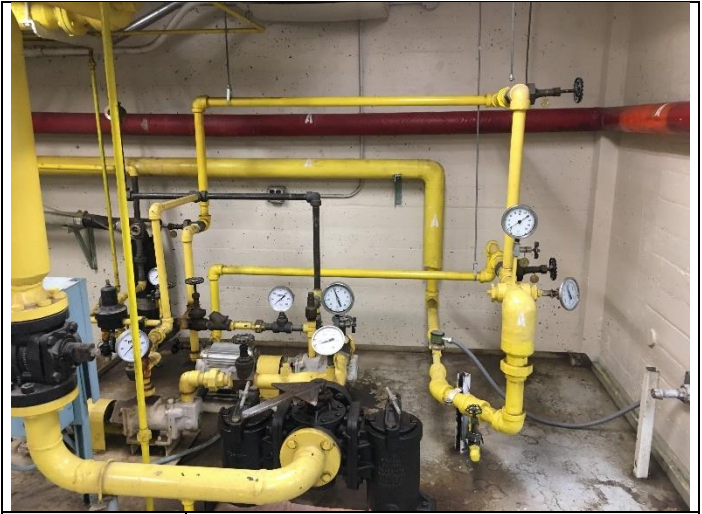
PHOTO 16 Yellow Jacketed TSI Fittings
Assumed ACM

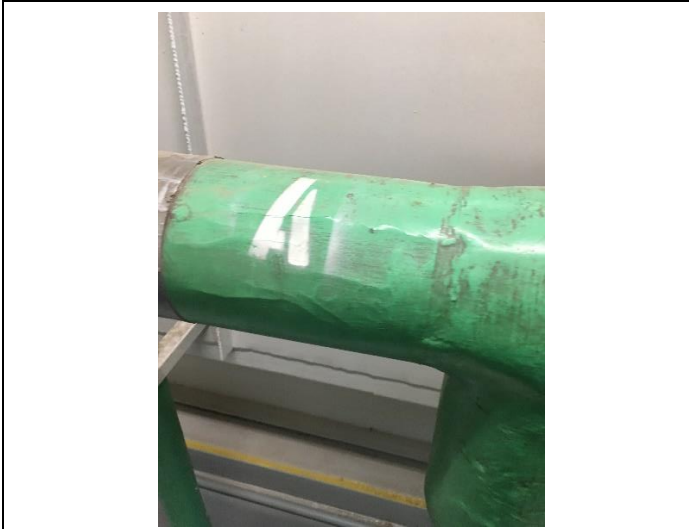
PHOTO 17 Green Jacketed TSI on Pipe
Assumed ACM

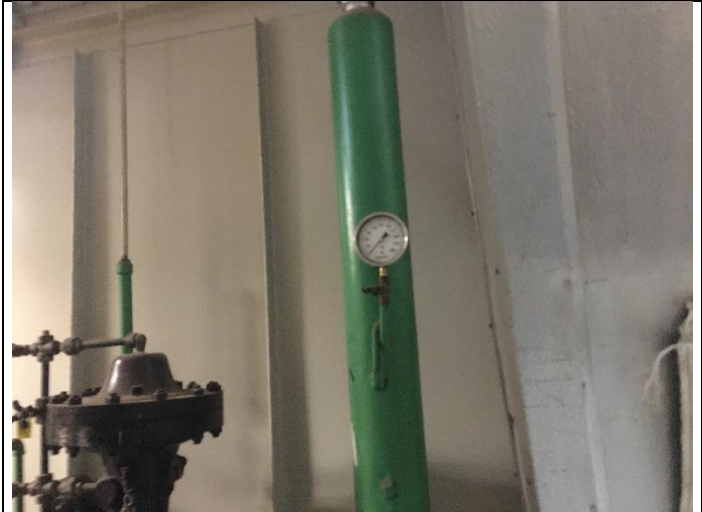
PHOTO 18 Green Jacketed TSI on Pipe
Assumed ACM

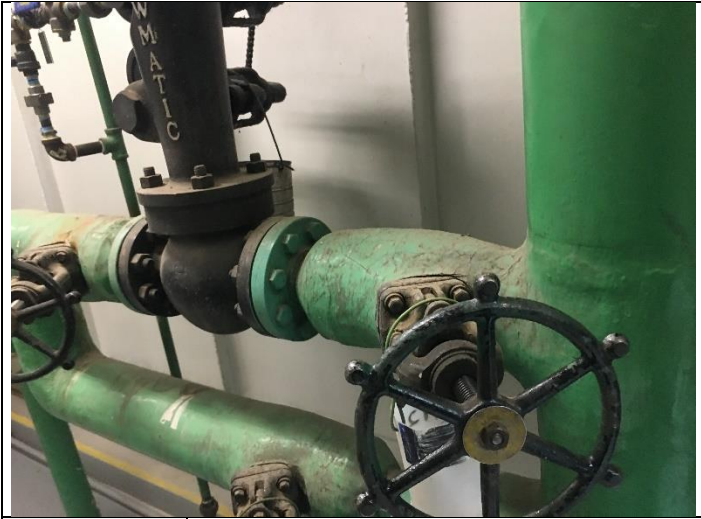
PHOTO 19 Green Jacketed TSI on Pipe
Assumed ACM

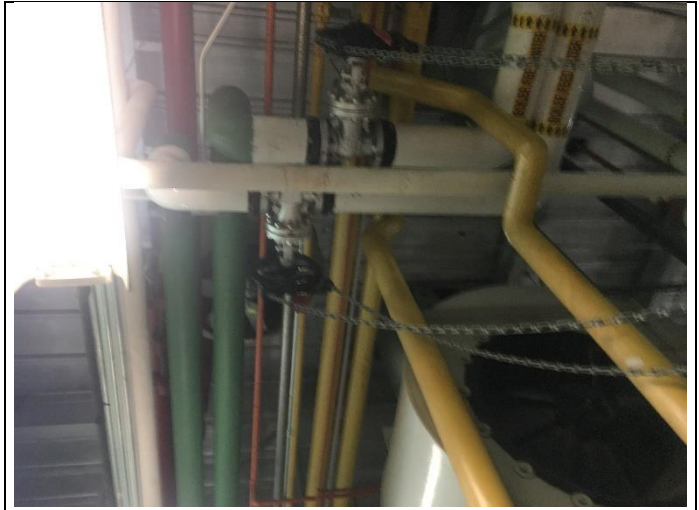
PHOTO 20 Green Jacketed TSI Fittings
Assumed ACM

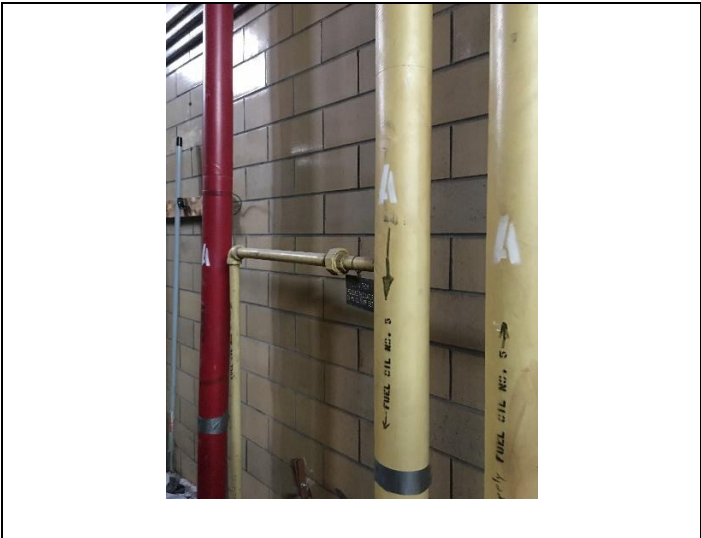
PHOTO 21 White Jacketed TSI Fittings
Assumed ACM

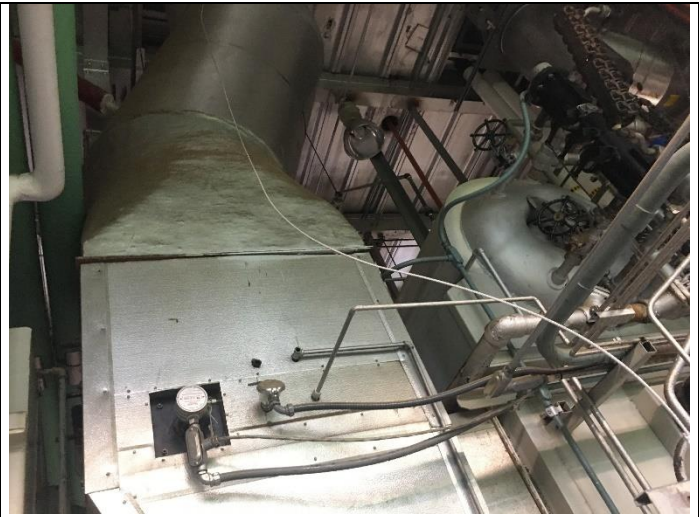
PHOTO 22 Silver Painted Flue
Assumed ACM

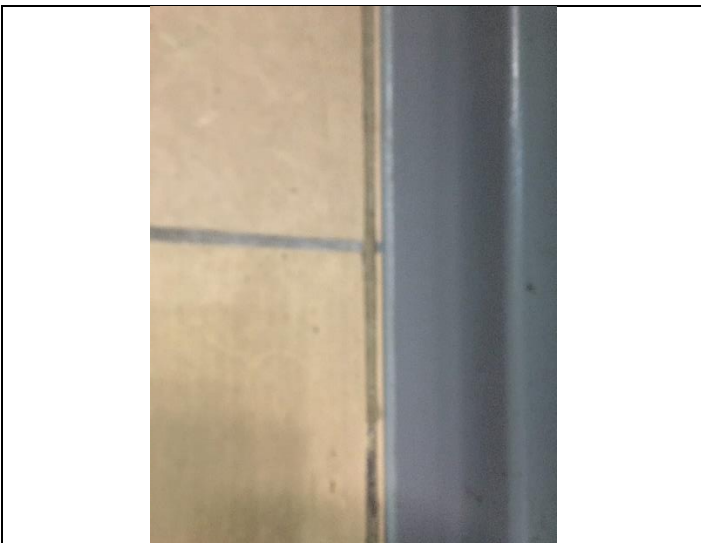
PHOTO 23 Gray Caulk on OH Door
Non-ACM

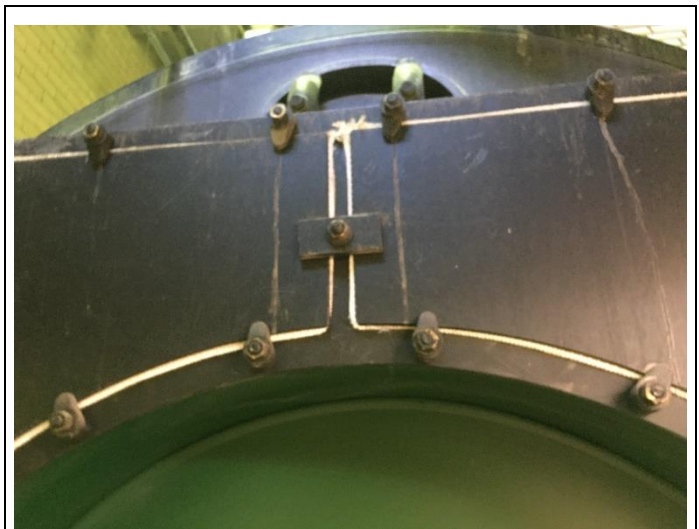
PHOTO 24 White Gasket on Boiler 3 Ends
Non-ACM

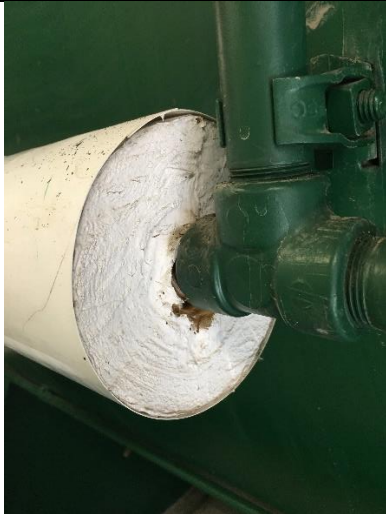
PHOTO 25

White Caulk on ends of Fiberglass TSI Pipe
Building 2 Boiler Room Non-ACM

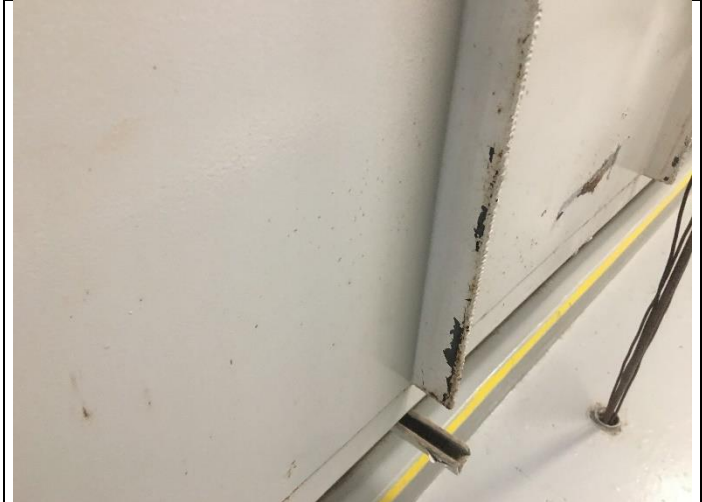
PHOTO 8 Building 2 Boiler Room – Gray Paint (Boiler 1)
>0.5% Lead

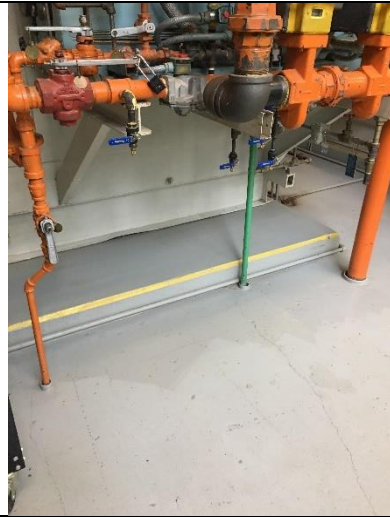
PHOTO 10 Building 2 Boiler Room Orange Painted Pipe
>0.5% lead

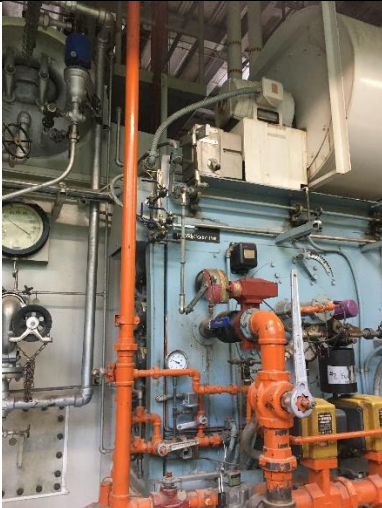
PHOTO 11 Building 2 Boiler Room Blue Paint on Boilers 1&2
>0.5% lead

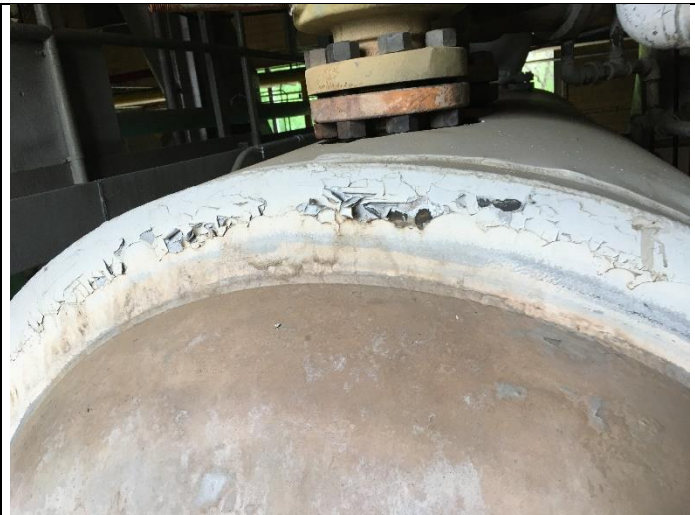
PHOTO 16 Building 2 Boiler Room Edge strip paint 1&2
>0.5% lead

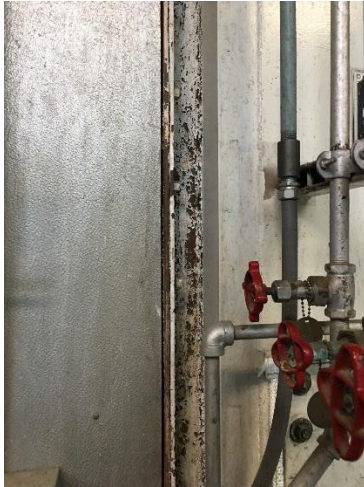
PHOTO 19

Building 2 Boiler Room – Painted Seams
>0.5% lead

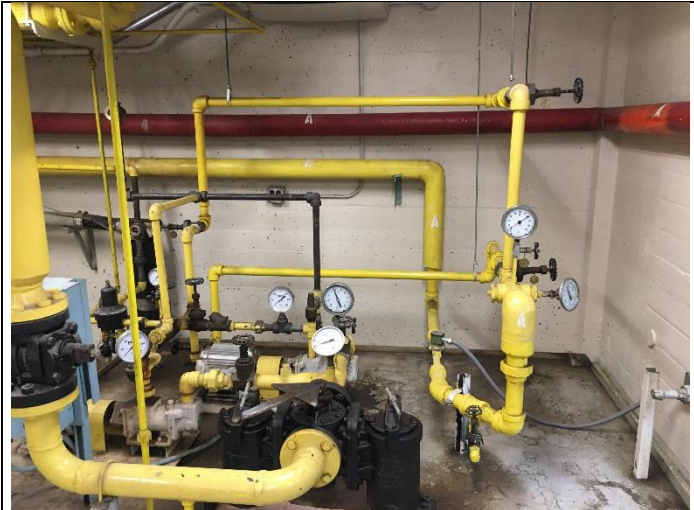
PHOTO 20

Building 2 Sub grade below boiler Room
Yellow Painted Pipes
>0.5% lead

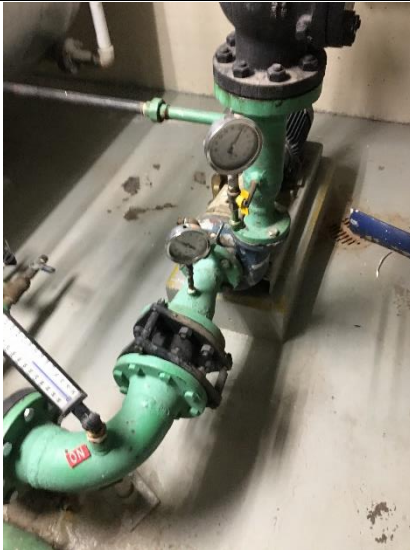
PHOTO 21

Building 2 Sub grade below boiler Room
Green Painted Pipes
>0.5% lead

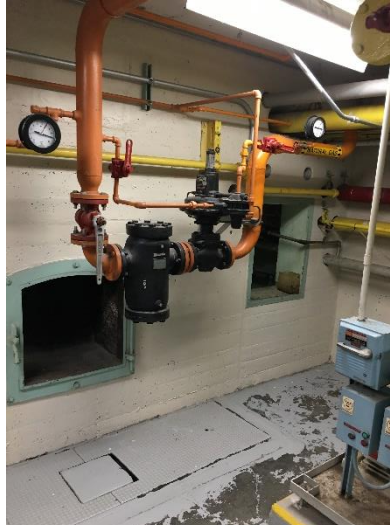
PHOTO 34 Building 2 Subgrade to Boiler Room 3-Black painted valves >0.5% Lead
