HAZARDOUS BUILDING MATERIALS INSPECTION REPORT

Sioux Falls VA Medical Center

**New SPS Addition
Sioux Falls, South Dakota**

May 22, 2019

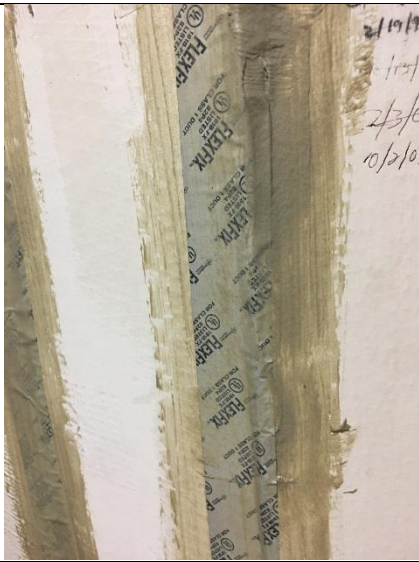
PHOTO 1 Gray Mastic – Duct in below grade mechanical room

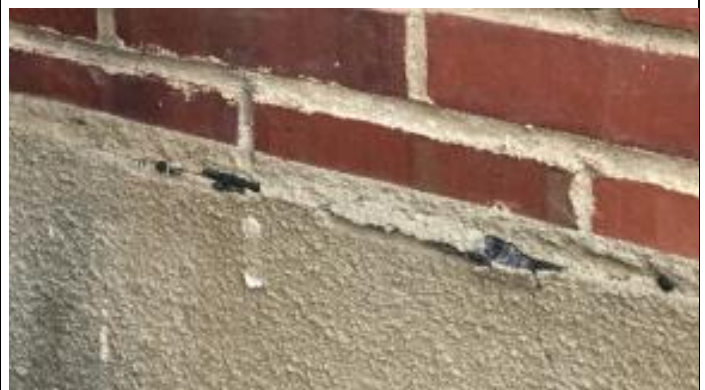
PHOTO 6 Black Tar Under EFIS – Mech. Room Entry

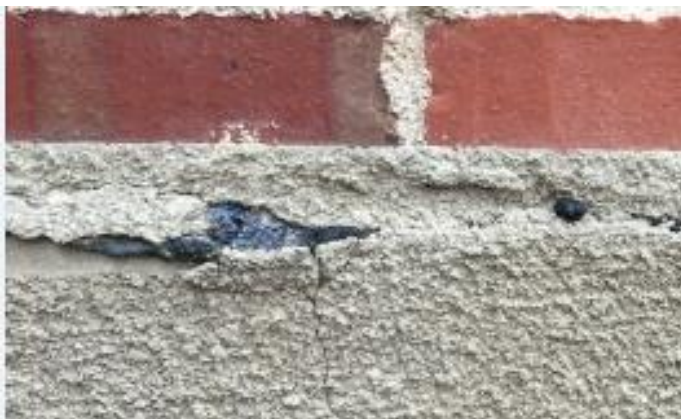
PHOTO 7 Black Tar Under EFIS – Mech. Room Entry

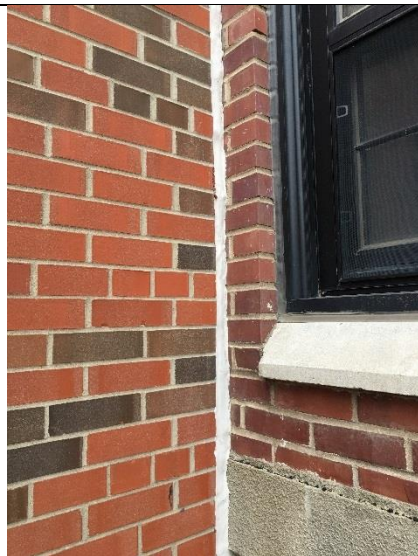
PHOTO 8 White Joint Caulk – Entry to Mech. Room

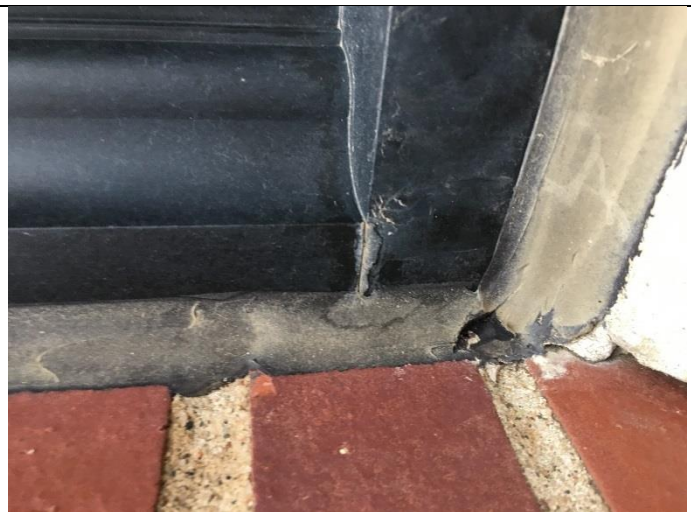
PHOTO 10 Gray Window Caulk - Exterior

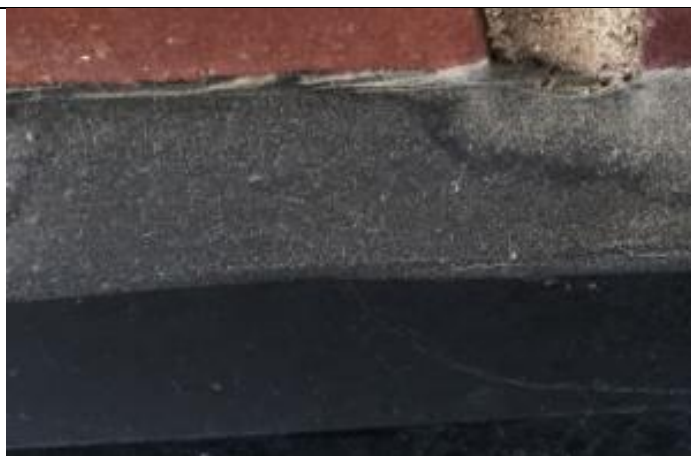
PHOTO 11 Gray Window Caulk - Exterior

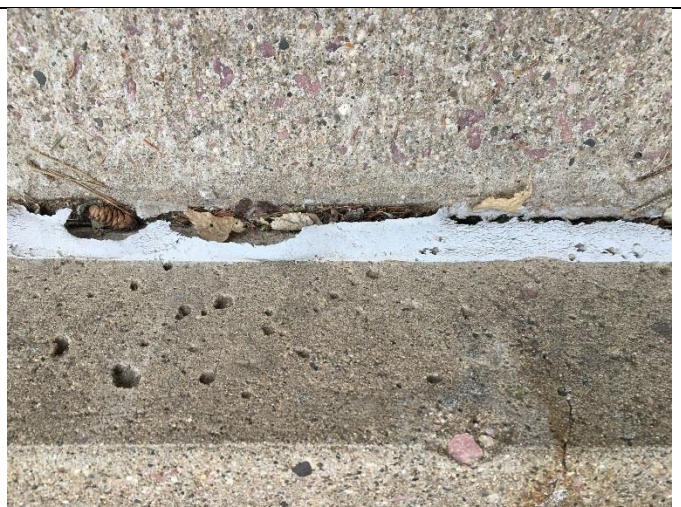
PHOTO 12 Gray Joint Caulk – Horizontal Concrete Pad

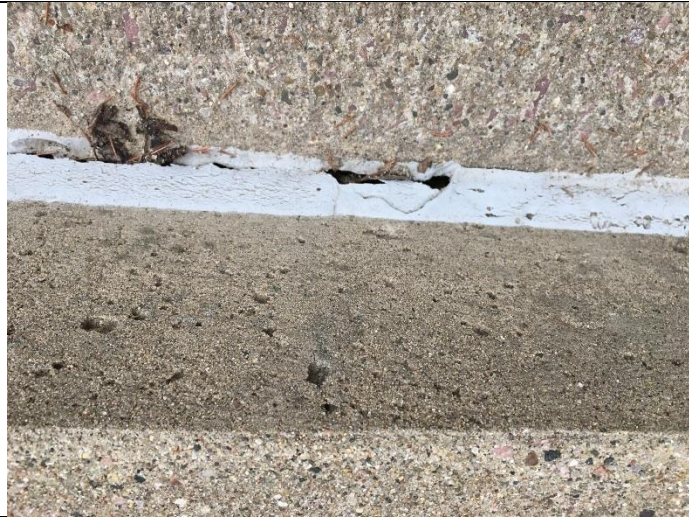
PHOTO 13 Gray Joint Caulk – Horizontal Concrete Pad

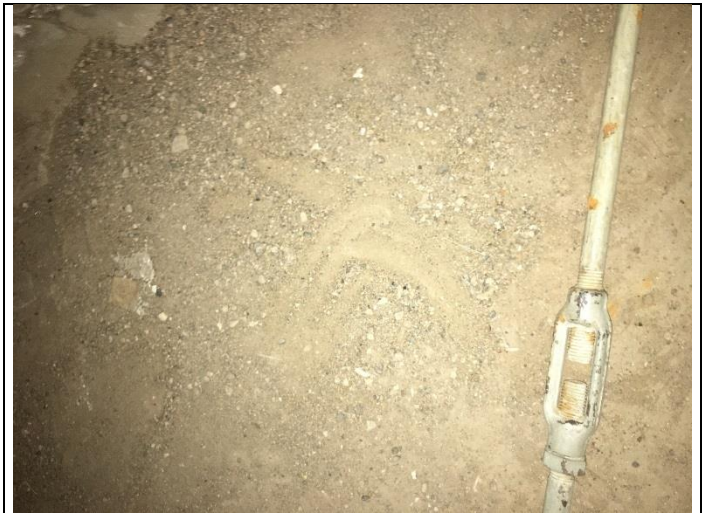
PHOTO 16 Debris on Tunnel Floor

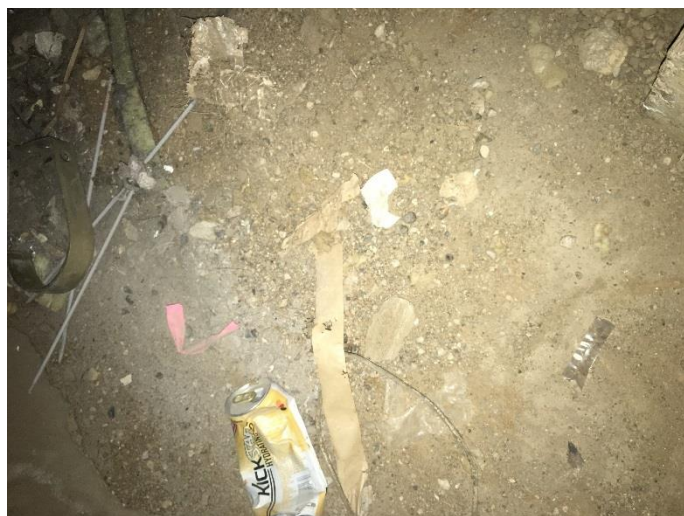
PHOTO 17 Debris on Tunnel Floor

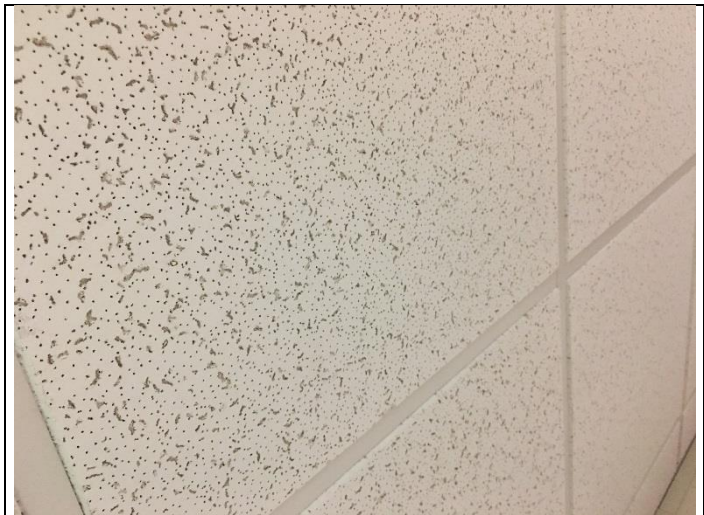
PHOTO 18 2' x 2' Ceiling Tile D-17

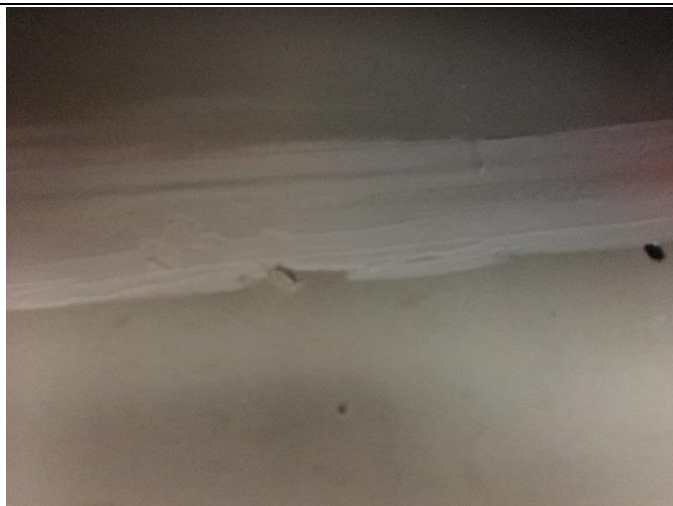
PHOTO 21 | Drywall/Joint Compound D-17

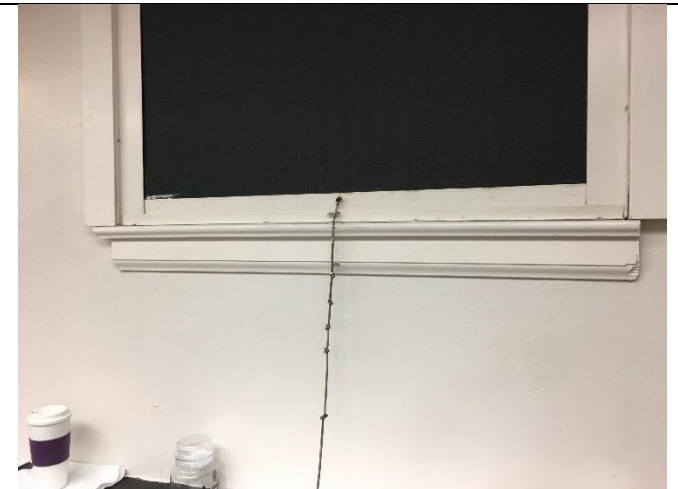
PHOTO 22 | Black Window Caulk – Windows Throughout

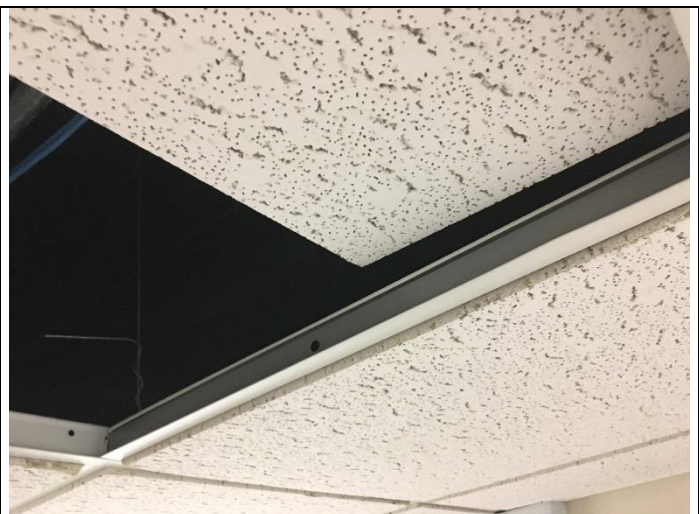
PHOTO 24 | 2' x 2' Ceiling Tile Hallway

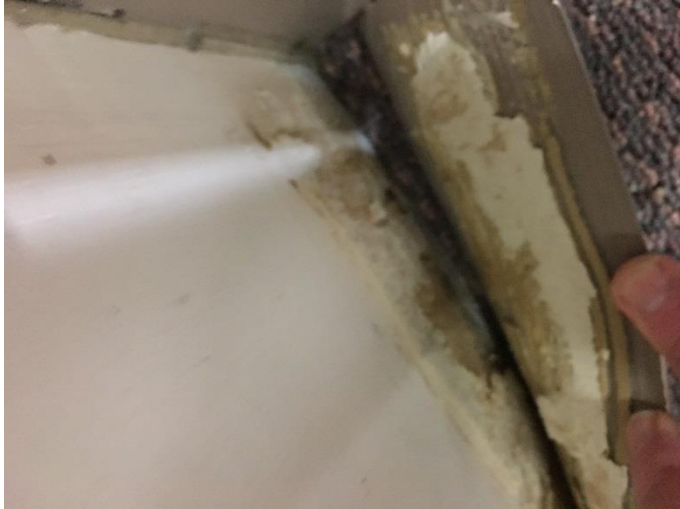
PHOTO 25 Tan Base Cove Mastic

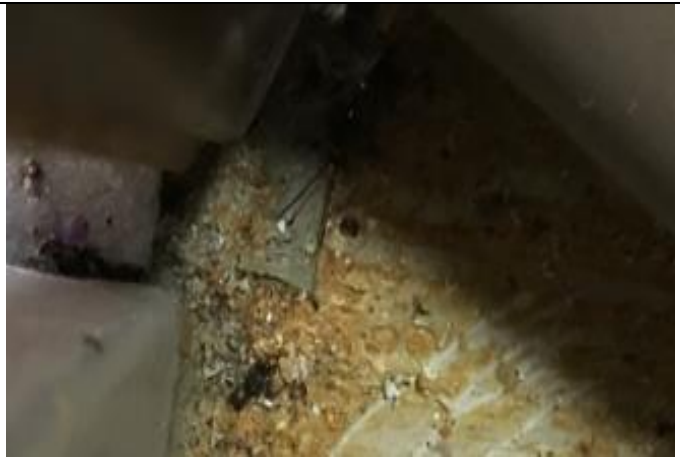
PHOTO 27 Brown Carpet Mastic – D 21

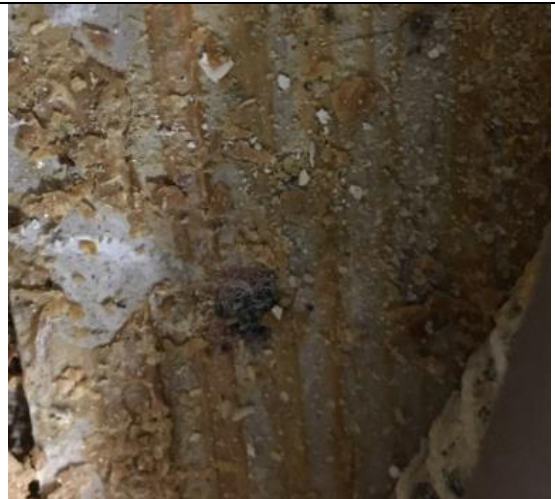
PHOTO 28 Brown Carpet Mastic – D 21

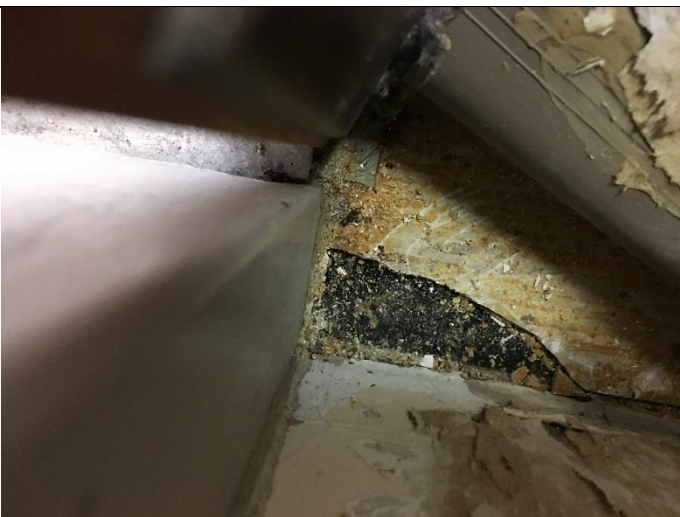
PHOTO 29 Beige VFT Black Mastic (under carpet) – D 21

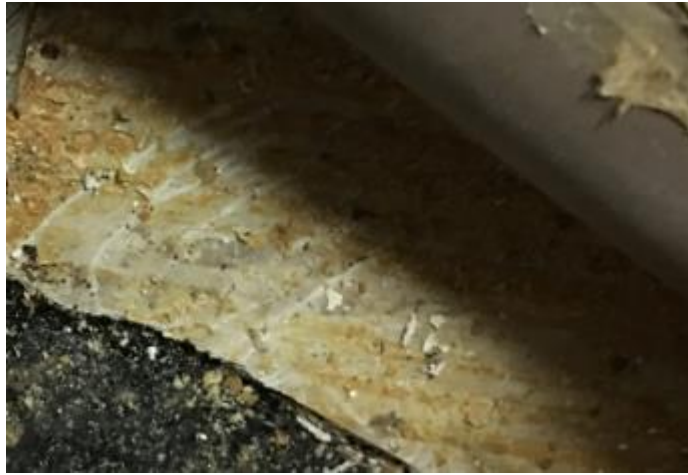
PHOTO 31 Beige VFT Black Mastic (under carpet) – D 21

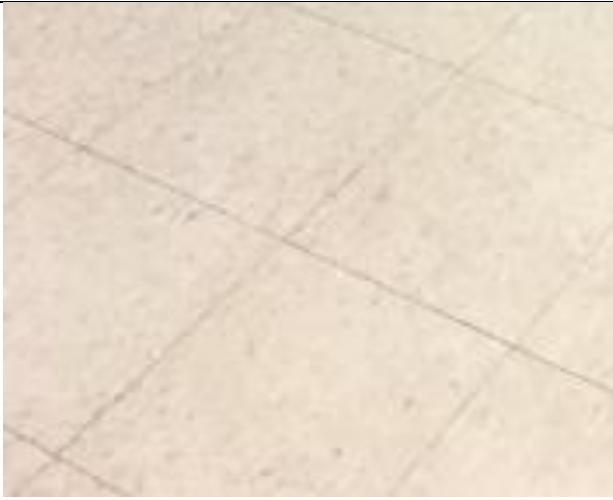
PHOTO 33 12" x 12" Beige VFT – D-27 (throughout space)

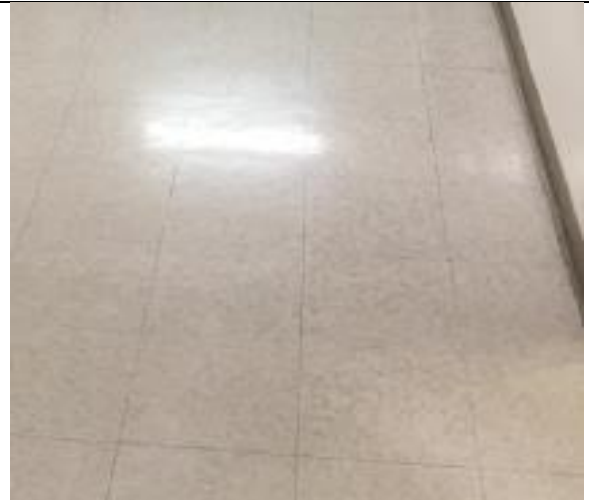
PHOTO 34 12" x 12" Beige VFT – D-27 (throughout space)

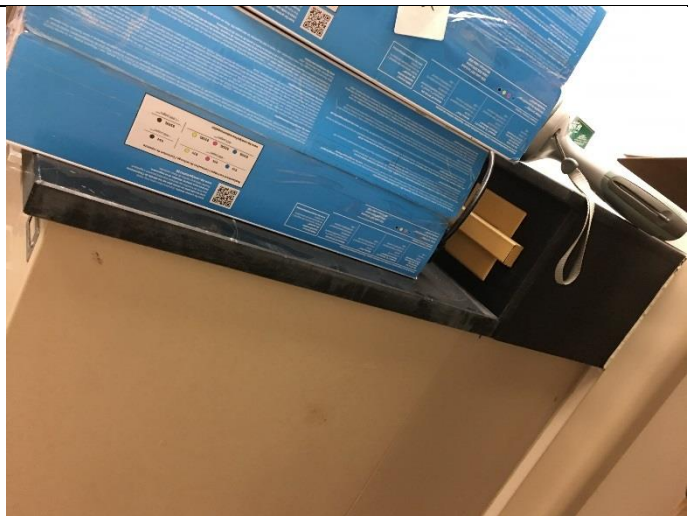
PHOTO 35 Epoxy Resin Bench Top - Lab

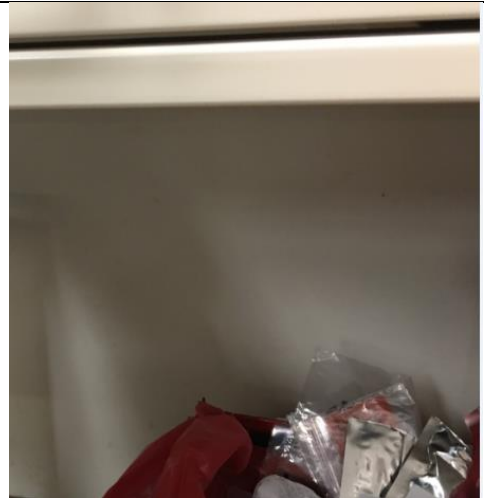
PHOTO 38 Plaster Wall – Lab (Exterior Wall)

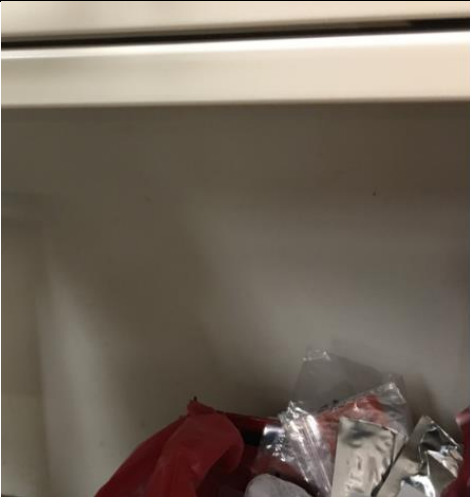
PHOTO 39 Plaster Wall – Lab (Exterior Wall)

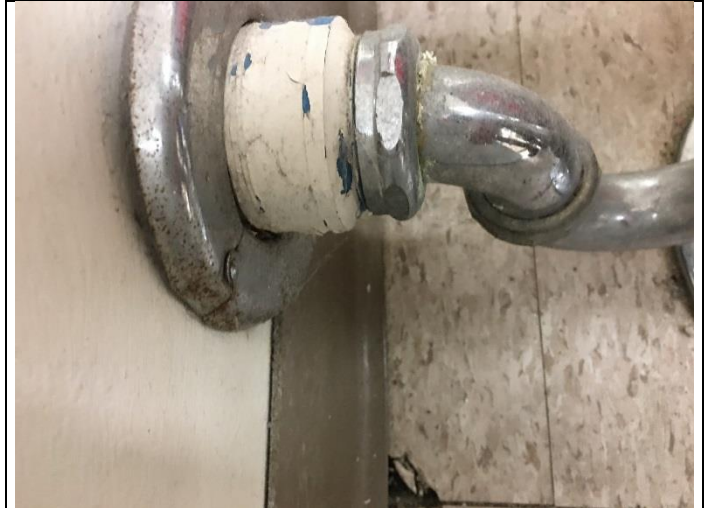
- Black mastic under 12" x 12" VFT patched area in main lab (50 ft²)
The VFT is considered ACM since it is associated with the black mastic present on the underside of the VFT applications. Both VFT and Black Mastic are considered ACM.-
- Black mastic in Rm D20 (Mechanical Room) Not associated with VFT. (40 ft²)

PHOTO 40 12" x 12" VFT Tan Blotchy/Mastic
Black Mastic 4% Chrysotile

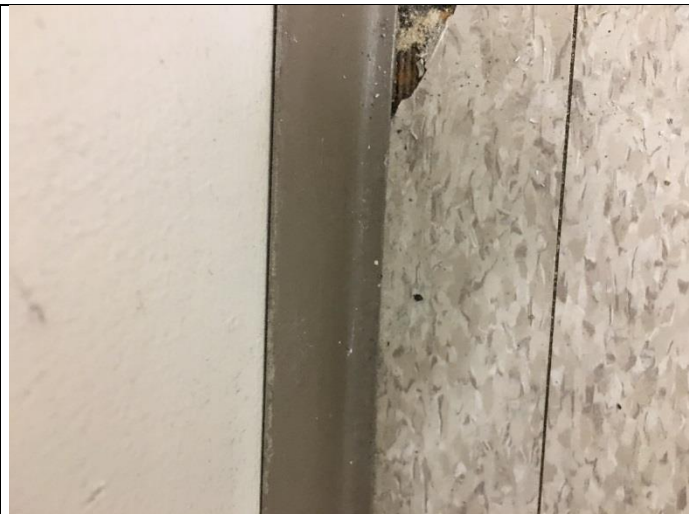
PHOTO 41 12" x 12" VFT Tan Blotchy/Mastic
Black Mastic 4% Chrysotile

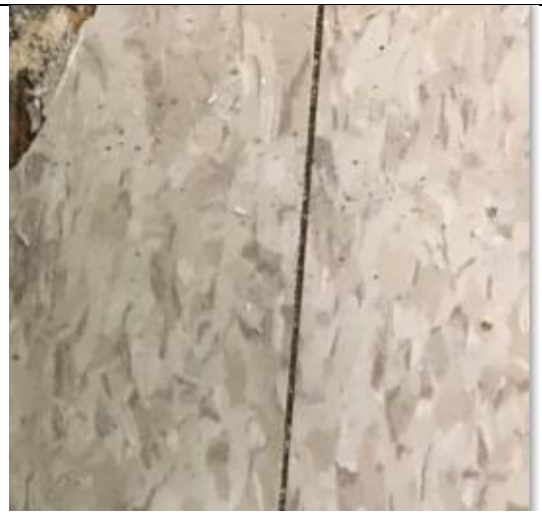
PHOTO 42 12" x 12" VFT Tan Blotchy/Mastic
Black Mastic 4% Chrysotile

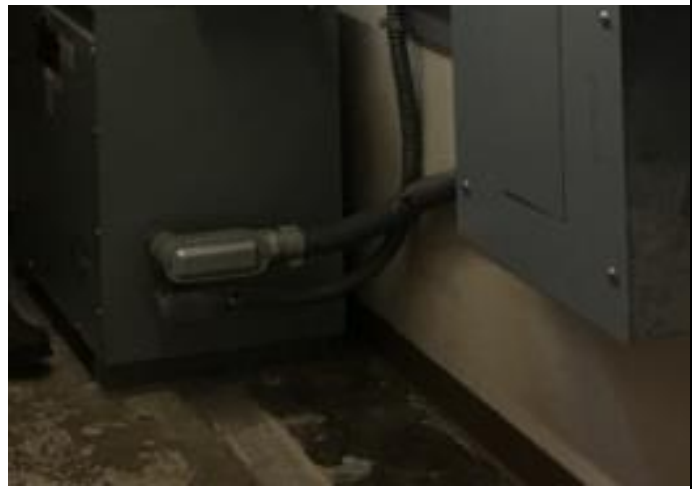
PHOTO 44 Black Mastic – D-20
5% Chrysotile

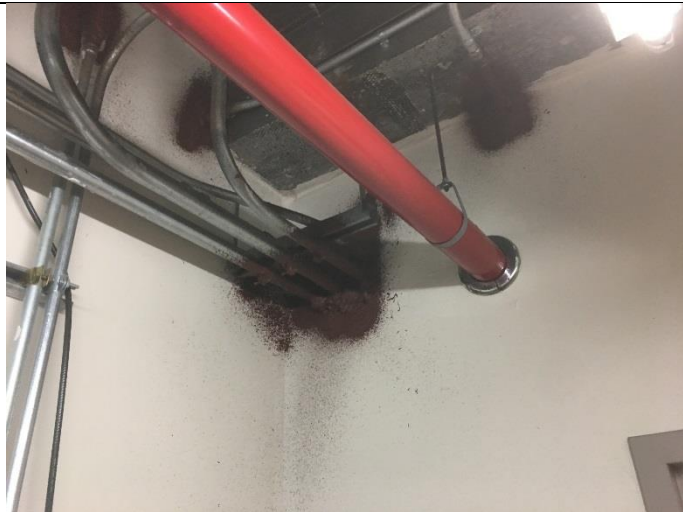
PHOTO 45 Firestop – D-20

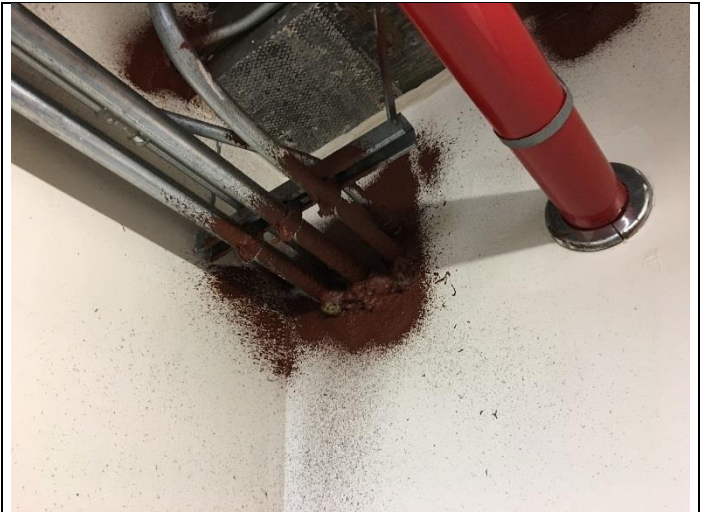
PHOTO 46 Firestop – D-20

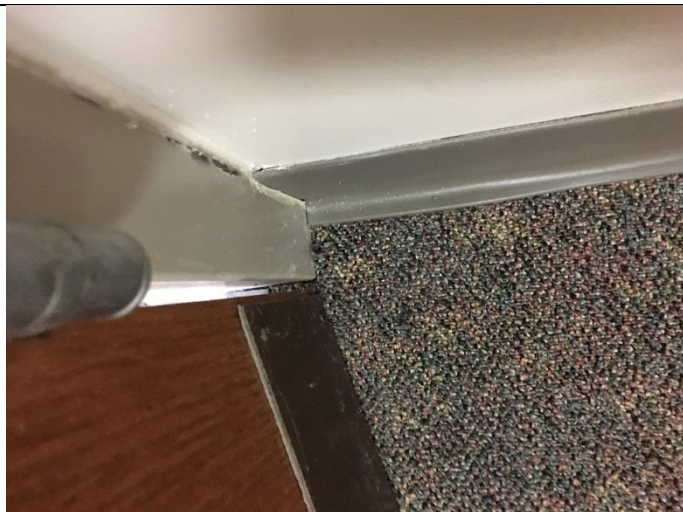
PHOTO 47 12" x 12" VFT Tan/Black Mastic
Under Carpet D-22

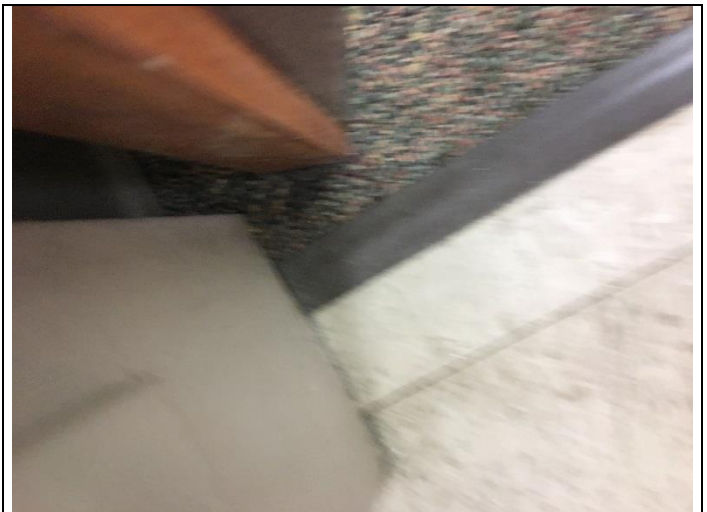
PHOTO 48 12" x 12" VFT Tan/Black Mastic
Under Carpet D-22

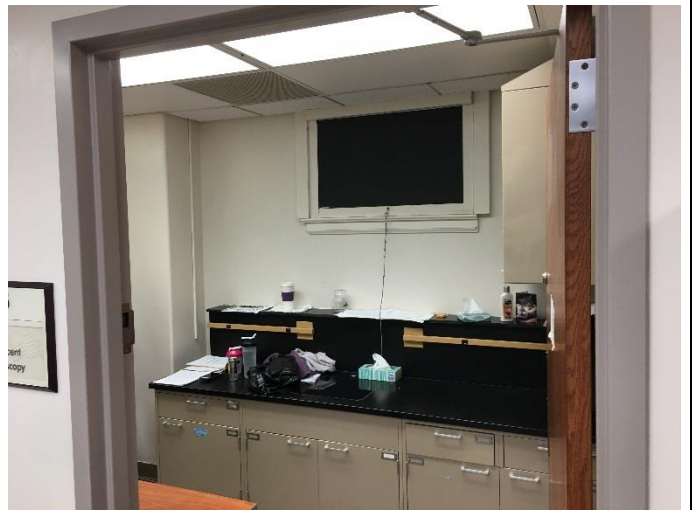
PHOTO 50

Black Epoxy Resin Bench Top – D-25

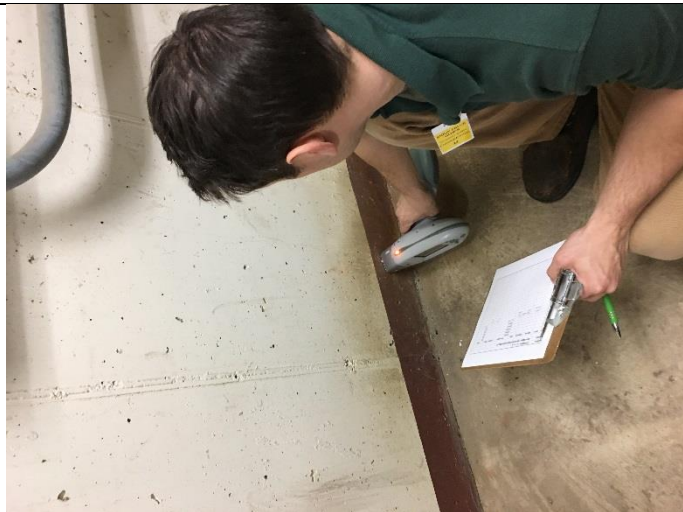
PHOTO 3 Red Base Cove Paint – Below Grade Mech. Room
<1mg/cm² lead

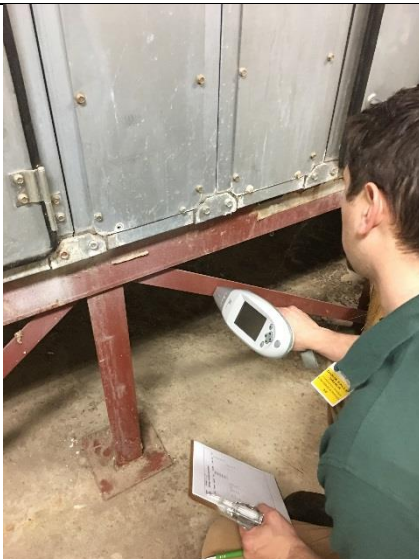
PHOTO 5 Red Painted Frame – Below Grade Mech. Room
<1mg/cm² lead

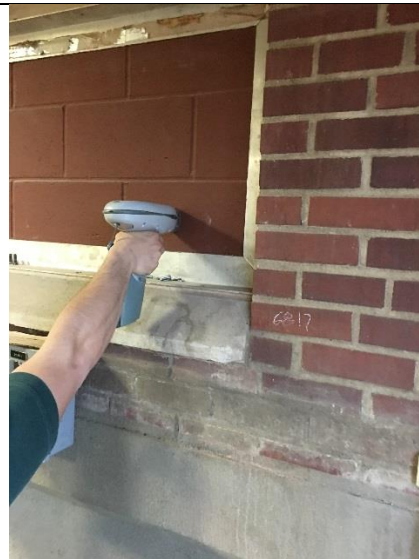
PHOTO 6 Red Painted Block Wall – Below Grade Mech. Rm
<1mg/cm² lead

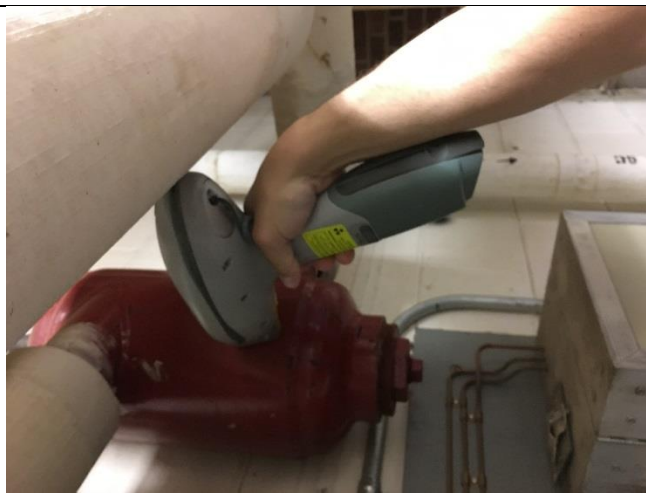
PHOTO 8 Red Painted Mixing Chamber – Below Grade Mech. Room
<1mg/cm² lead

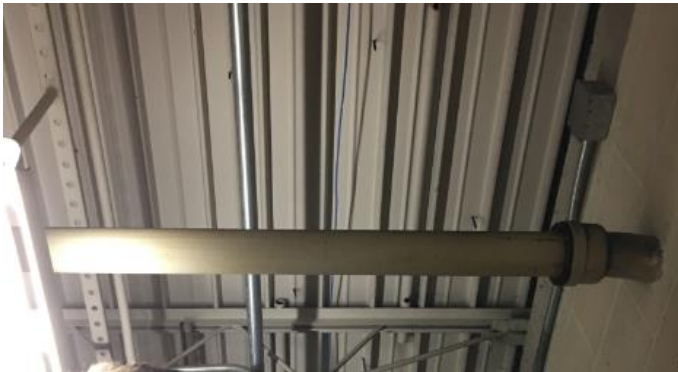
PHOTO 17 White Painted Pipe – Below Grade Mech. Room
<1mg/cm² lead

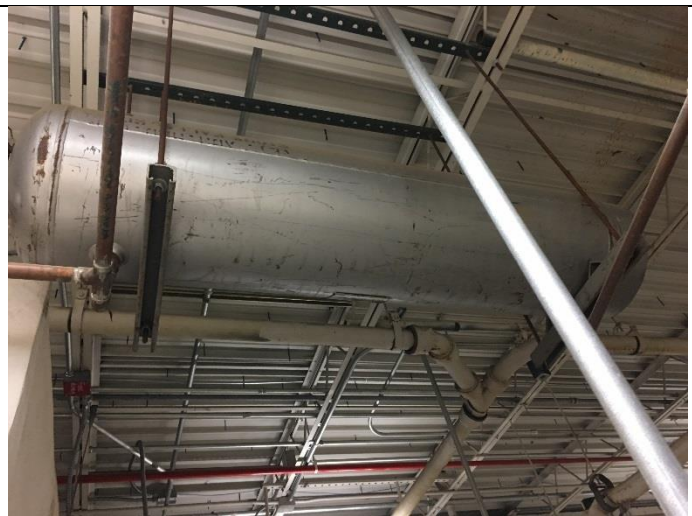
PHOTO 18 Silver Overhead Tank – Below Grade Mech. Room
<1mg/cm² lead

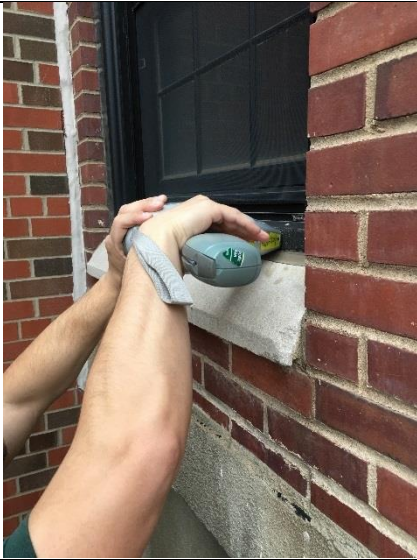
PHOTO 19 Black Window Frame - Exterior
<1mg/cm² lead

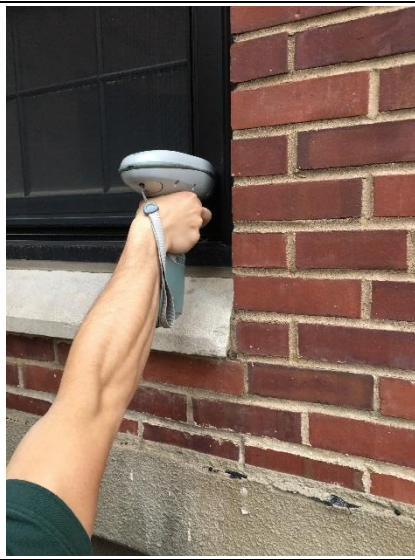
PHOTO 20 Black Window - Exterior
<1mg/cm² lead

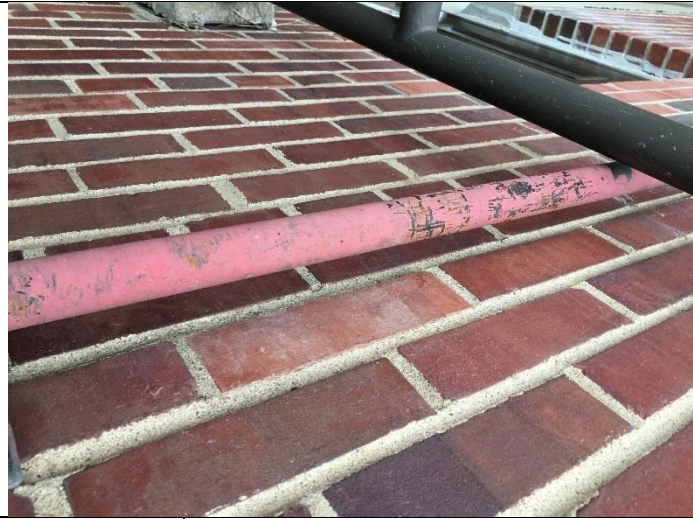
PHOTO 25 Red Pipe - Exterior
<1mg/cm² lead

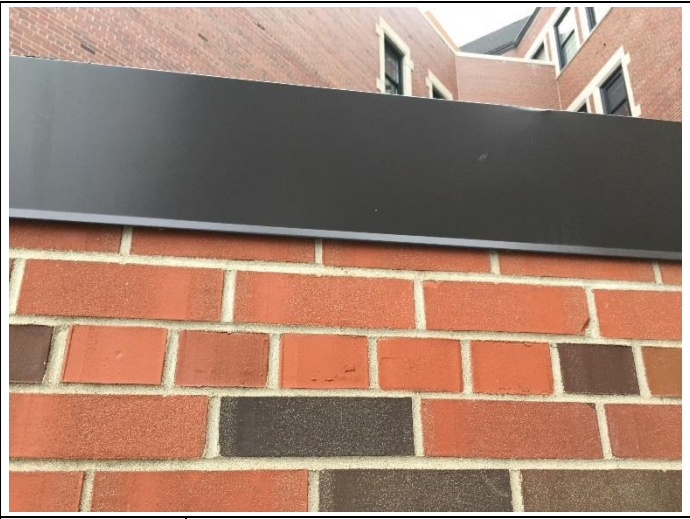
PHOTO 26 Black Flashing - Exterior
<1mg/cm² lead

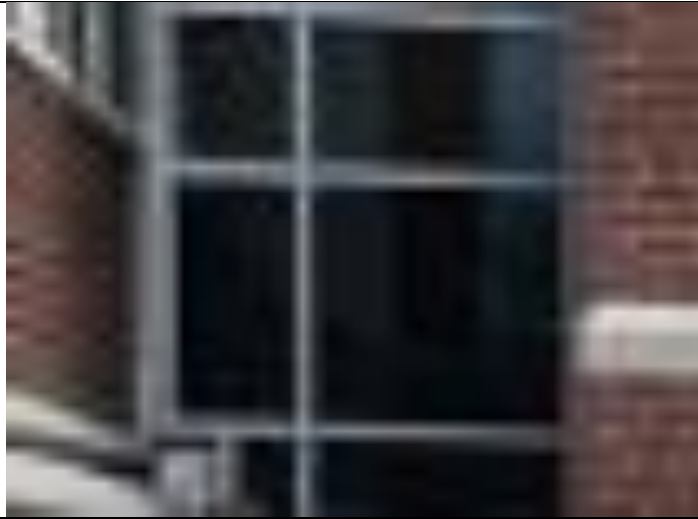
PHOTO 31 Silver Window Frame
<1mg/cm² lead

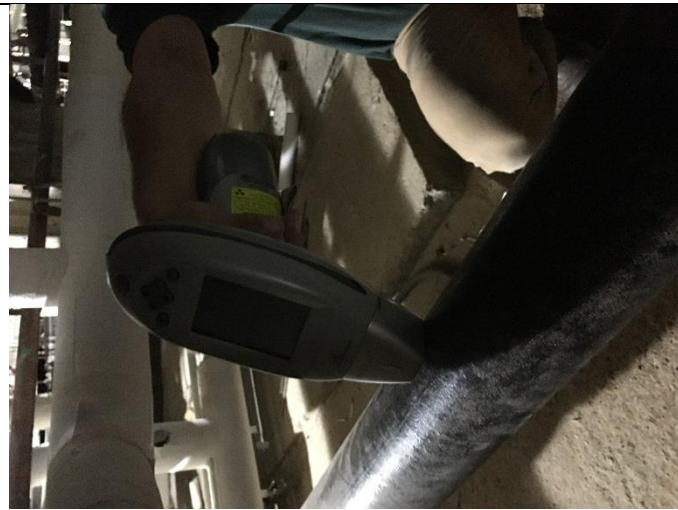
PHOTO 33 Black Pipe – Tunnel
<1mg/cm² lead

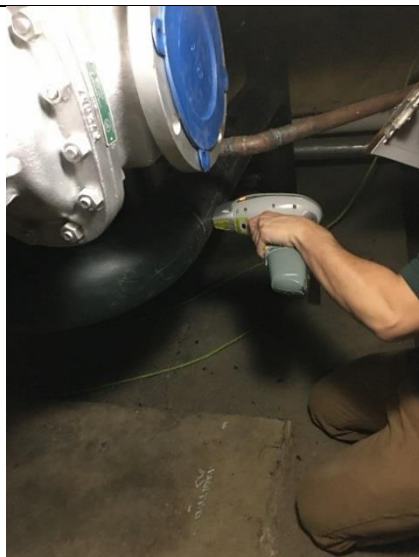
PHOTO 38 Black Pipe – Tunnel
 $<1\text{ mg/cm}^2$ lead

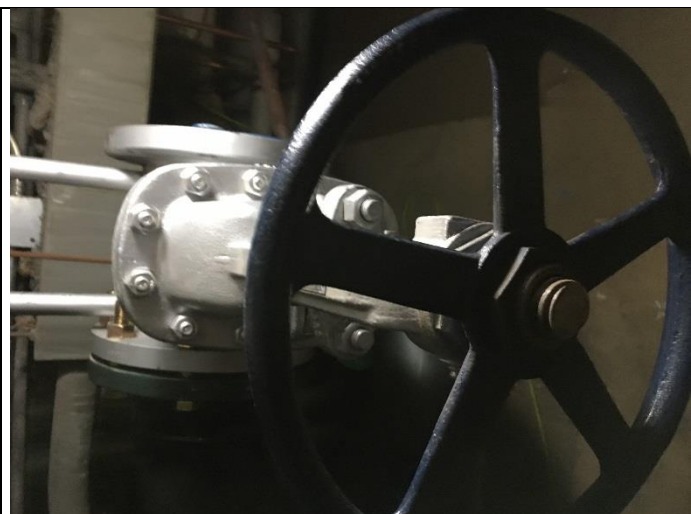
PHOTO 42 Silver Valve - Tunnel
 $<1\text{ mg/cm}^2$ lead

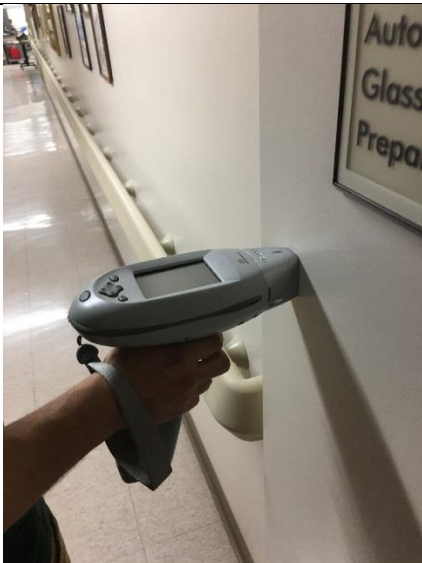
PHOTO 53 White Painted Wall – Hallway by D-17
<1mg/cm² lead

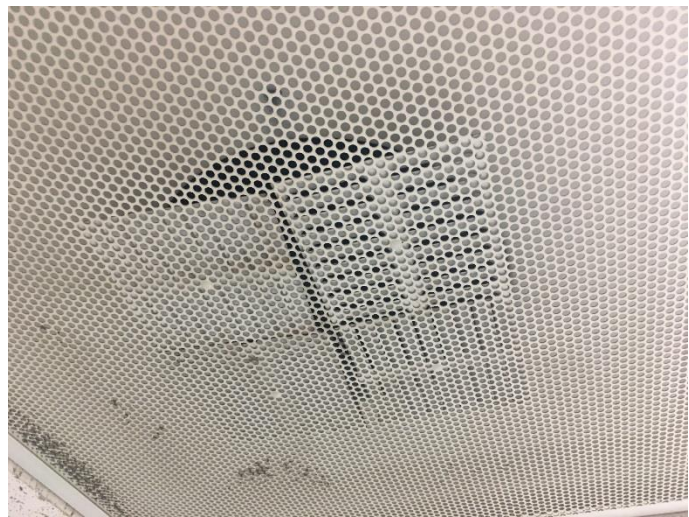
PHOTO 54 Diffuser Grate – Hallway by D-17
<1mg/cm² lead

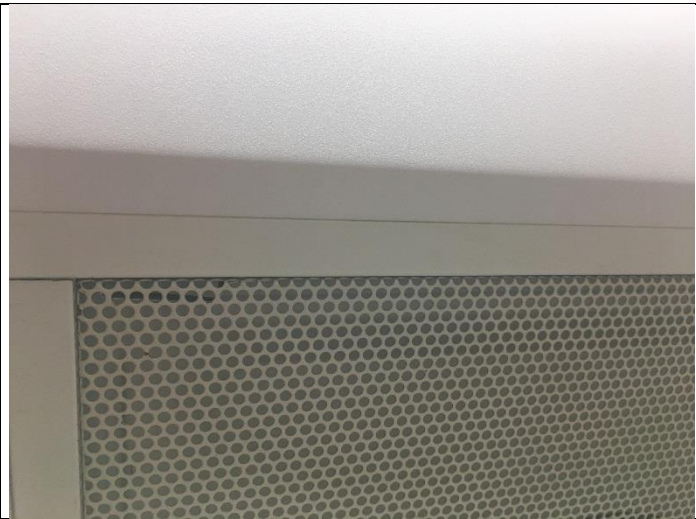
PHOTO 55 Ceiling Grid Hallway by D-17
<1mg/cm² lead

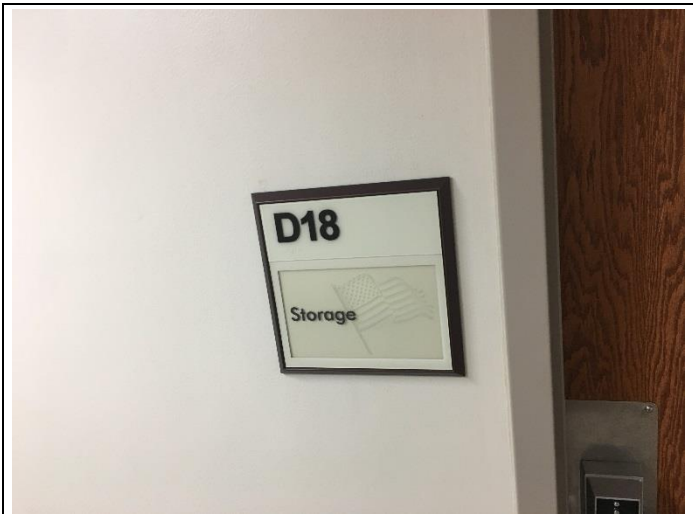
PHOTO 56 Beige Door Frame D-18
<1mg/cm² lead

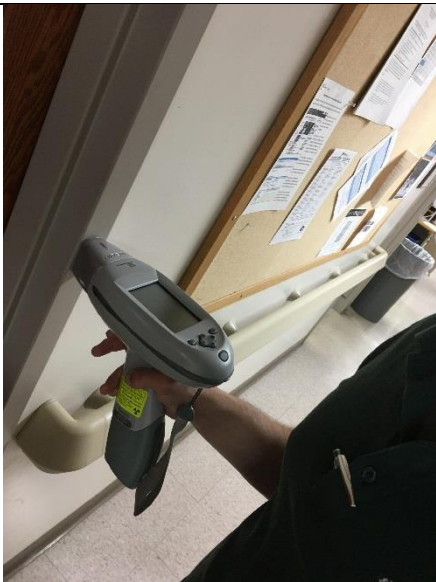
PHOTO 57 Beige Door Frame D-22
<1mg/cm² lead

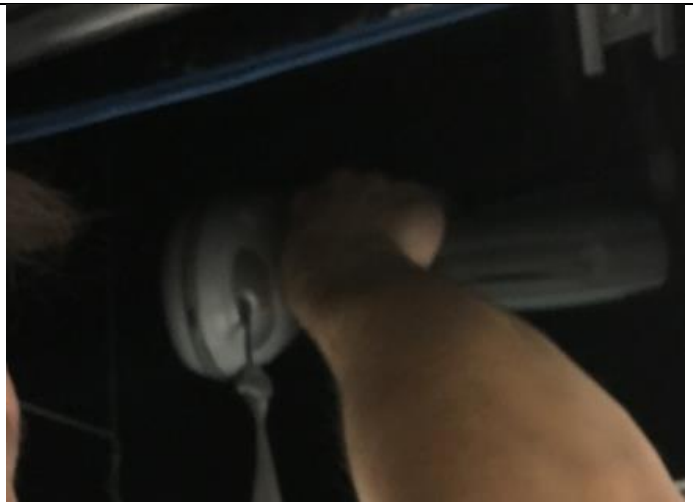
PHOTO 58 Black Pipe - Hallway
<1mg/cm² lead

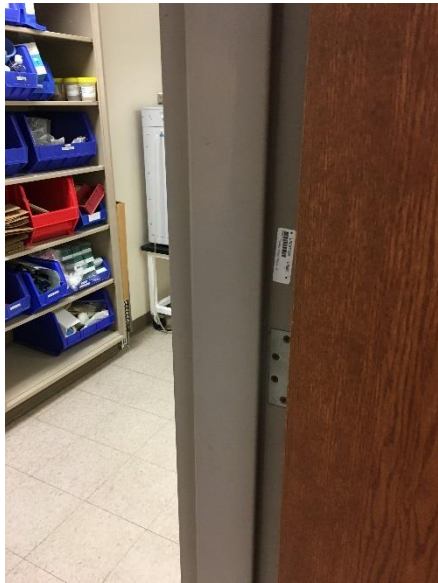
PHOTO 61 Beige Door Frame Room D-27
<1mg/cm² lead

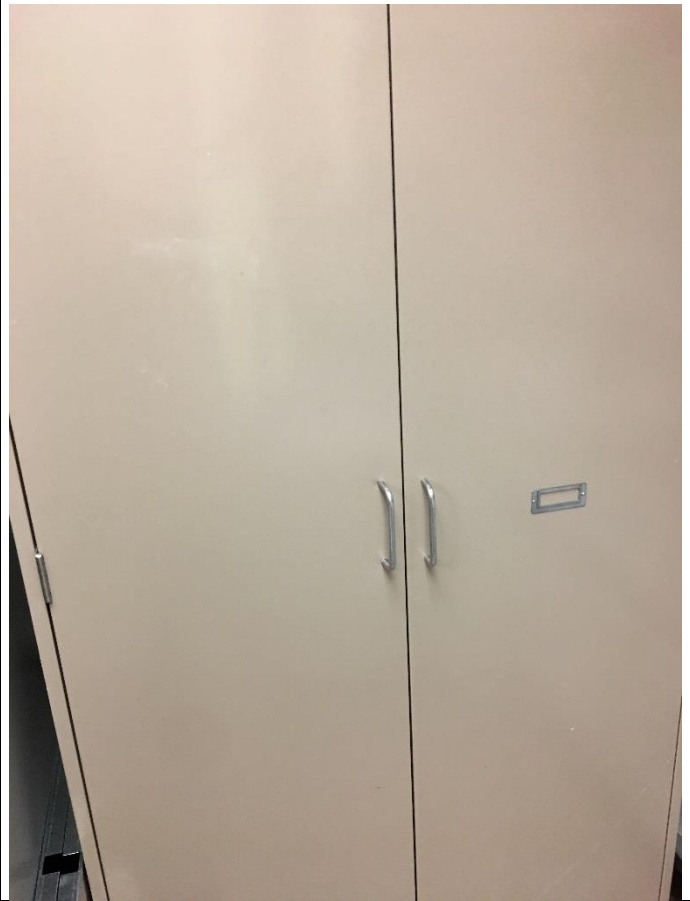
PHOTO 62 Beige Cabinet Room D-27
<1mg/cm² lead

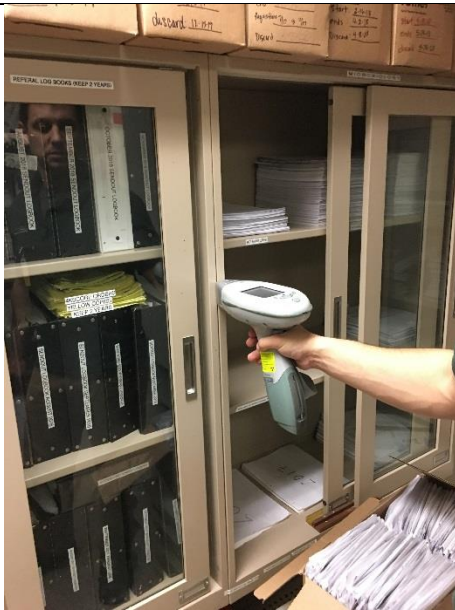
PHOTO 63 Beige Cabinet with Glass Room D-27
<1mg/cm² lead

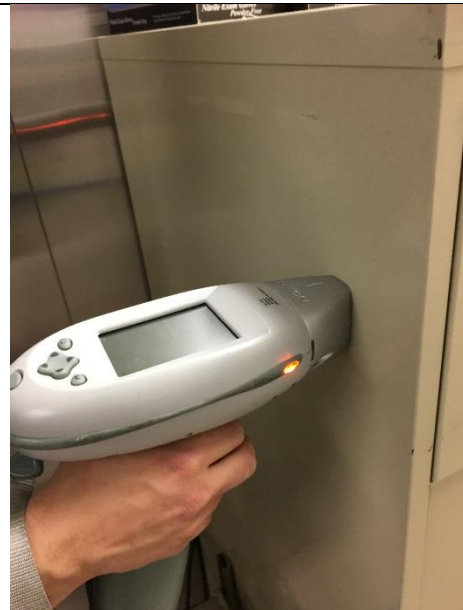
PHOTO 64 File Cabinet – S End
<1mg/cm² lead

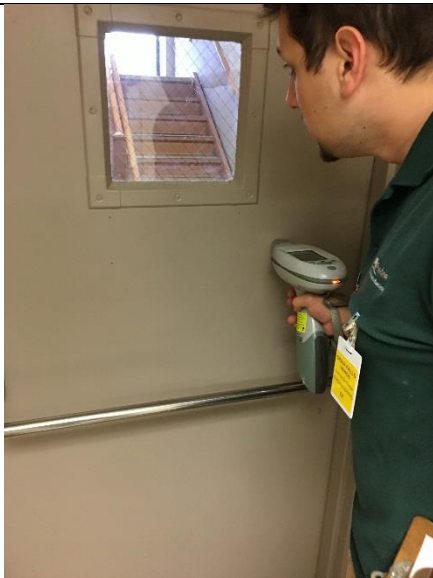
PHOTO 65 Cream Door – S End
<1mg/cm² lead

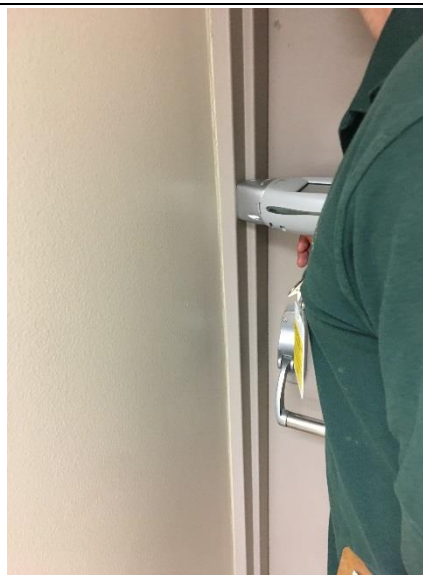
PHOTO 66 Cream Door Frame – S End
<1mg/cm² lead

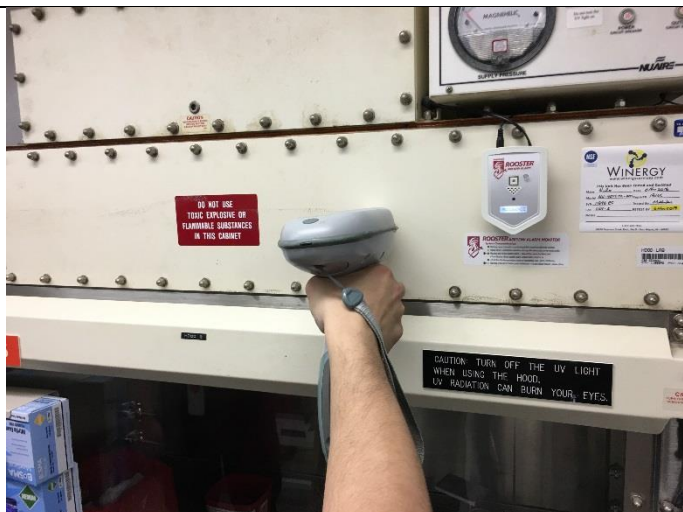
PHOTO 69 Cream Fume Hood – West Wall
<1mg/cm² lead

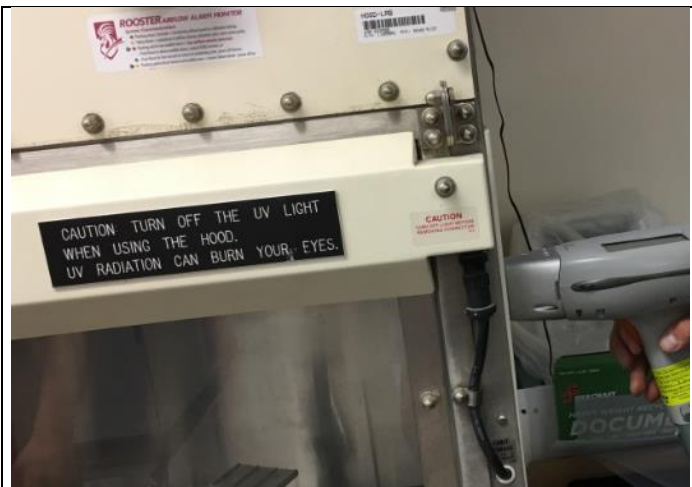
PHOTO 70 Cream Fume Hood – West Wall
<1mg/cm² lead

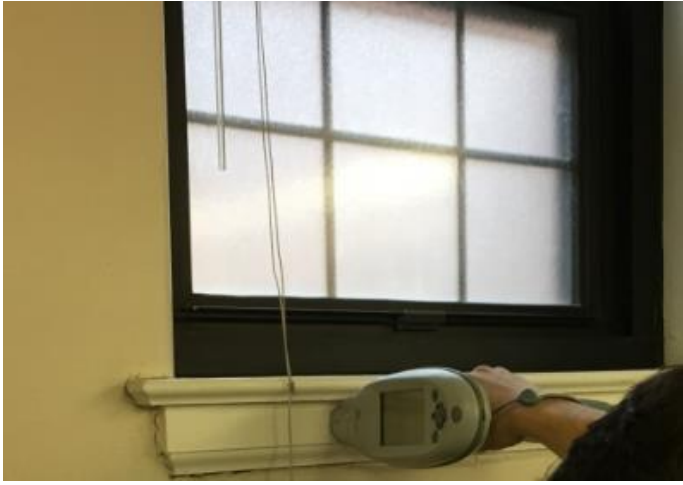
PHOTO 71 Window Sill and Trim Below Window
5.3 mg/cm² lead

Based on the initial lead paint testing results, AMIE recommends TCLP testing be conducted on the existing building materials, painted and unpainted, prior to the start of renovation or demolition activity. In addition, trade contractors who work in the facility should also be notified of the presence of lead so that they can appropriately monitor and protect their workers against lead exposure.

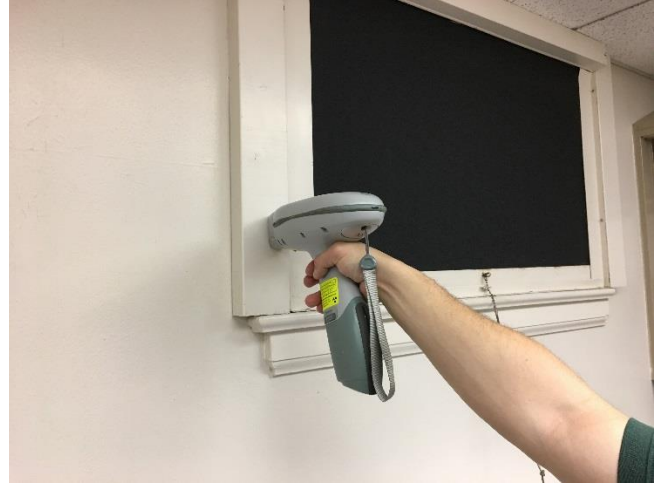
PHOTO 72 Non-Decorative Window Trim
<1mg/cm² lead

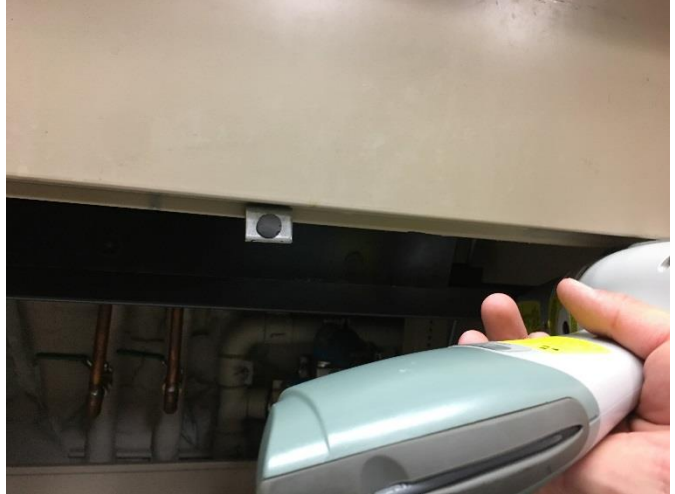
PHOTO 74 Black Metal surrounding sink basin
<1mg/cm² lead

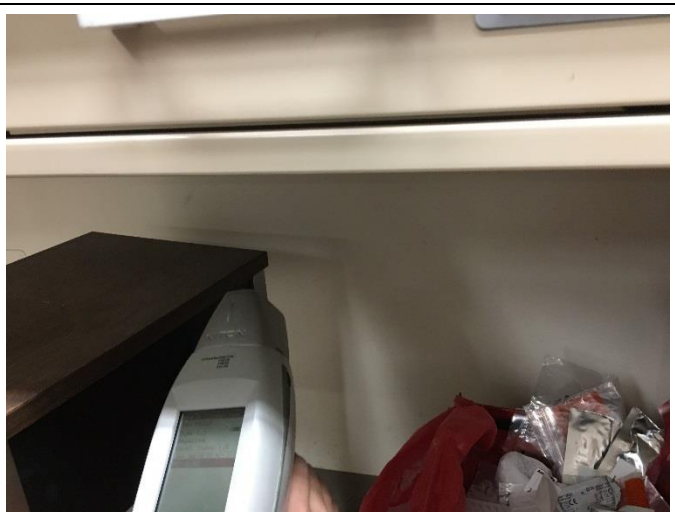
PHOTO 76 White Paint on Plaster
<1mg/cm² lead

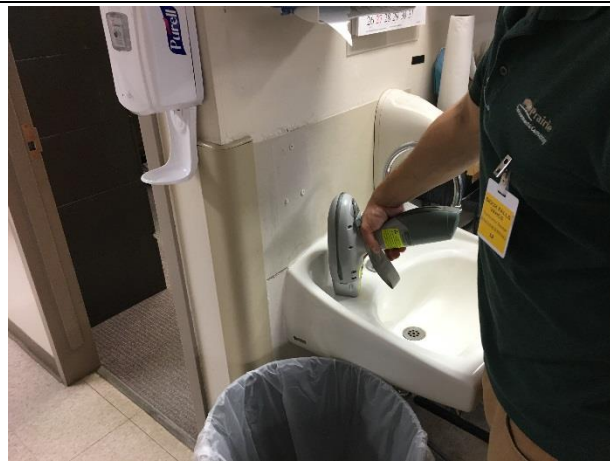
PHOTO 86 Porcelain Sink – Lab
<1mg/cm² lead

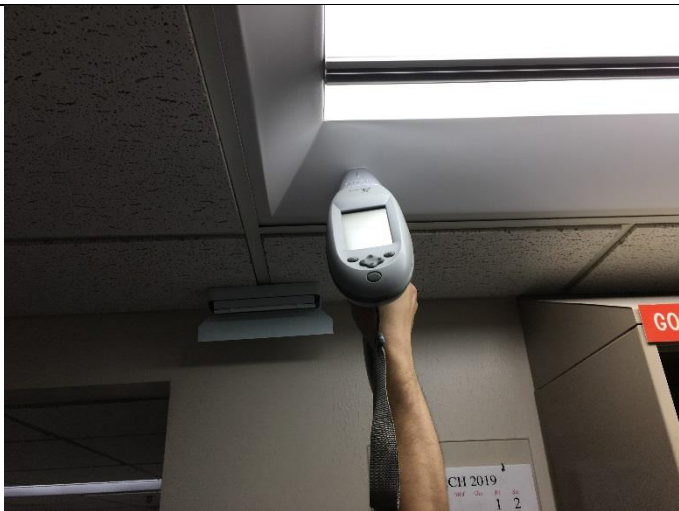
PHOTO 87 Ceiling Light Fixture
<1mg/cm² lead

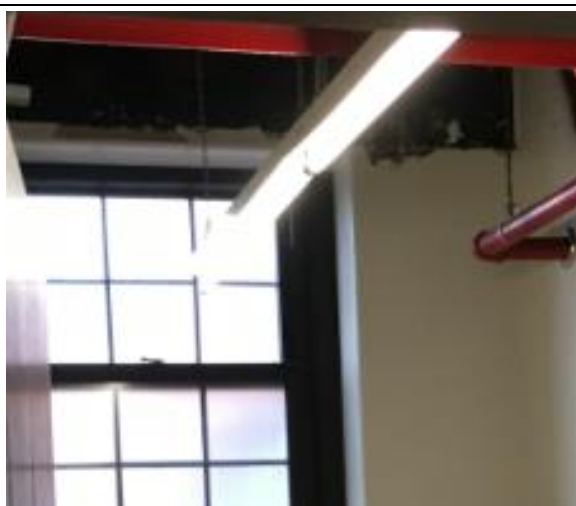
PHOTO 88 Black Concrete Wall Above Window – D-20
<1mg/cm² lead
