4. SUMMARY OF INSPECTION FINDINGS

Location:		VA Medical Center, Sioux Falls, SD - Building 5 (Mech Rm, Tunnel, Lower Level)						
Inspector:		Jason Biggins, Prairie Environmental Consulting, LLC						
XRF Model: NITON XLp Series Lead Analyzer, serial #24794					Lead Paint ≥ 1.0 mg/cm²			
XRF #	Unit #	Substrate	Component	Color	Test Location	Condition	Results	Notes
1					Calibrate			Test
2					Calibrate			Test
3					Calibrate			Test
4					Calibrate			Test
5					Calibrate			Test
6					Calibrate			Test
7	Mech Rm	Metal	Electrical Panel	Grey	Mech Rm	Good	0.00	
8	Mech Rm	Concrete	Wall	White	Mech Rm	Fair	0.00	
9	Mech Rm	Concrete	Wall	Red	Mech Rm	Fair	0.00	
10	Mech Rm	Metal	Duct	Grey	Mech Rm	Fair	0.00	
11	Mech Rm	Metal	Frame	Red	Mech Rm	Fair	0.01	
12	Mech Rm	Concrete	Wall	Red	Mech Rm	Good	0.00	
13	Mech Rm	Metal	Tank	Silver	Mech Rm	Fair	0.01	
14	Mech Rm	Metal	Mixing Chamber	Red	Mech Rm	Fair	0.25	
15	Mech Rm	Wood	Panel	Grey	Mech Rm	Fair	0.00	
16	Mech Rm	Metal	Casing	Grey	Mech Rm	Good	0.01

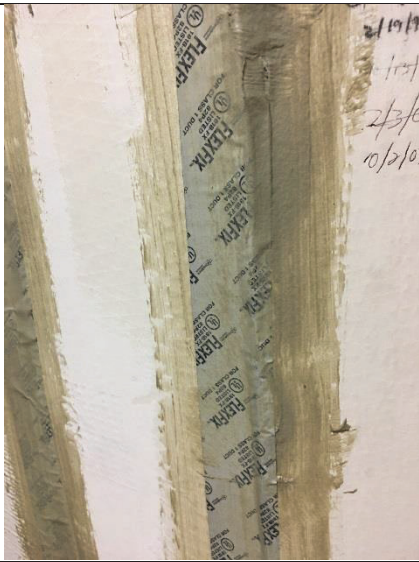
PHOTO 1 Gray Mastic – Duct in below grade mechanical room

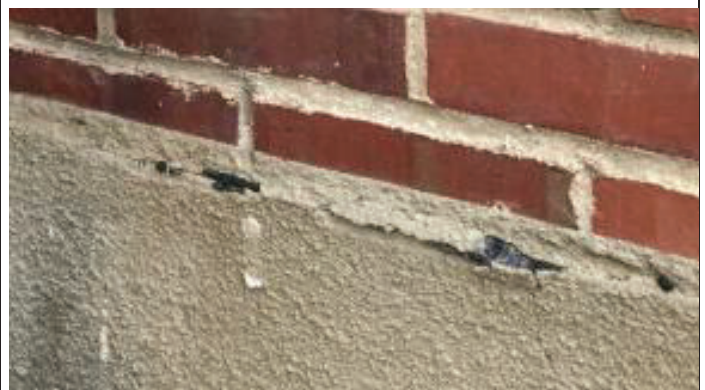
PHOTO 6 Black Tar Under EFIS – Mech. Room Entry

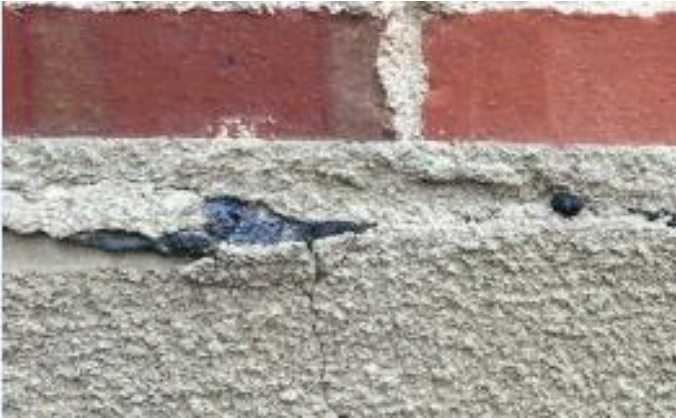
PHOTO 7 Black Tar Under EFIS – Mech. Room Entry

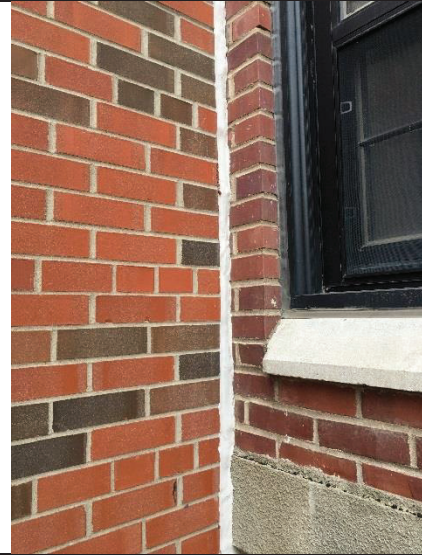
PHOTO 8 White Joint Caulk – Entry to Mech. Room

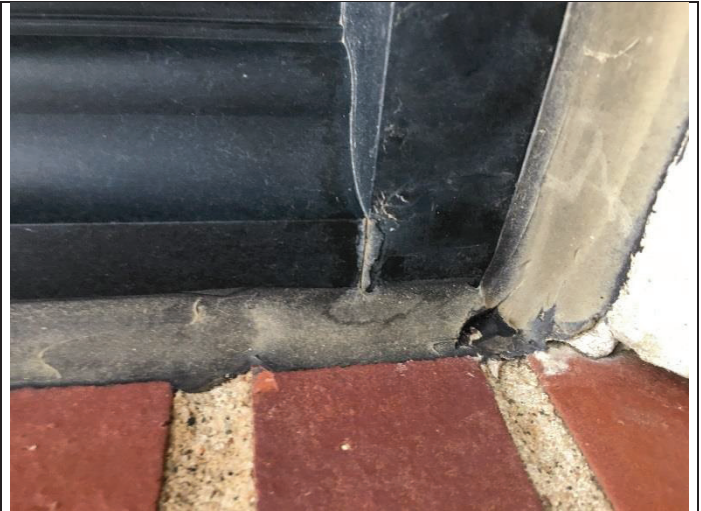
PHOTO 10 Gray Window Caulk - Exterior

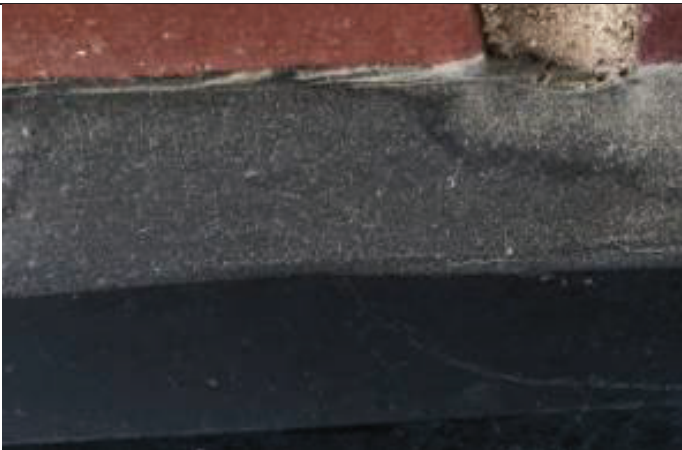
PHOTO 11 Gray Window Caulk - Exterior

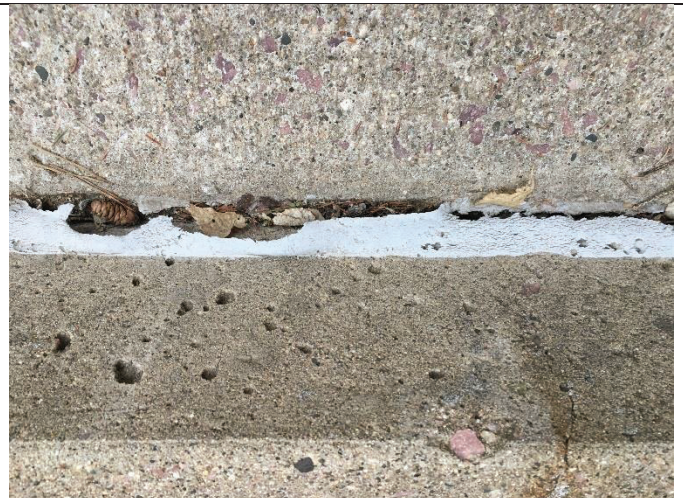
PHOTO 12 Gray Joint Caulk – Horizontal Concrete Pad

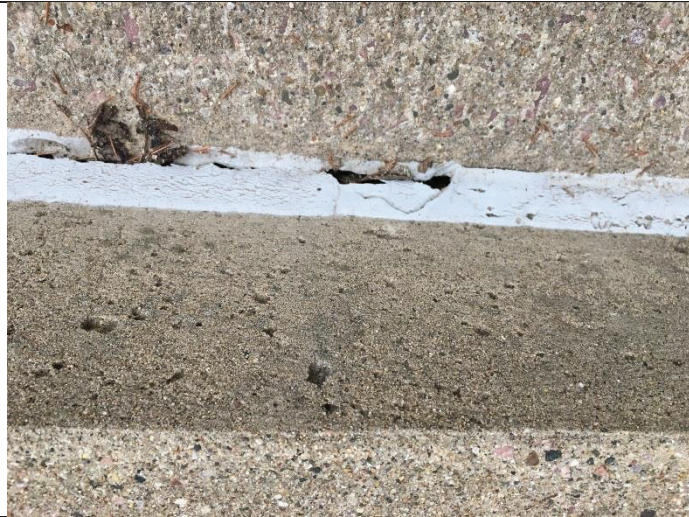
PHOTO 13 Gray Joint Caulk – Horizontal Concrete Pad

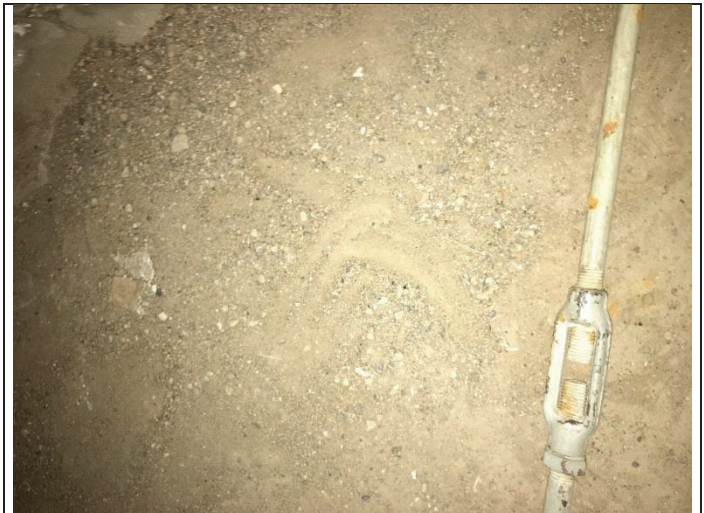
PHOTO 16 Debris on Tunnel Floor

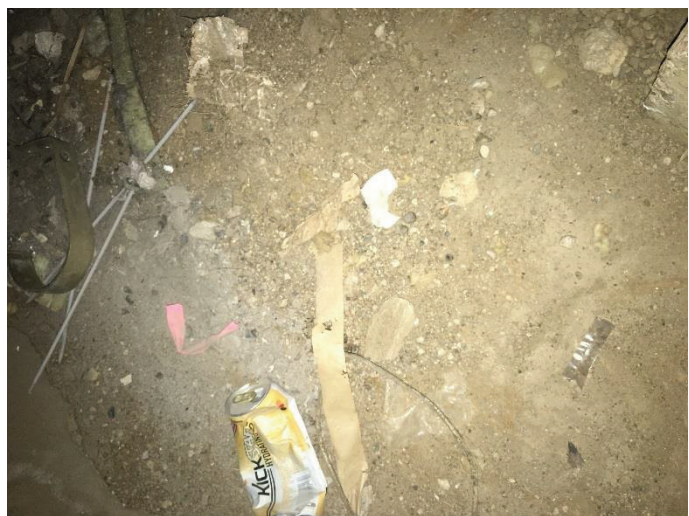
PHOTO 17 Debris on Tunnel Floor

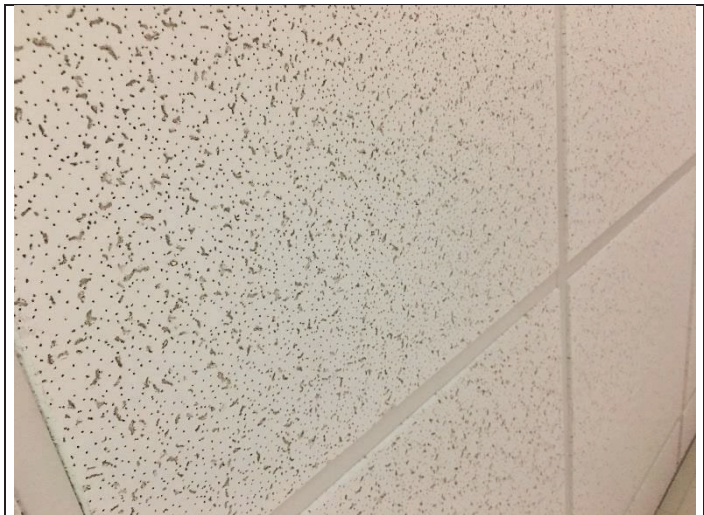
PHOTO 18 2' x 2' Ceiling Tile D-17

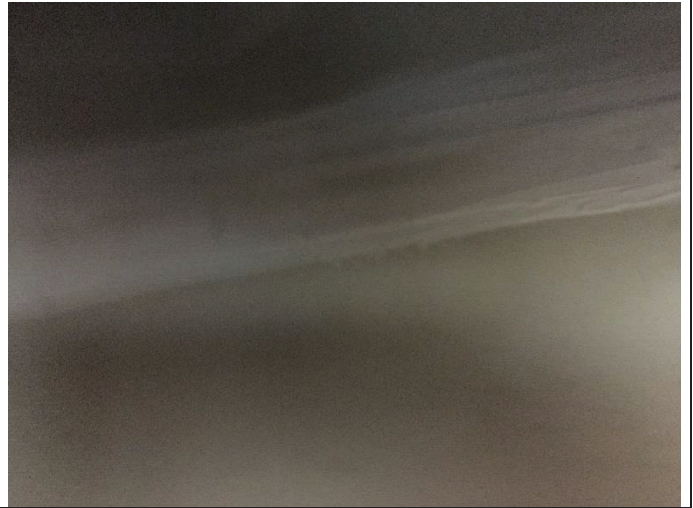
PHOTO 20 | Drywall/Joint Compound D-17

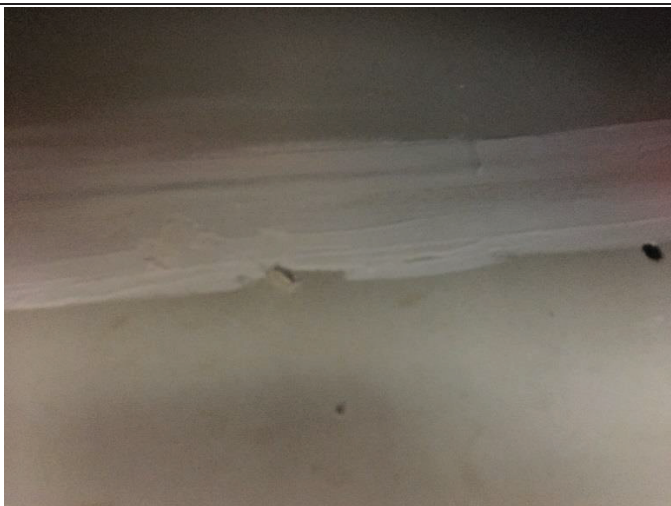
PHOTO 21 | Drywall/Joint Compound D-17

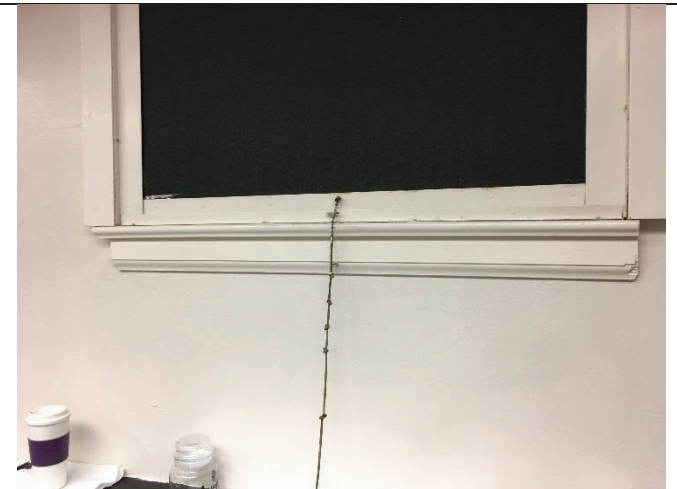
PHOTO 22 | Black Window Caulk – Windows Throughout

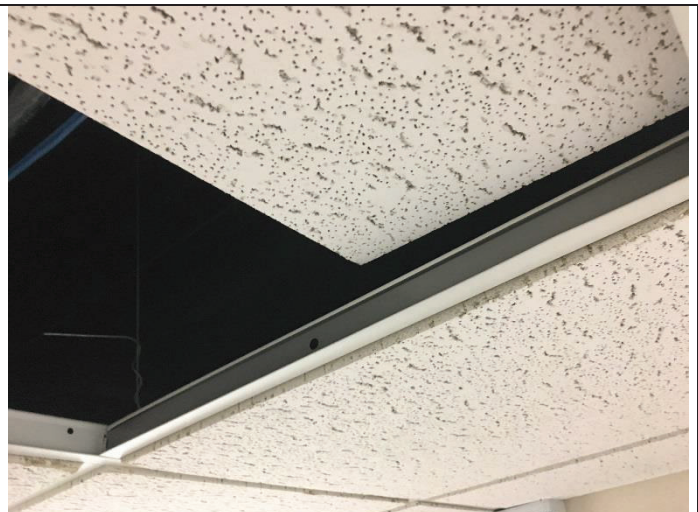
PHOTO 24 | 2' x 2' Ceiling Tile Hallway

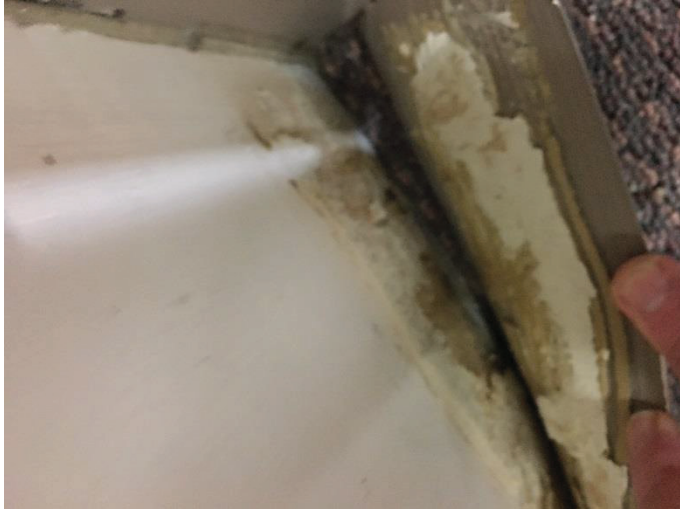
PHOTO 25 Tan Base Cove Mastic

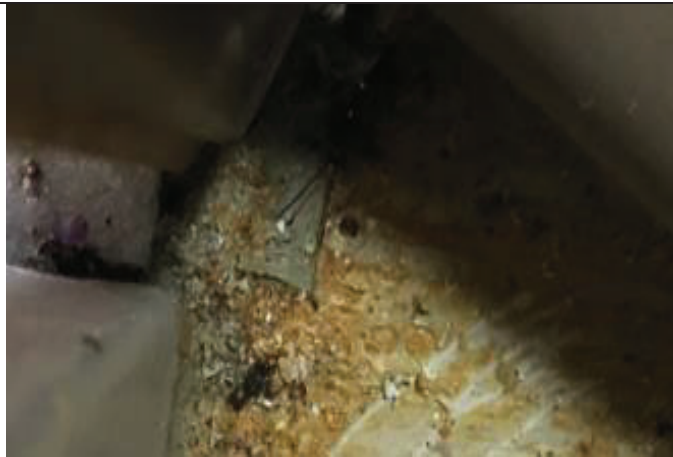
PHOTO 27 Brown Carpet Mastic – D 21

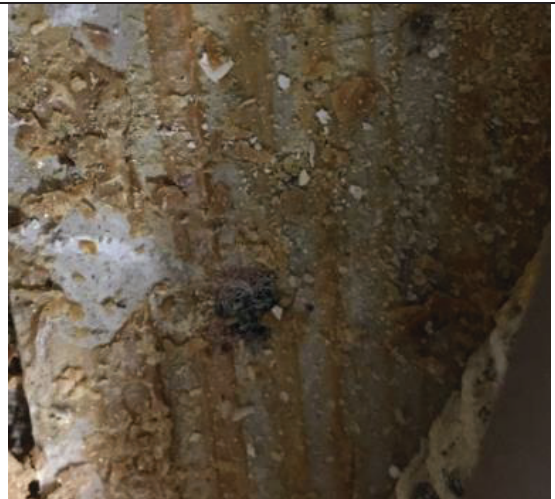
PHOTO 28 Brown Carpet Mastic – D 21

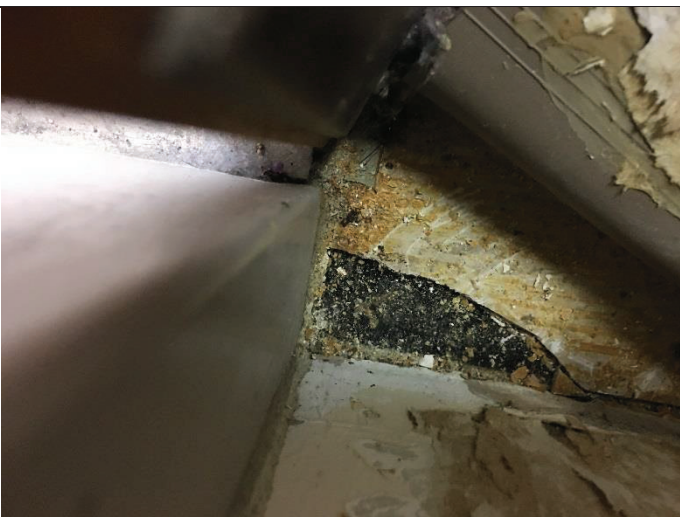
PHOTO 29 Beige VFT Black Mastic (under carpet) – D 21

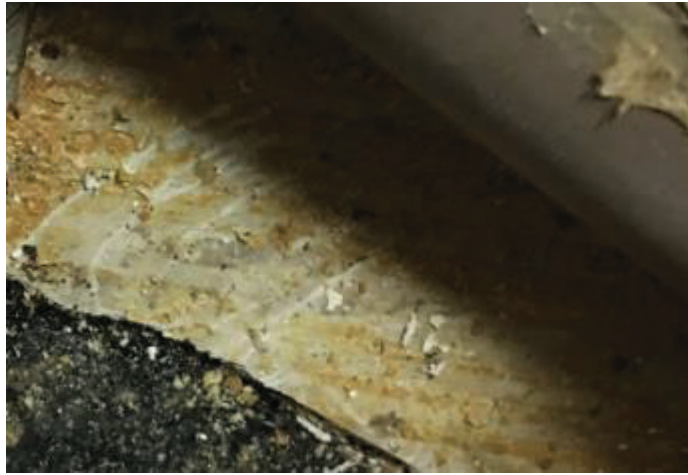
PHOTO 31 Beige VFT Black Mastic (under carpet) – D 21

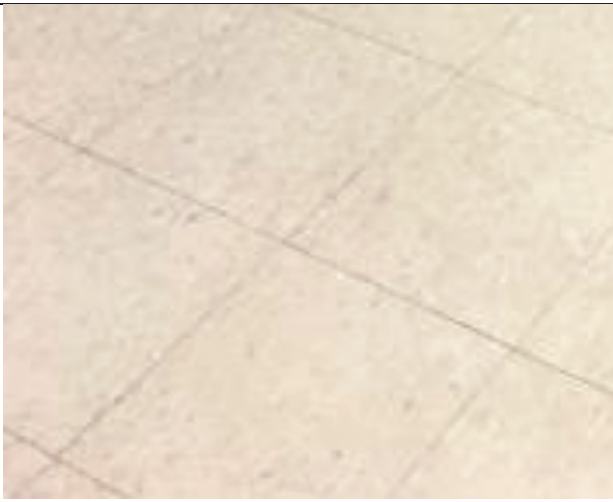
PHOTO 33 12" x 12" Beige VFT – D-27 (throughout space)

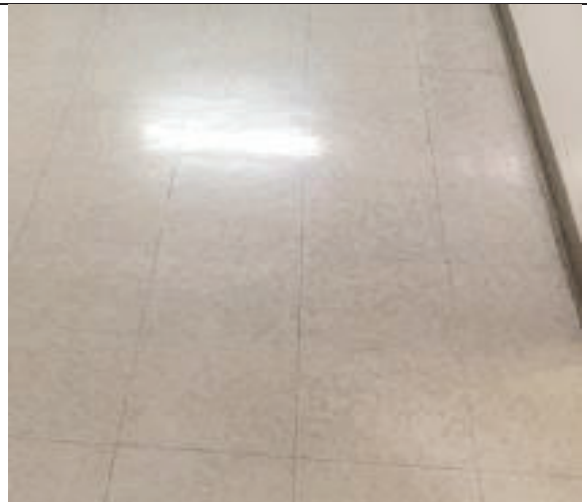
PHOTO 34 12" x 12" Beige VFT – D-27 (throughout space)

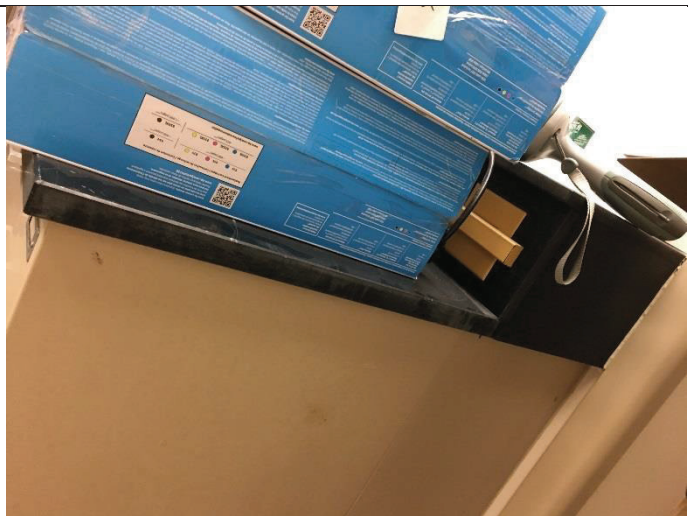
PHOTO 35 Epoxy Resin Bench Top - Lab

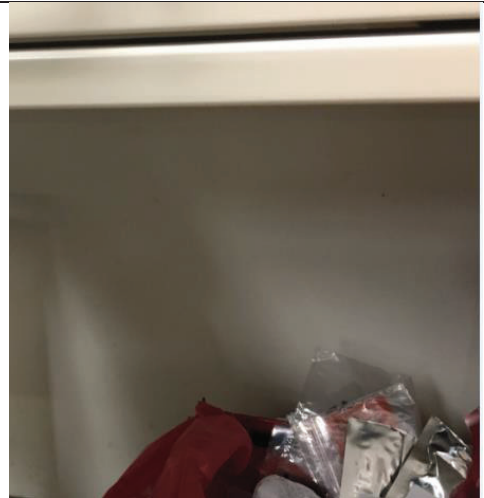
PHOTO 38 Plaster Wall – Lab (Exterior Wall)

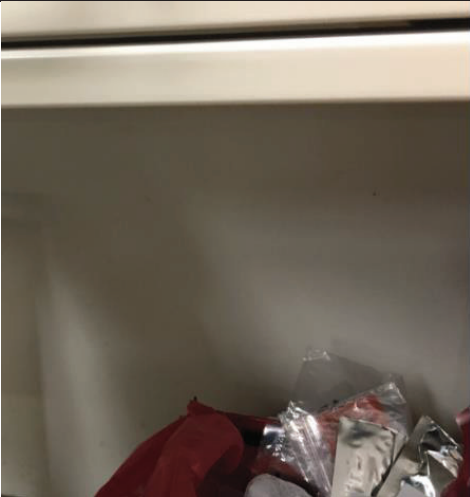
PHOTO 39 Plaster Wall – Lab (Exterior Wall)

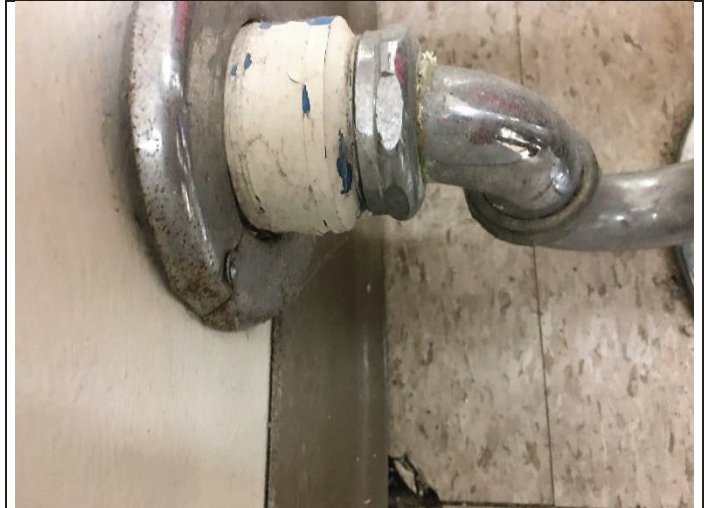
- Black mastic under 12" x 12" VFT patched area in main lab (50 ft²)
The VFT is considered ACM since it is associated with the black mastic present on the underside of the VFT applications. Both VFT and Black Mastic are considered ACM.-
- Black mastic in Rm D20 (Mechanical Room) Not associated with VFT. (44 ft²)

PHOTO 40 12" x 12" VFT Tan Blotchy/Mastic
Black Mastic 4% Chrysotile

State and/or federal regulations require that ACMs be removed prior to demolition or renovation activities that will impact the ACMs. Depending on the specific renovation work to be performed, certain ACMs may not require removal if they will not be disturbed and do not pose a risk to building occupants or construction trade workers. However, to ensure worker safety and to eliminate future asbestos-related maintenance and management costs and risks, AMIE recommends removal of all identified ACMs in the areas to be renovated. While partial abatement may be technically possible, it is often impractical and not cost-effective.

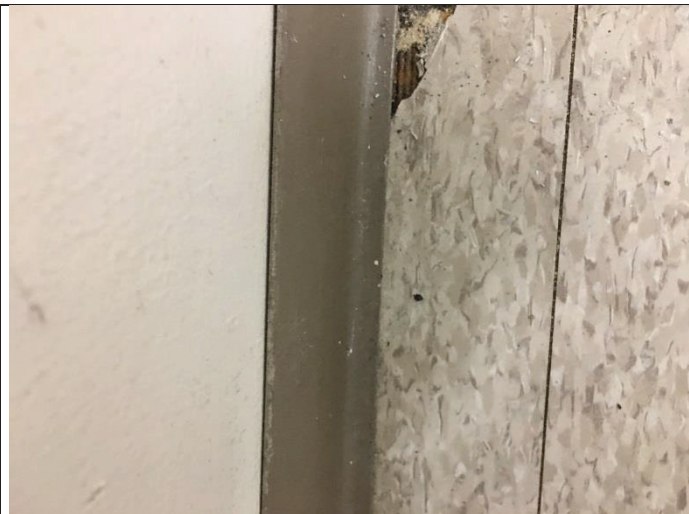
PHOTO 41 12" x 12" VFT Tan Blotchy/Mastic
Black Mastic 4% Chrysotile

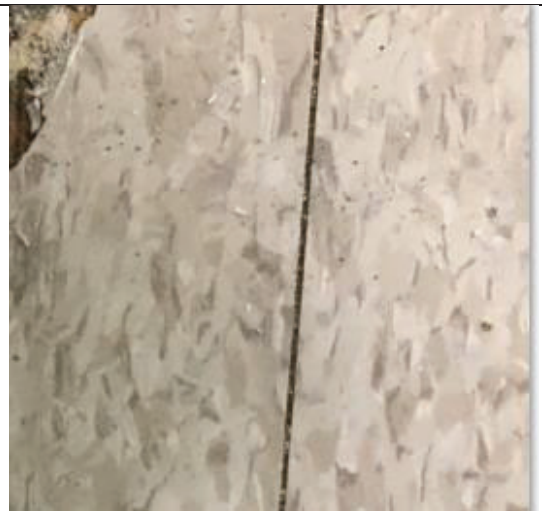
PHOTO 42 12" x 12" VFT Tan Blotchy/Mastic
Black Mastic 4% Chrysotile

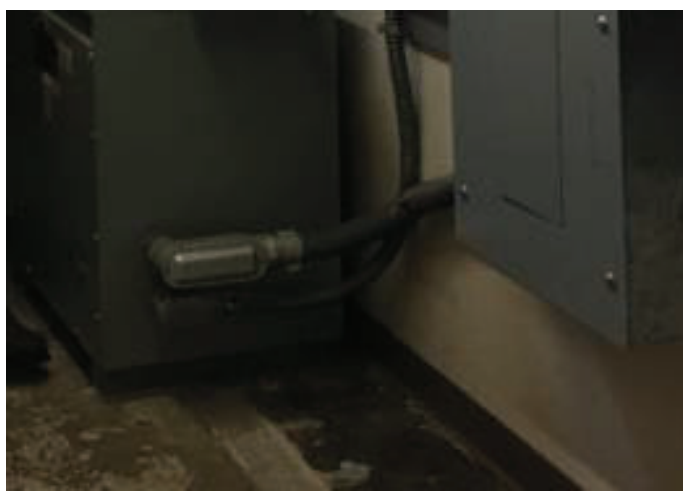
PHOTO 44 Black Mastic – D-20
5% Chrysotile

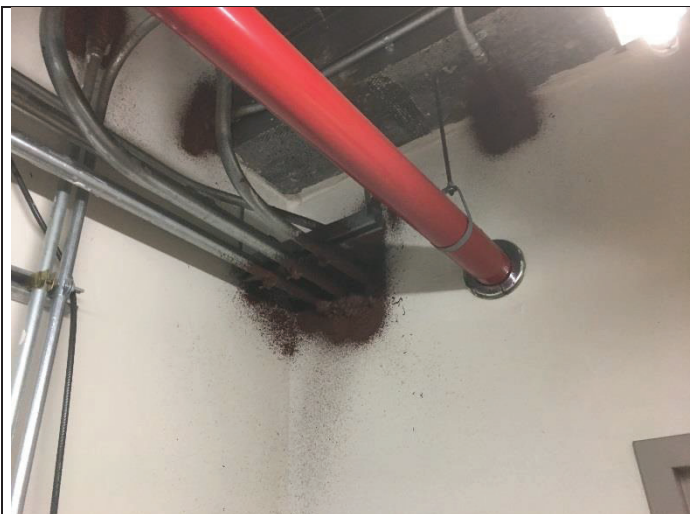
PHOTO 45 Firestop – D-20

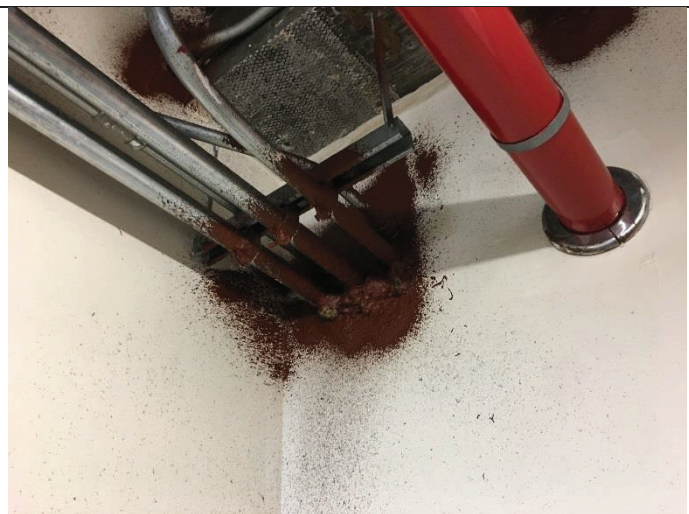
PHOTO 46 Firestop – D-20

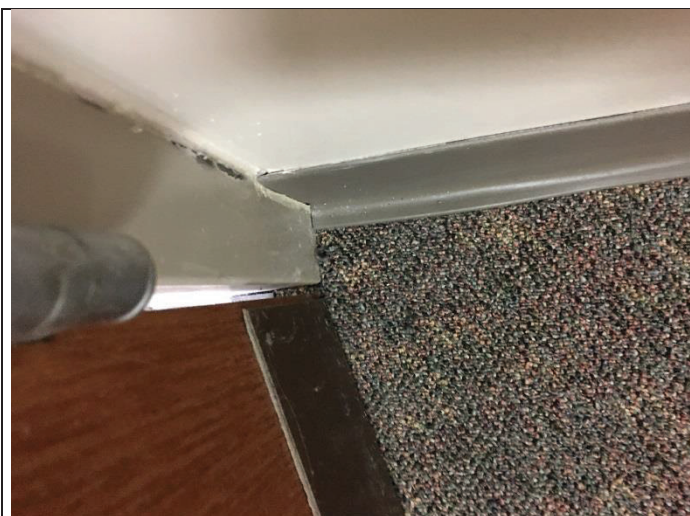
PHOTO 47 12" x 12" VFT Tan/Black Mastic
Under Carpet D-22

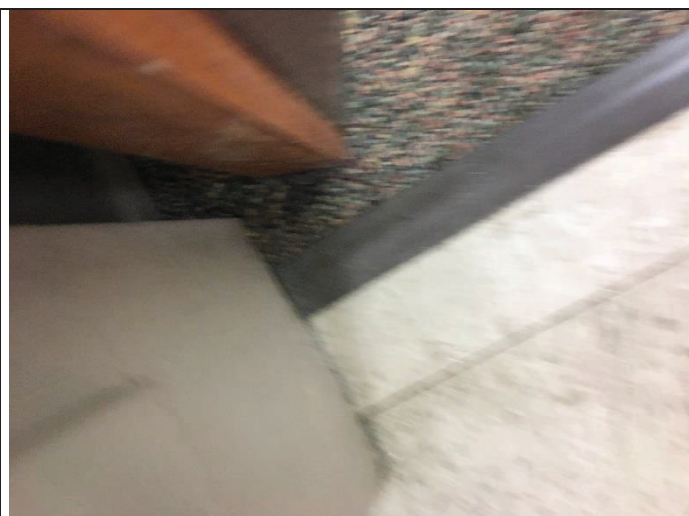
PHOTO 48 12" x 12" VFT Tan/Black Mastic
Under Carpet D-22

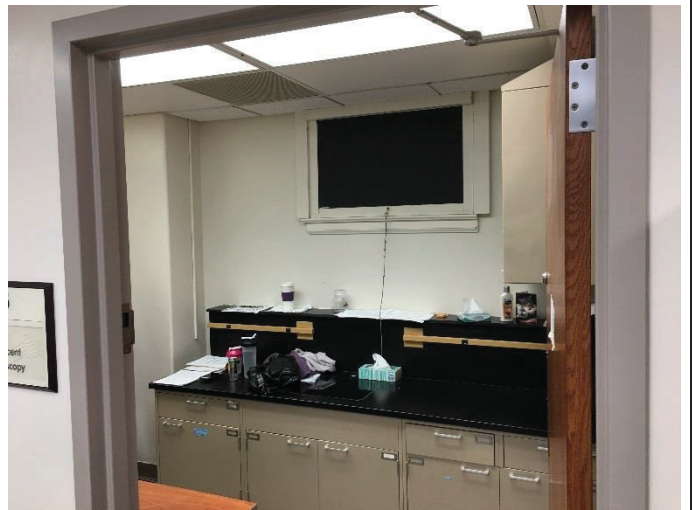
PHOTO 50

Black Epoxy Resin Bench Top – D-25

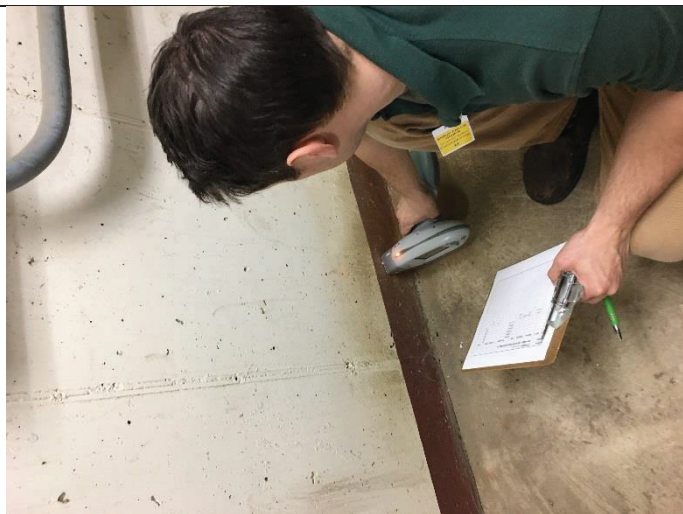
PHOTO 3 Red Base Cove Paint – Below Grade Mech. Room
<1mg/cm² lead

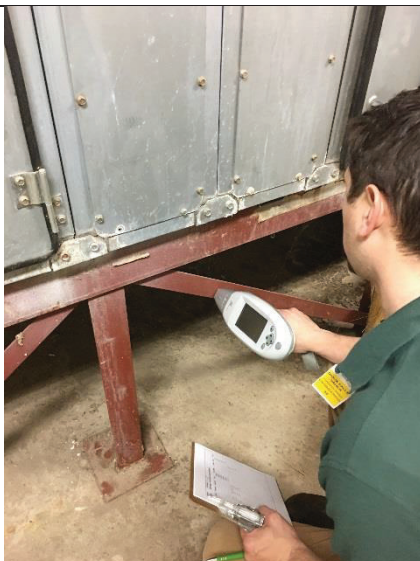
PHOTO 5 Red Painted Frame – Below Grade Mech. Room
<1mg/cm² lead

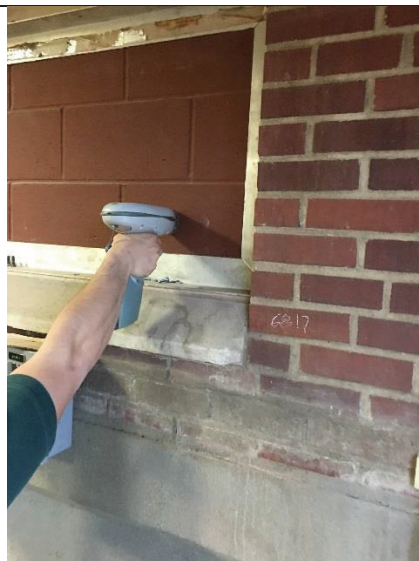
PHOTO 6 Red Painted Block Wall – Below Grade Mech. Rm
<1mg/cm² lead

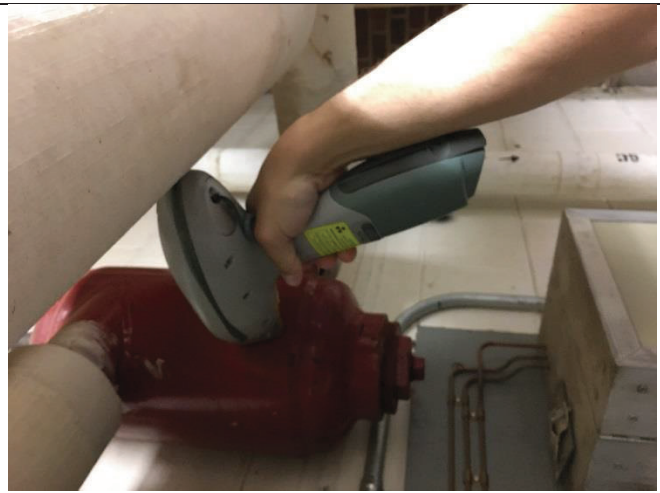
PHOTO 8 Red Painted Mixing Chamber – Below Grade Mech. Room
<1mg/cm² lead

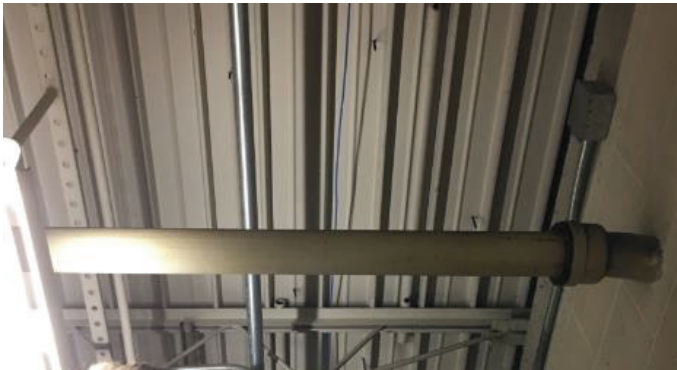
PHOTO 17 White Painted Pipe – Below Grade Mech. Room
<1mg/cm² lead

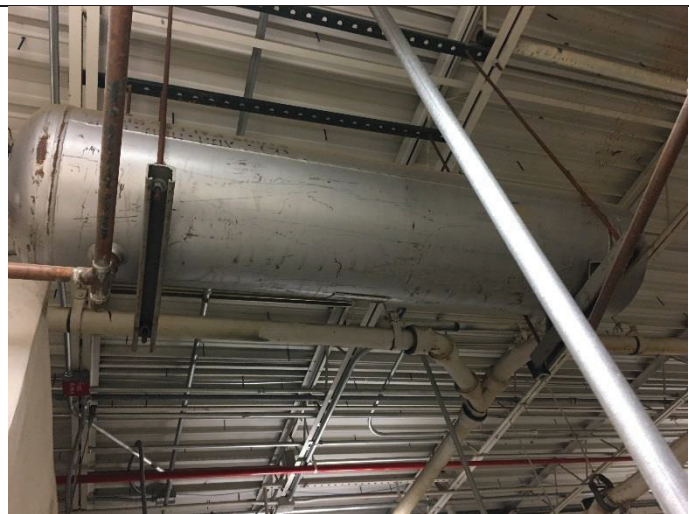
PHOTO 18 Silver Overhead Tank – Below Grade Mech. Room
<1mg/cm² lead

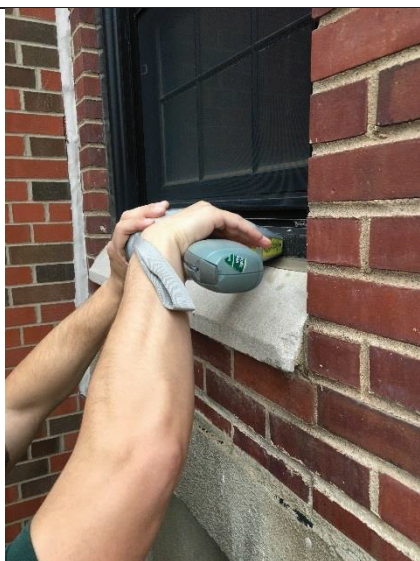
PHOTO 19 Black Window Frame - Exterior
<1mg/cm² lead

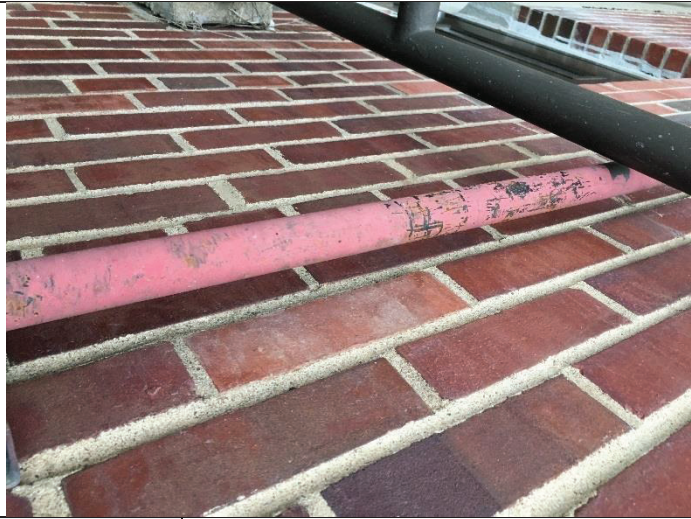
PHOTO 25 Red Pipe - Exterior
<1mg/cm² lead

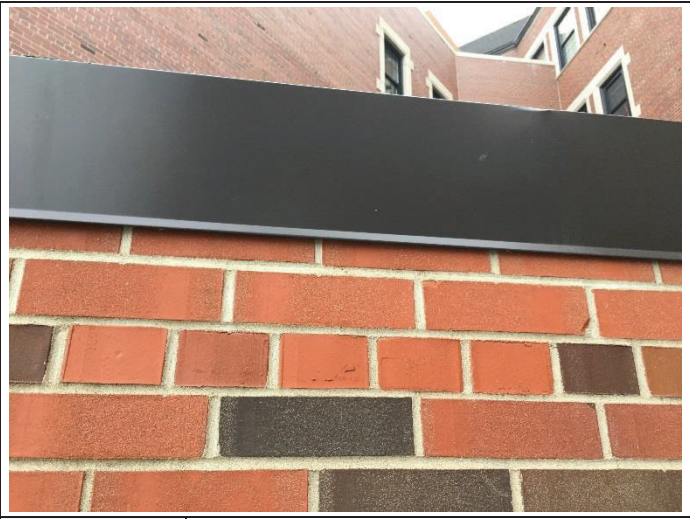
PHOTO 26 Black Flashing - Exterior
<1mg/cm² lead

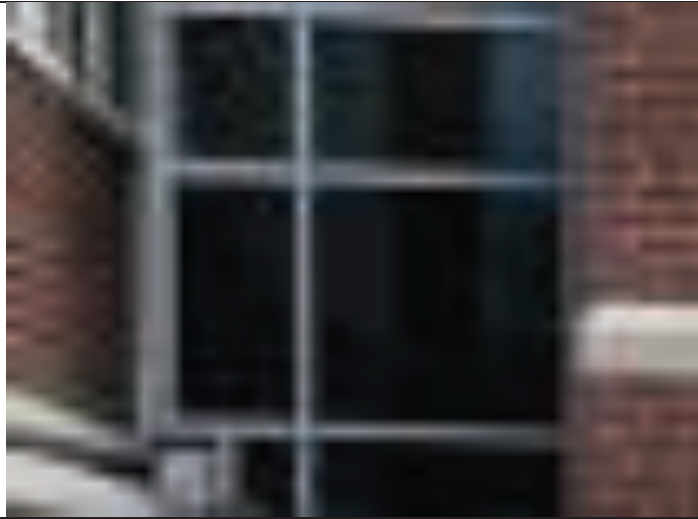
PHOTO 31 Silver Window Frame
<1mg/cm² lead

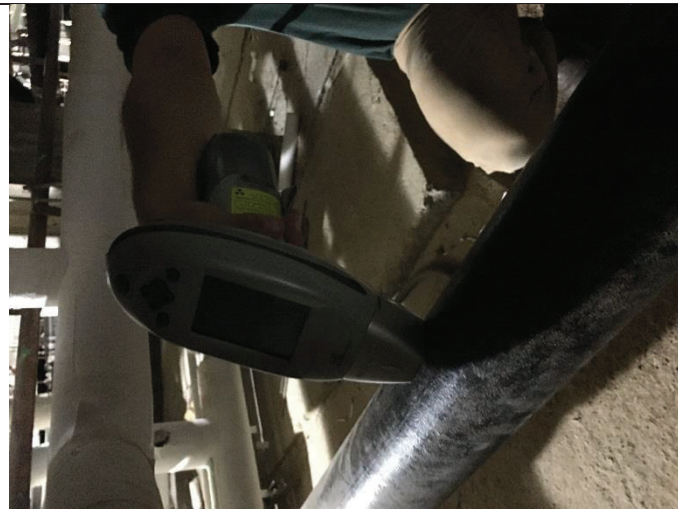
PHOTO 33 Black Pipe – Tunnel
<1mg/cm² lead

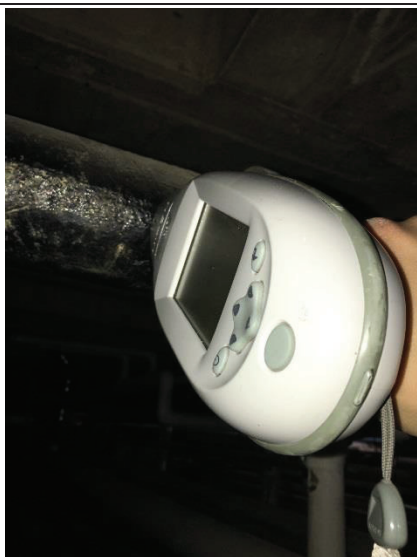
PHOTO 37 Black Pipe – Tunnel
 $<1\text{mg}/\text{cm}^2$ lead

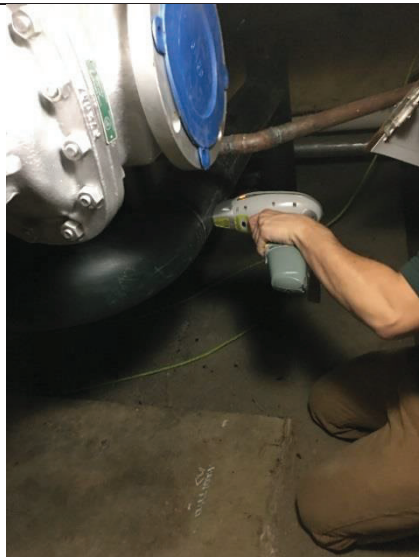
PHOTO 38 Black Pipe – Tunnel
 $<1\text{mg}/\text{cm}^2$ lead

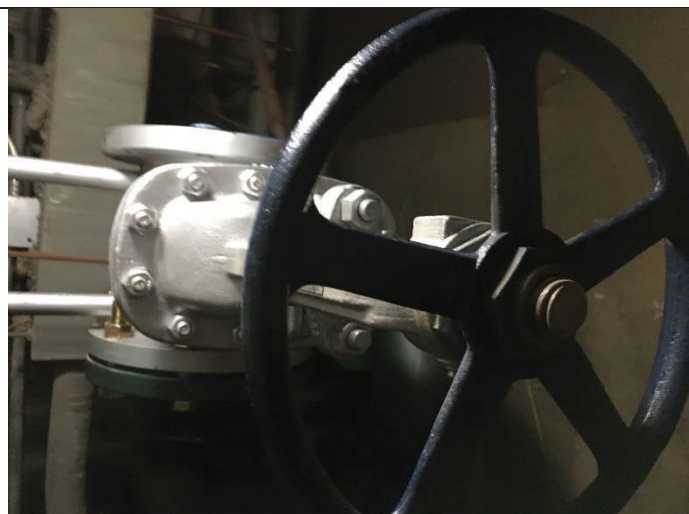
PHOTO 42 Silver Valve - Tunnel
 $<1\text{mg}/\text{cm}^2$ lead

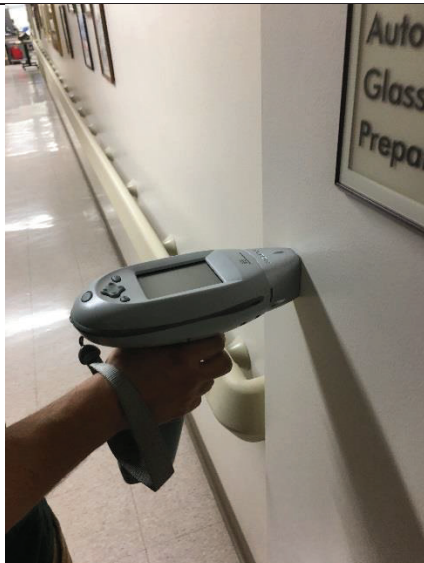
PHOTO 53 White Painted Wall – Hallway by D-17
<1mg/cm² lead

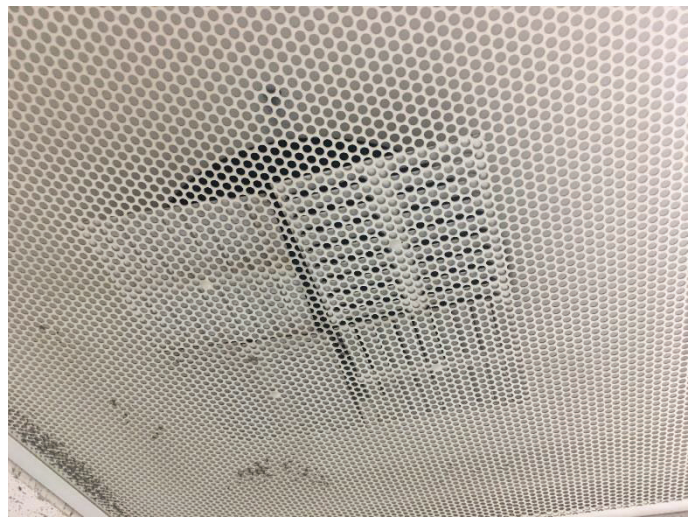
PHOTO 54 Diffuser Grate – Hallway by D-17
<1mg/cm² lead

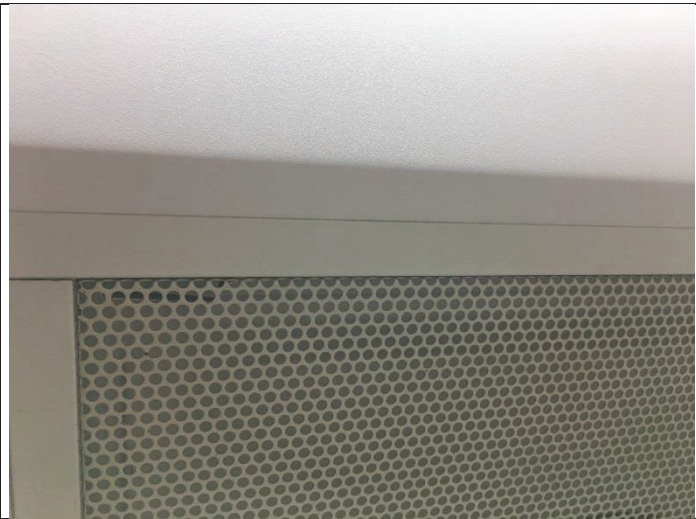
PHOTO 55 Ceiling Grid Hallway by D-17
<1mg/cm² lead

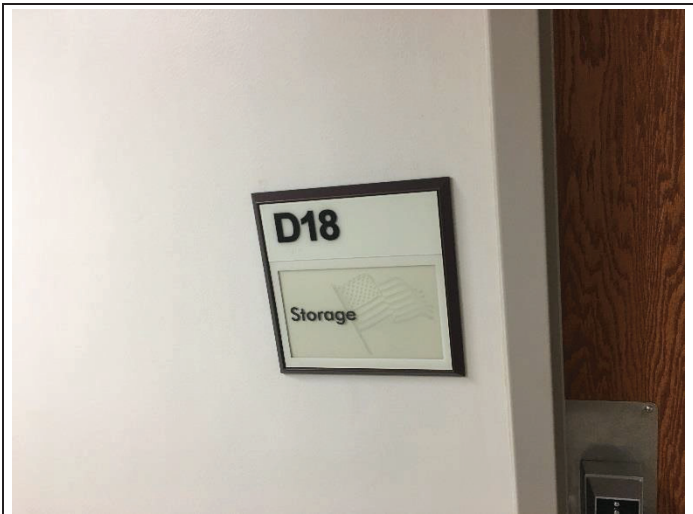
PHOTO 56 Beige Door Frame D-18
<1mg/cm² lead

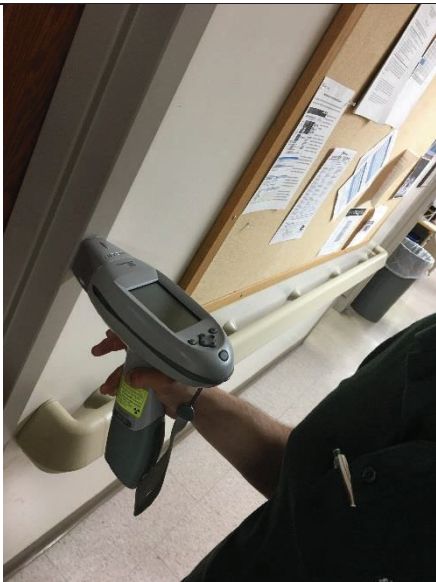
PHOTO 57 Beige Door Frame D-22
<1mg/cm² lead

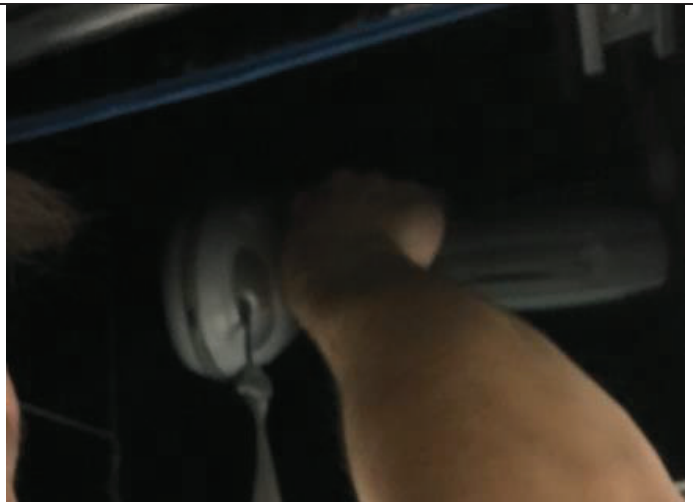
PHOTO 58 Black Pipe - Hallway
<1mg/cm² lead

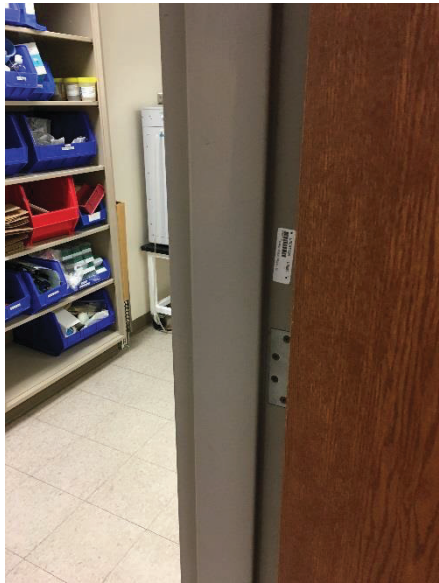
PHOTO 61 Beige Door Frame Room D-27
<1mg/cm² lead

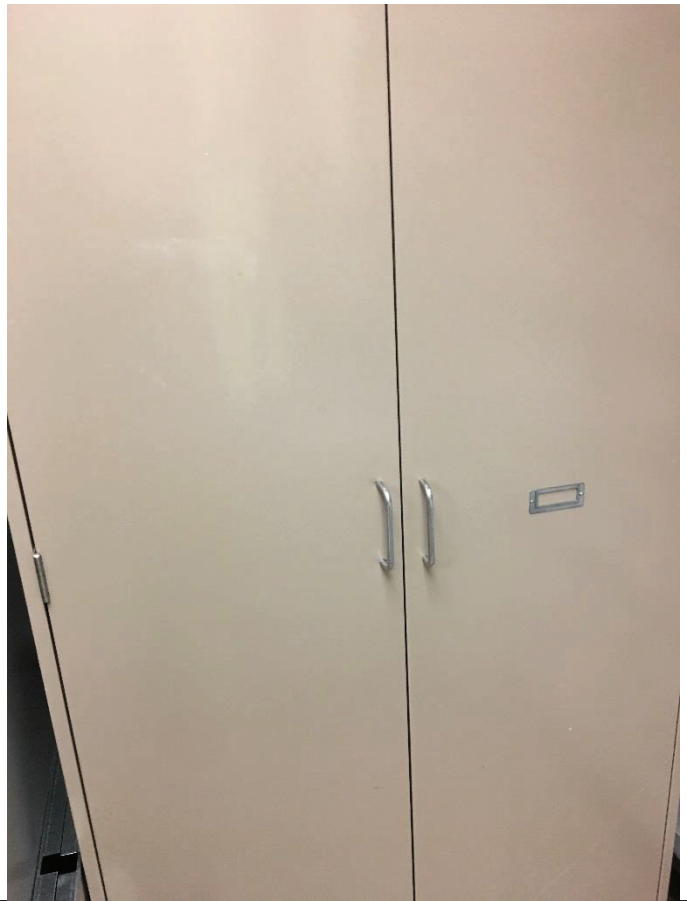
PHOTO 62 Beige Cabinet Room D-27
<1mg/cm² lead

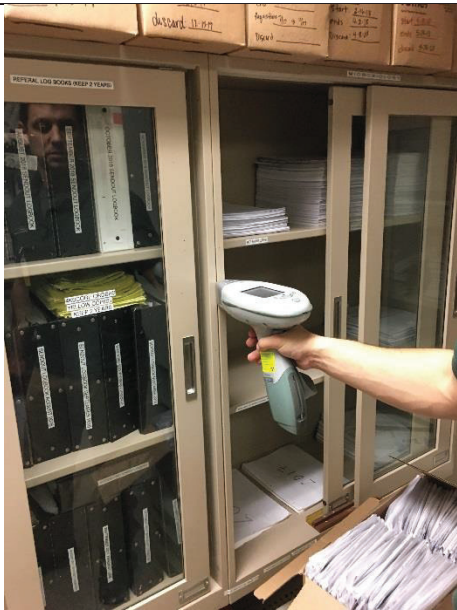
PHOTO 63 Beige Cabinet with Glass Room D-27
<1mg/cm² lead

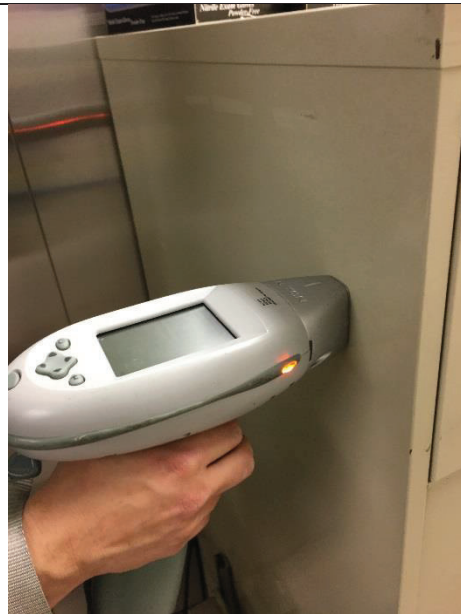
PHOTO 64 File Cabinet – S End
<1mg/cm² lead

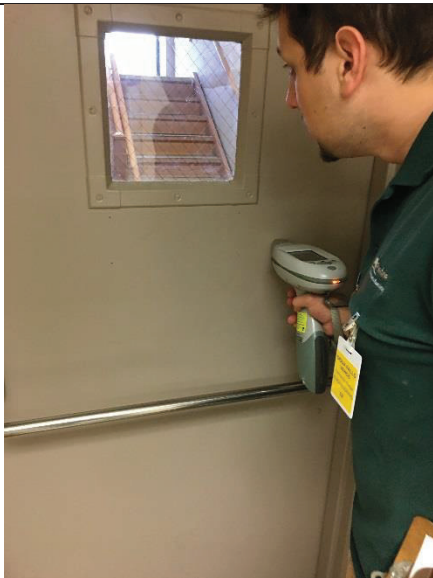
PHOTO 65 Cream Door – S End
<1mg/cm² lead

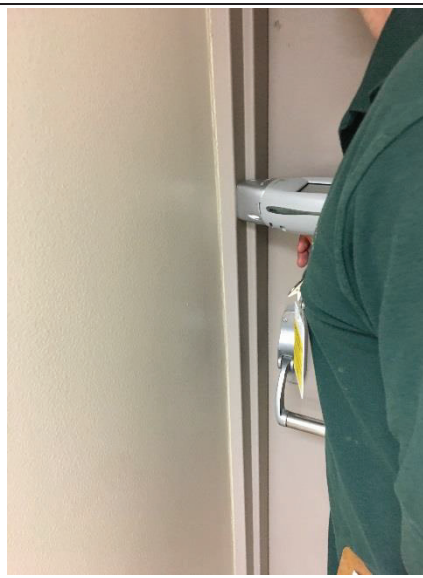
PHOTO 66 Cream Door Frame – S End
<1mg/cm² lead

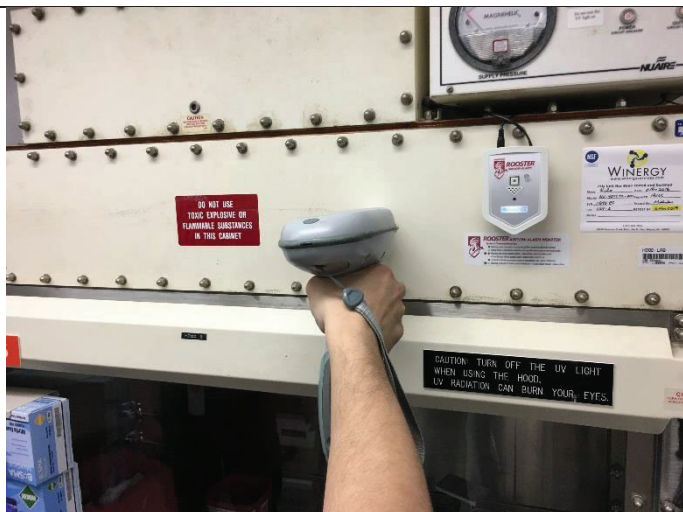
PHOTO 69 Cream Fume Hood – West Wall
<1mg/cm² lead

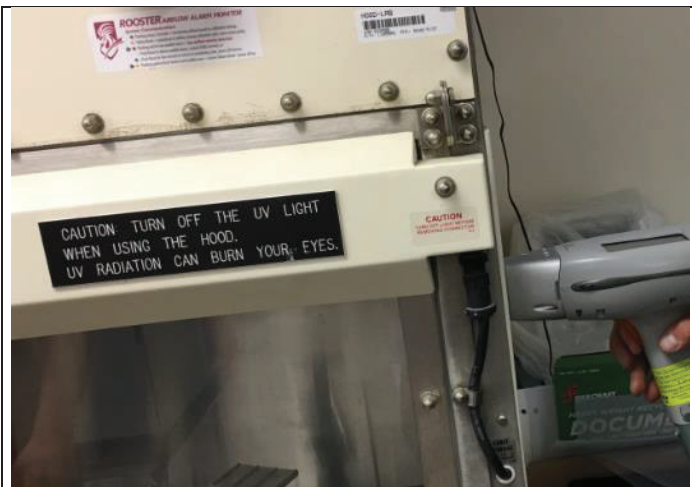
PHOTO 70 Cream Fume Hood – West Wall
<1mg/cm² lead

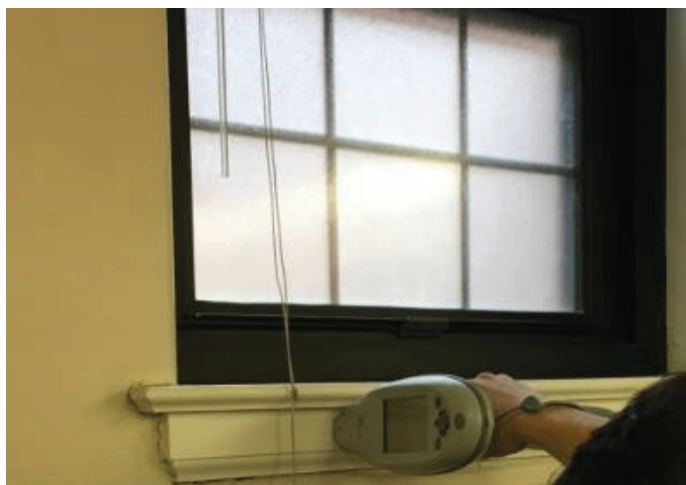
- LBP, brown, is present is present on exterior hand railings, near the entrance of the below grade mechanical room. (Approximately 150 linear ft.)
- LBP, brown, is present on decorative grates within the brick on exterior of the first floor of the building. (15 sq. ft.)
- LBP, white is present on top plate of 11 exterior windows (44 sq. ft.)
- LBP, brown, is present is present on interior hand railings on stairs leading to the tunnel. (Approximately 25 linear ft.)
- LBP, brown, is present on stairs leading to the tunnel. (100 sq. ft.)
- LBP, gray, is present on a ladder in the tunnel. (1 each)
- LBP, white, is present on window sills in the interior windows of the Inspection Area. (50 sq. ft.)

PHOTO 71 Window Sill and Trim Below Window
5.3 mg/cm² lead

Based on the initial lead paint testing results, AMIE recommends TCLP testing be conducted on the existing building materials, painted and unpainted, prior to the start of renovation or demolition activity. In addition, trade contractors who work in the facility should also be notified of the presence of lead so that they can appropriately monitor and protect their workers against lead exposure.

Any lead-based painted building components not removed during renovation should be considered for inclusion in a facility management plan that maintains potential exposure below OSHA action levels and ensures the material will be handled properly and in accordance with applicable regulations.

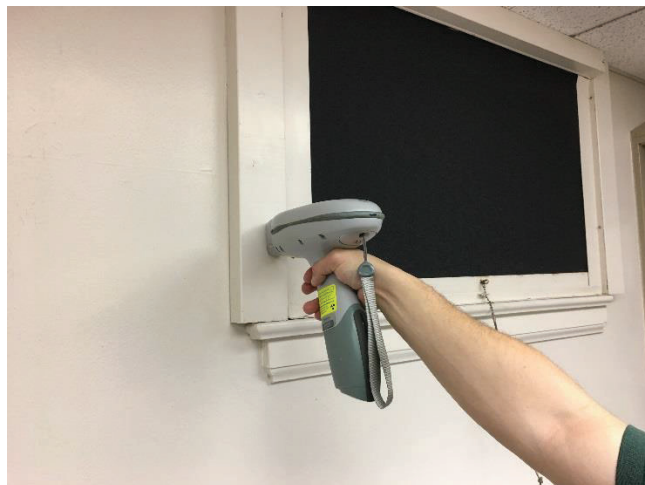
PHOTO 72 Non-Decorative Window Trim
<1mg/cm² lead

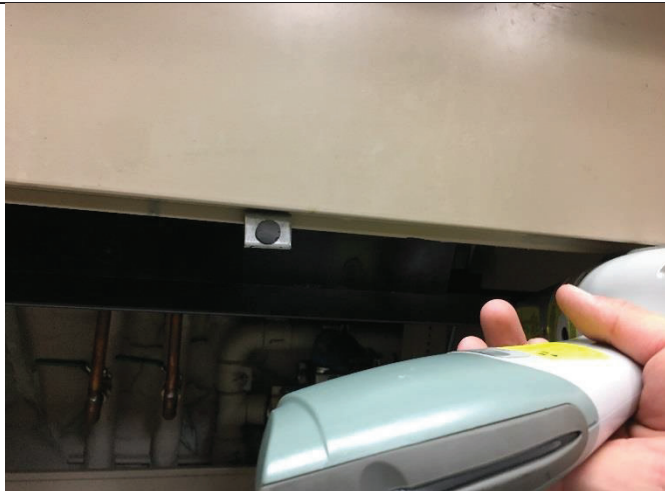
PHOTO 74 Black Metal surrounding sink basin
<1mg/cm² lead

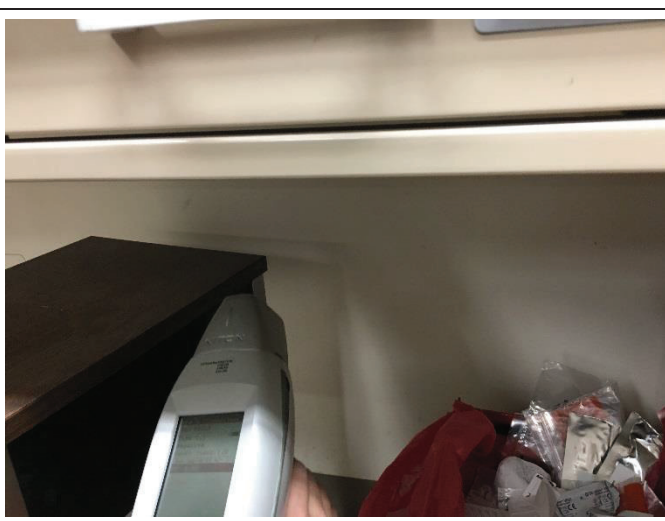
PHOTO 76 White Paint on Plaster
<1mg/cm² lead

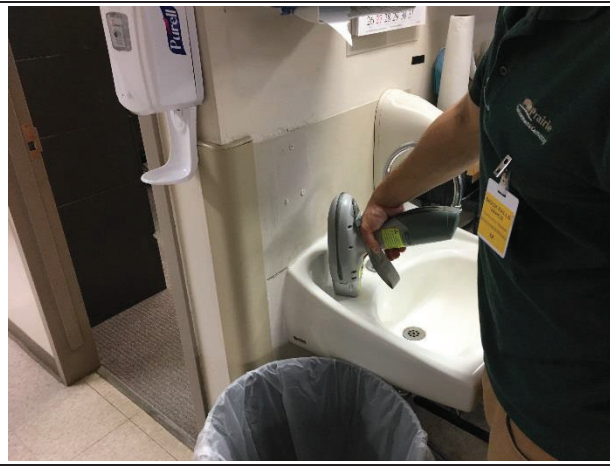
PHOTO 86 Porcelain Sink – Lab
<1mg/cm² lead
