4. SUMMARY OF INSPECTION FINDINGS

Location:		VA Medical Center, Sioux Falls, SD - Building 5 (Mech Rm, Tunnel, Lower Level)						
Inspector:		Jason Biggins, Prairie Environmental Consulting, LLC						
XRF Model: NITON XLp Series Lead Analyzer, serial #24794					Lead Paint ≥ 1.0 mg/cm²			
XRF #	Unit #	Substrate	Component	Color	Test Location	Condition	Results	Notes
1					Calibrate			Test
2					Calibrate			Test
3					Calibrate			Test
4					Calibrate			Test
5					Calibrate			Test
6					Calibrate			Test
7	Mech Rm	Metal	Electrical Panel	Grey	Mech Rm	Good	0.00	
8	Mech Rm	Concrete	Wall	White	Mech Rm	Fair	0.00	
9	Mech Rm	Concrete	Wall	Red	Mech Rm	Fair	0.00	
10	Mech Rm	Metal	Duct	Grey	Mech Rm	Fair	0.00	
11	Mech Rm	Metal	Frame	Red	Mech Rm	Fair	0.01	
12	Mech Rm	Concrete	Wall	Red	Mech Rm	Good	0.00	
13	Mech Rm	Metal	Tank	Silver	Mech Rm	Fair	0.01	
14	Mech Rm	Metal	Mixing Chamber	Red	Mech Rm	Fair	0.25	
15	Mech Rm	Wood	Panel	Grey	Mech Rm	Fair	0.00	
16	Mech Rm	Metal	Casing	Grey	Mech Rm	Good	0.01

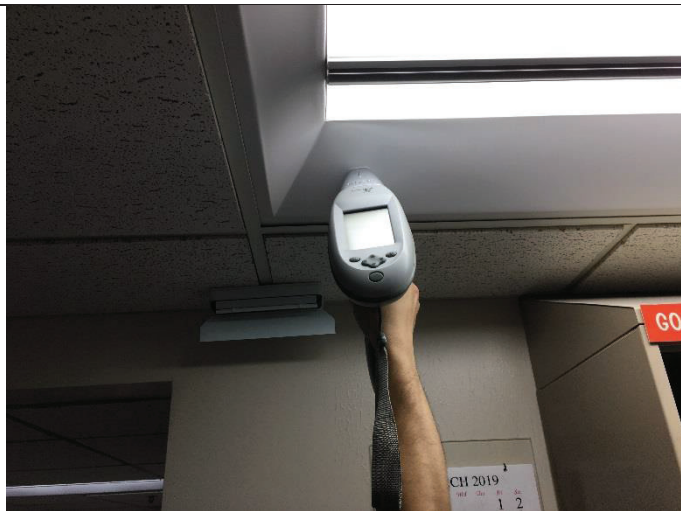
PHOTO 87 Ceiling Light Fixture
<1mg/cm² lead

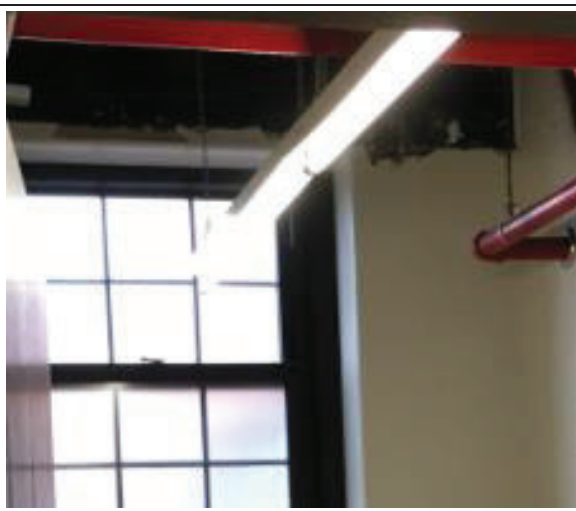
PHOTO 88 Black Concrete Wall Above Window – D-20
<1mg/cm² lead
