**35% SCHEMATIC DESIGN SUBMISSION  
ASBESTOS & HAZMAT MATERIALS SUMMARY  
ST. CLOUD VA MEDICAL CENTER – ST. CLOUD, MN  
BUILDING 50 – REPAIR BASEMENT KITCHEN PROJECT 656-20-130**

ASBESTOS & HAZMAT MATERIALS SURVEY  
ST. CLOUD VA MEDICAL CENTER – ST. CLOUD, MN  
BUILDING 50 – REPAIR BASEMENT KITCHEN PROJECT 656-20-130

**PROJECT:  
REPAIR BASEMENT KITCHEN - BUILDING 50  
656-20-130**

**INSPECTION DATE:  
OCTOBER 12, 2023**

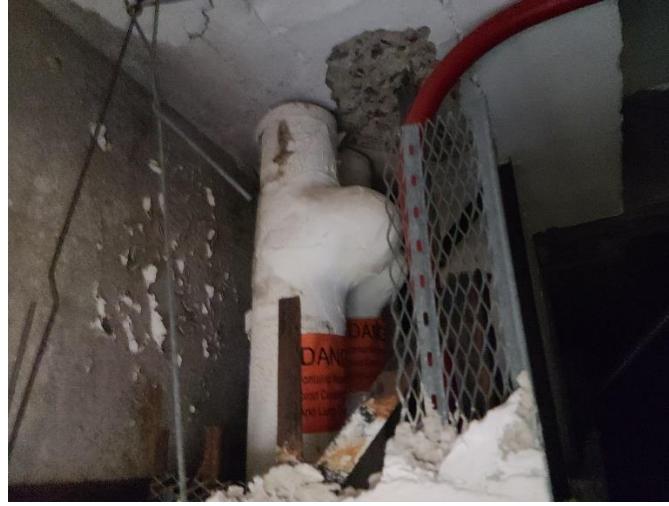
<b>Asbestos Containing Material</b>	<b>Locations</b>	<b>Quantity</b>
Pipe insulation on steam and domestic water lines	Vertical pipe chases behind hard plaster walls in 7B and 10B	480 lf
Pipe insulation debris in soil	Crawl spaces under 7B and 10B	4,800 sf

<b>Photo A-1</b> Pipe insulation in vertical wall chases

**ASBESTOS:** The asbestos containing pipe insulation identified in the renovation area are not expected to be disturbed as part of the renovations and must only be identified to the GC so that they are not damaged during the demolition of the ceramic tiles on the walls. In addition, the contractors who enter the crawl spaces must conduct personal air monitoring for their workers to ensure their exposure to asbestos fibers in the soil is below the established OSHA PEL for asbestos in construction.

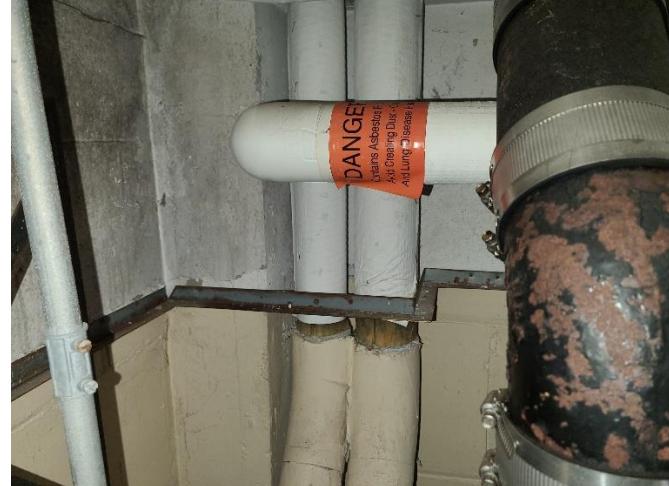
<b>Photo A-2</b> Pipe insulation in vertical wall chases

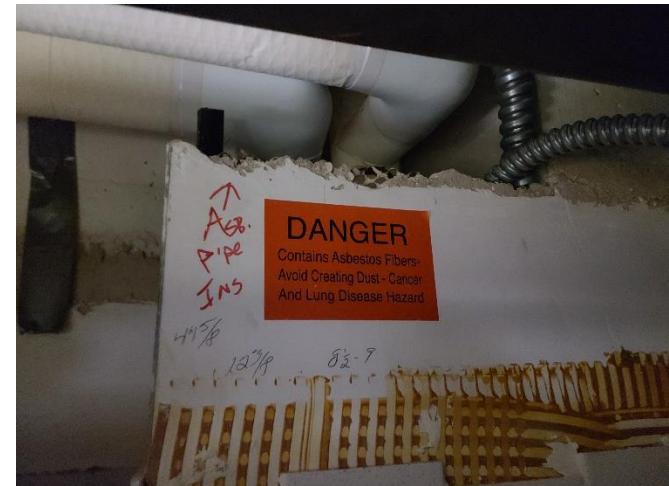
<b>Photo A-3</b> Pipe insulation in vertical wall chases

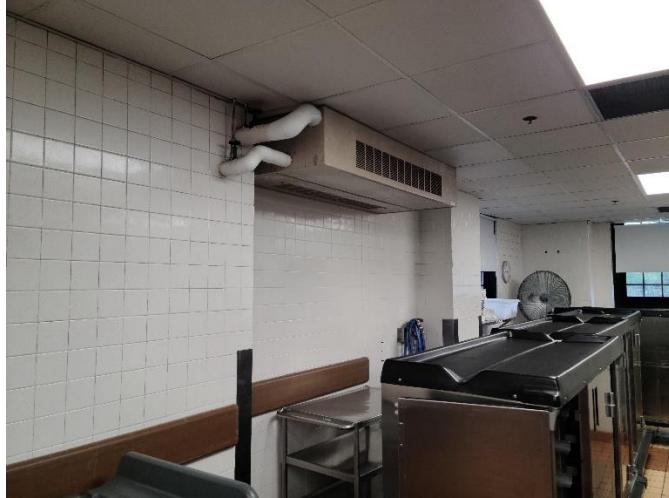
<b>Lead Painted or Lead Building Materials</b>	<b>Locations</b>
Ceramic Wall Tile Glaze	7B and 10B walls

<p><b>Photo L-1</b> Ceramic wall tiles</p>

**LEAD-CONTAINING BUILDING COMPONENTS:** The identified lead painted components can be removed and disposed of by the GC during the demolition with proper personal air monitoring on the first day of demolition to comply with OSHA requirements for lead exposure in construction to establish a negative exposure assessment.

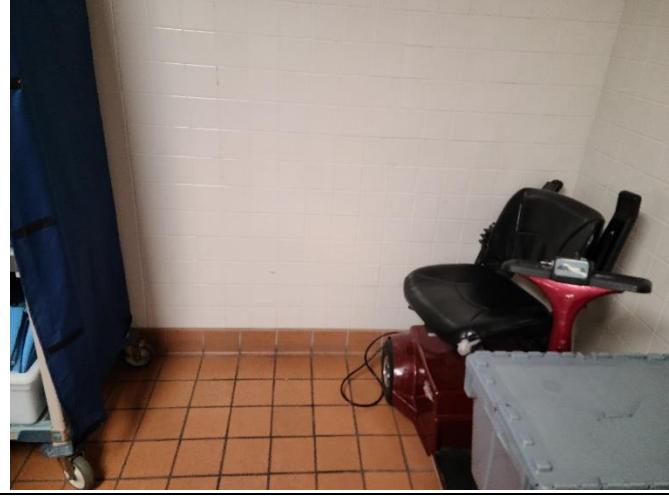
A photograph showing a wall covered in white ceramic tiles. Above the wall is a white ceiling with a rectangular air vent and a large, curved white pipe. To the right, there is a stainless steel preparation table and a large stainless steel oven or range.
<p><b>Photo L-2</b> Ceramic wall tiles</p>

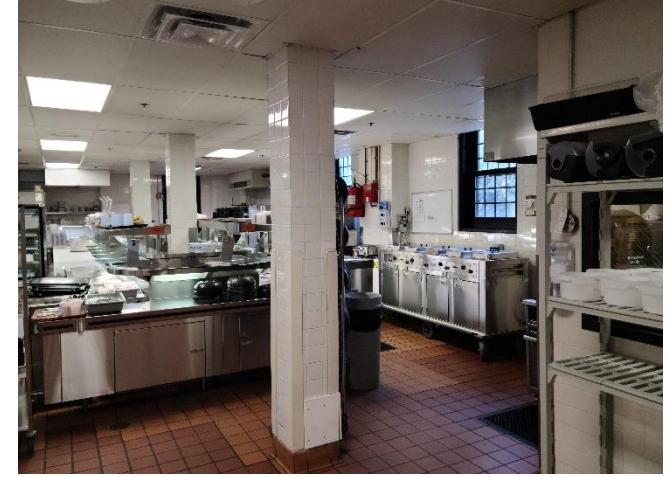
A photograph showing a wall covered in white ceramic tiles. In the foreground, there is a red and black piece of equipment, possibly a vacuum cleaner or a piece of kitchen machinery, sitting on a tiled floor. A blue curtain is visible on the left.
<p><b>Photo L-3</b> Ceramic wall tiles</p>

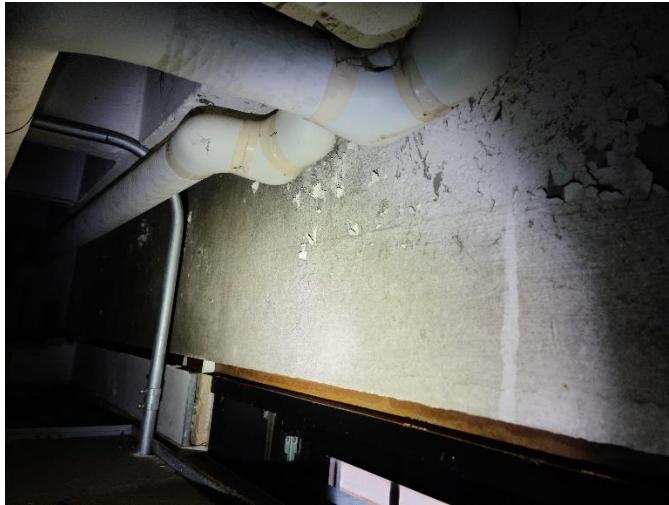
<b>Mold Impacted Building Materials</b>	<b>Locations</b>	<b>Quantity</b>
Concrete exterior walls above lay-in ceiling tiles and 2x4 lay-in ceiling tiles & grid	10B Cart washing area	120 sf of concrete 420 sf of ceiling tile & grid

<p><b>Photo L-1</b> Above ceiling tiles on exterior painted concrete walls in cart washing area</p>

**MOLD GROWTH:** The identified building materials with visible mold growth should be removed by a qualified remediation contractor prior to the interior renovations. All mold remediation work is recommended to be conducted by a qualified remediation contractor utilizing industry standard practices for mold remediation and in accordance with VA specifications.

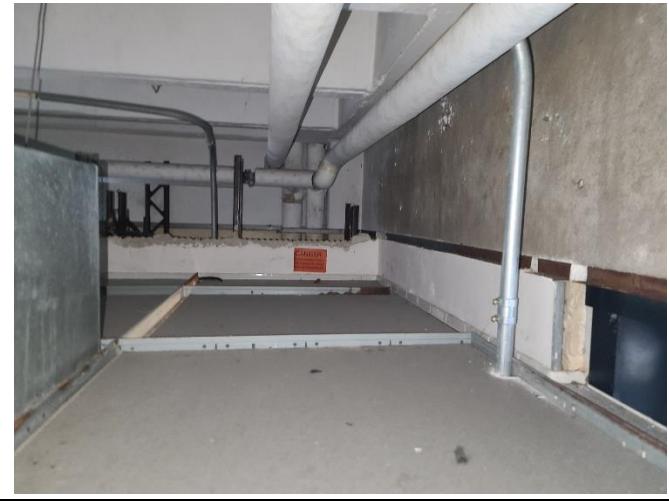
<p><b>Photo L-2</b> Above ceiling tiles on exterior painted concrete walls in cart washing area</p>

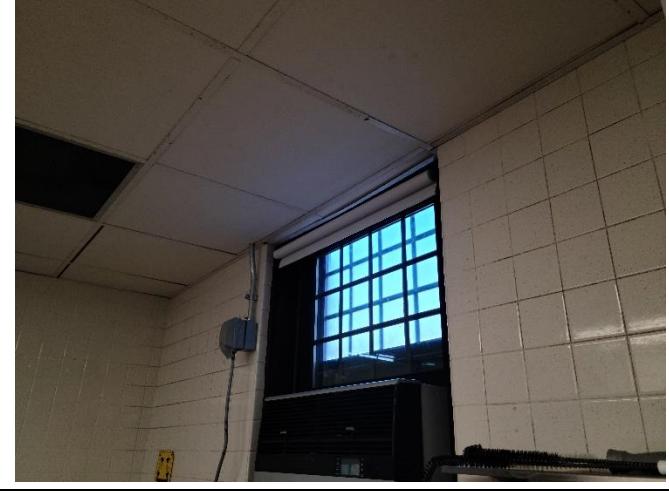
<p><b>Photo L-3</b> Ceiling tiles and grid in cart washing area</p>
