## **LIMITED ASBESTOS AND LEAD INSPECTION REPORT**

VA Black Hills Health Care System  
113 Comanche Road  
Fort Meade, SD 57741

**AET Project No. P-0011150**

April 8, 2022

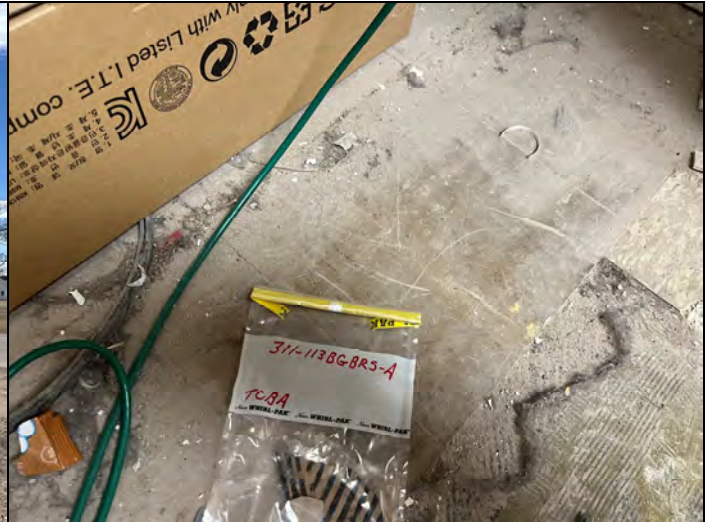
- 311-113BGBRS-A – Photo 2 – Building 113, 9”x9” beige with brown streaks floor tile and black mastic was found to contain 5% asbestos in the tile only, the mastic DOES NOT contain asbestos. Approximately 11 total square feet (SF) of the floor tile was identified in Basement Rm. TCBA.

Photo 2 – Sample 311-113BGBRS-A, asbestos containing 9" beige with brown streaks floor tile in building 113, room TC8A. Only tile contains.

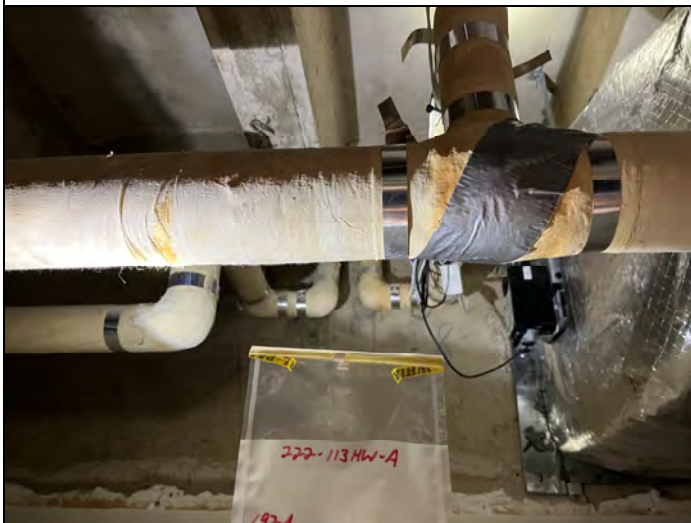
- 222113HW-A, B, C – Photo 3 – Building 113, 0-4” hard white fibrous pipe fittings were found to contain 10% asbestos. Approximately 15 total fittings (EA) were identified in Fl. 01 Rm. 192A.

Photo 3 – Samples 222-113HW-A, B, C, asbestos containing 0-4" hard white pipe fittings in building 113 room 192A.

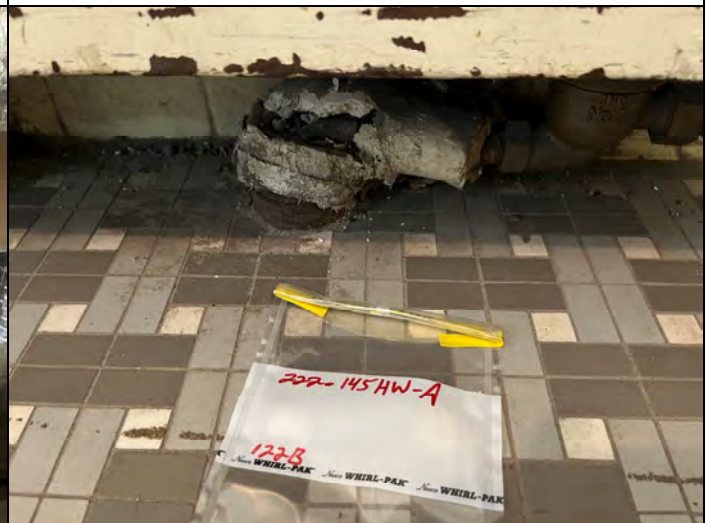
- 222-145HW-A, B, C – Photo 4 – Building 145, 0-4” hard white fibrous pipe fittings were found to contain 3% asbestos. Approximately 1 total fitting (EA) was identified in Fl. 01 Rm. 122B.

Photo 4 – Samples 222-145HW-A, B, C, asbestos containing 0-4" hard white pipe fittings in building 145 room 122B.

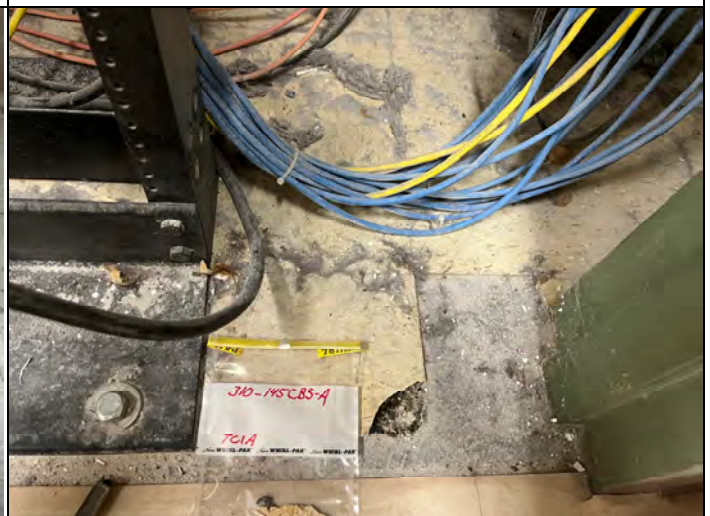
- 310-145CBS-A – Photo 6 – Building 145, 12”x12” cream with beige streaks floor tile and black mastic was found to contain 3% asbestos in the mastic only, the tile DOES NOT contain asbestos. Approximately 53 total square feet (SF) of the mastic was identified in Fl. 01 Rms. TC1A (17 SF) and 137C (36 SF).

Photo 6 – Sample 310-145CBS-A, asbestos containing 12" cream with brown streaks floor tile in building 145, rooms TC1A and 137C. Only mastic contains.

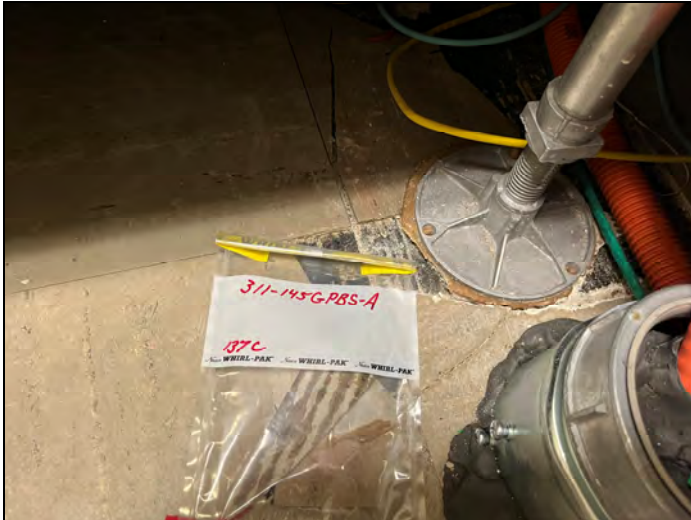
- 311-145GPBS-A – Photo 7 – Building 145, 9”x9” gray with pink and black streaks floor tile and black mastic was found to contain 8% asbestos in the tiles and 3% asbestos in the mastic. Approximately 666 total square feet (SF) of the floor tile and mastic was identified in Fl. 01 Rm. 137C.

Photo 7 – Sample 310-145GPBS-A, asbestos containing 12" gray with pink and black streaks floor tile and black mastic in building 145, room 137C. Both tile and mastic contain.

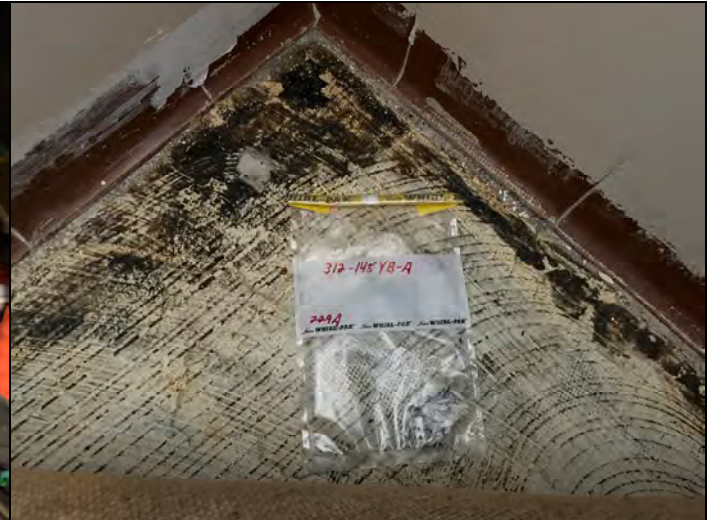
- 312-145YB-A – Photo 8 – Building 145, yellow and black floor tile mastic was found to contain 2% asbestos. Approximately 99 total square feet (SF) of the mastic was identified in Fl. 02 Rm. 229A.

Photo 8 – Sample 312-145YB-A, asbestos containing yellow and black mastic in building 145, room 229A.

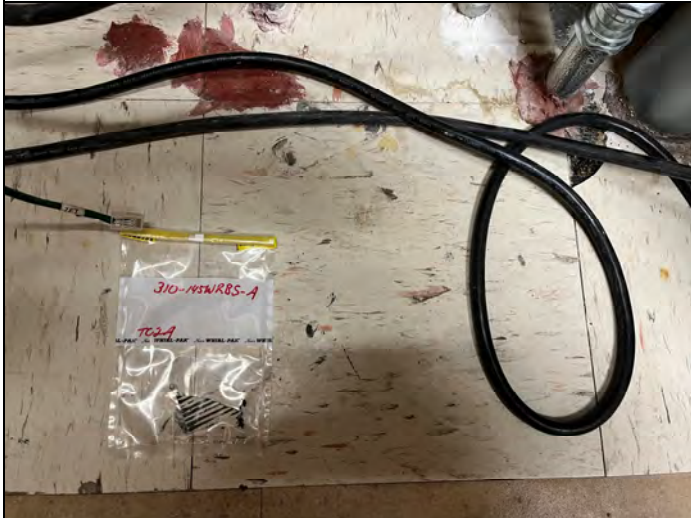
- 310-145WRBS-A – Photo 9 – Building 145, 12"x12" white with red and black streaks floor tile and black mastic was found to contain 3% asbestos in the mastic only, the tile DOES NOT contain asbestos. Approximately 9 total square feet (SF) of the mastic was identified in Fl. 02 Rm. TC2A.

Photo 9 – Sample 310-145WRBS-A, ACM 12" white w/ red and black streaks floor tile in bldg. 145, rm. TC2A. Only mastic contains.

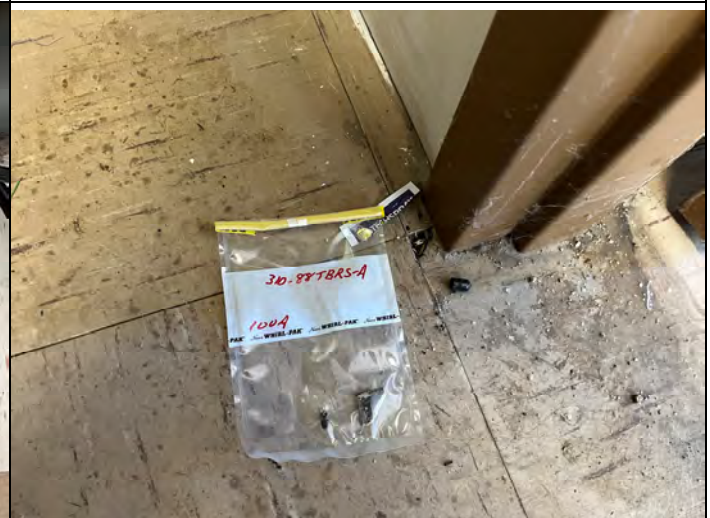
- 310-88TBRS-A – Photo 12 – Building 99, 12"x12" tan with brown streaks floor tile and black mastic was found to contain 6% asbestos in the tiles and 3% asbestos in the mastic. Approximately 30 total square feet (SF) of the floor tile and mastic was identified in Fl. 01 Rm. 100A.

Photo 10 – Sample 310-88TBRS-A, ACM 12" tan w/ brown streaks floor tile in building 88, room 100A. Both the tile and mastic contain.

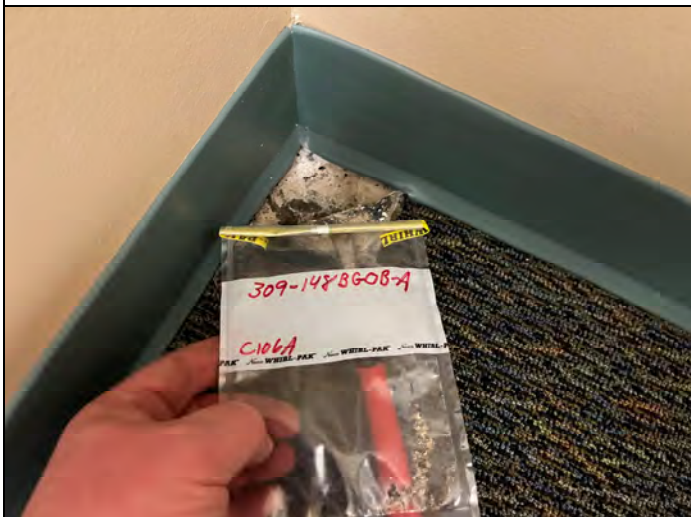
- 309-148BGOB-A – Photo 11 – Building 148, beige over black carpet mastic was found to contain 2% asbestos. Approximately 176 total square feet (SF) of the mastic was identified in Fl. 01 Rm. C106A.

Photo 11 – Sample 309-148T-A, asbestos containing beige over black carpet mastic in building 148, room C106A.

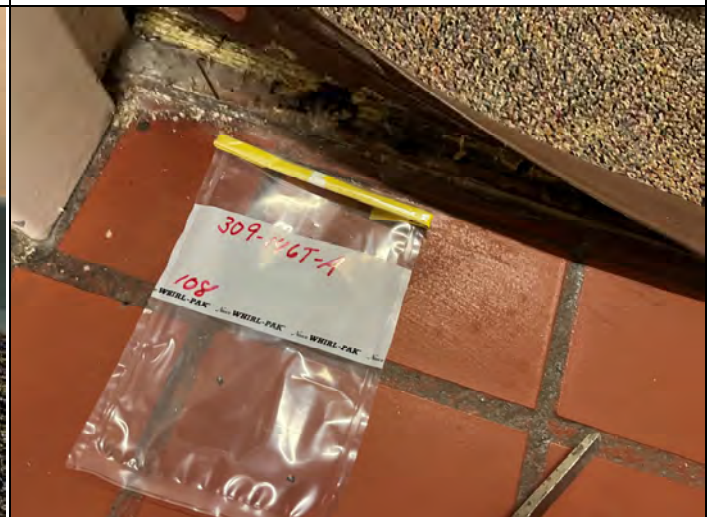
- 309-146T-A – Photo 10 – Building 146, tan carpet mastic was found to contain 2% asbestos. Approximately 99 total square feet (SF) of the mastic was identified in Fl. 01 Rm. 108.

Photo 12 – Sample 309-146T-A, asbestos containing tan carpet mastic in building 146, room 108.

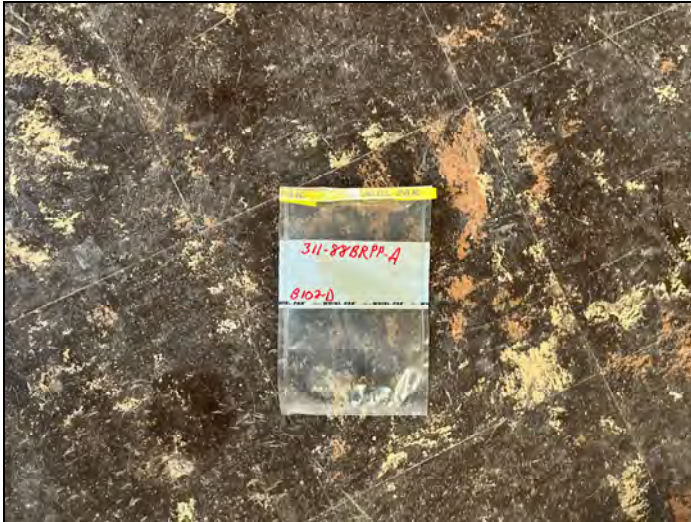
- 311-88BRPP-A – Photo 13 – Building 88, 9"x9" brown with pink patches floor tile and black mastic was found to contain 10% asbestos in the tiles and 3% asbestos in the mastic. Approximately 144 total square feet (SF) of the floor tile and mastic was identified in Fl. 01 Rm. B102D.

Photo 13 – Sample 311-88BRPP-A, asbestos containing 9" brown w/ pink patches floor tile bldg. 88, room B102D. Tile and mastic contain.

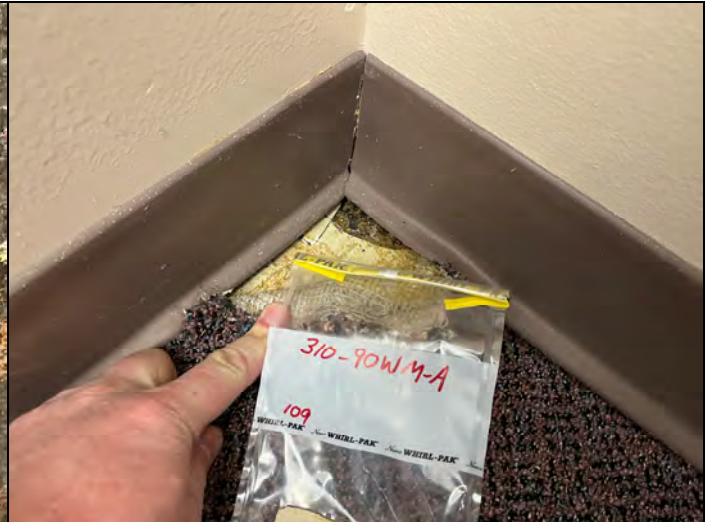
- 310-90WM-A – Photo 14 – Building 90, 12"x12" white mottled floor tile and black mastic was found to contain 3% asbestos in the mastic only, the tile DOES NOT contain asbestos. Approximately 110 total square feet (SF) of the mastic was identified in Fl. 01 Rm. 109.

Photo 14 – Sample 310-90WM-A, asbestos containing 12" white mottled floor tile in building 90, room 109. Only mastic contains.

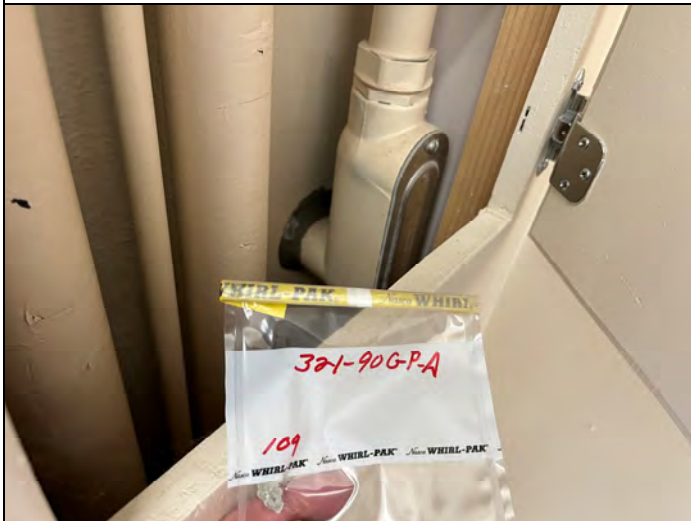
- 321-90GP-A – Photo 15 – Building 90, gray penetration caulk was found to contain 10% asbestos. Approximately 1 total square feet (SF) of the caulk was identified in Fl. 01 Rm. 109.

Photo 15 – Sample 321-90GP-A, asbestos containing gray penetration caulking in building 90, room 109.

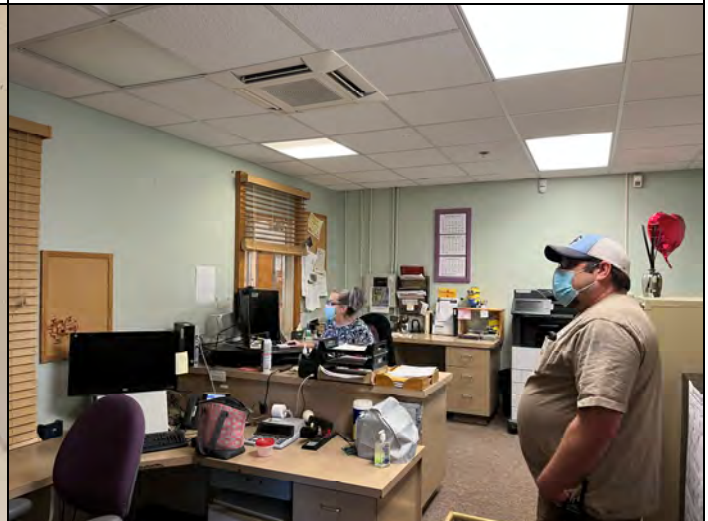
Photo 16 – Material 509-113BRF, presumed asbestos containing black raised floor adhesive in building 113, room 192A.

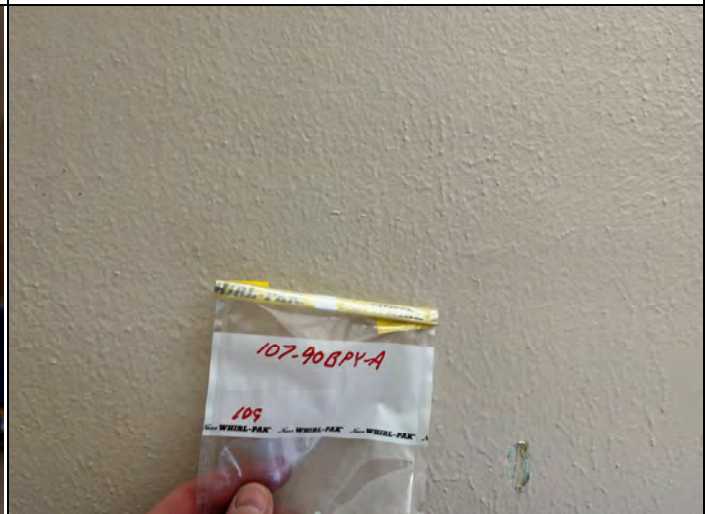
Photo 18 – Samples 107-90BPY-A, B, C, less than 1% asbestos containing bumpy textured walls in building 90 room 109.

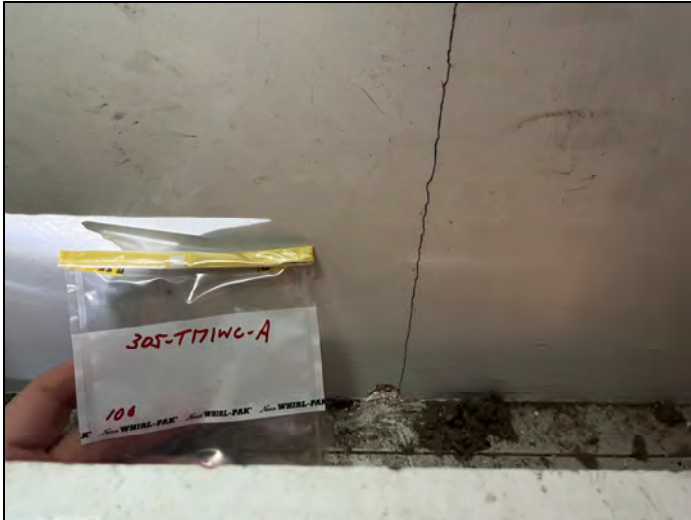
Photo 19 – Sample 305-T171WC-A, less than 1% asbestos containing sheetrock and taping compound walls and ceilings in building T171 room 100.

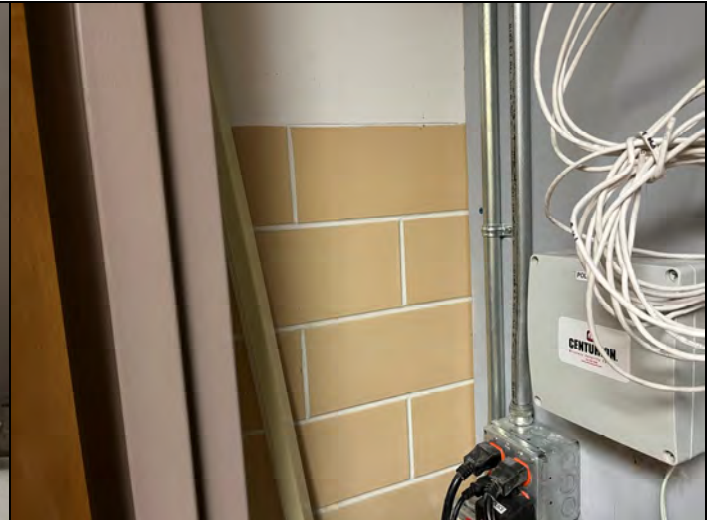
- Shot 18 - Photo 20 – Building 145, glazed tan terra cotta block walls were found to contain 1.50 mg/cm<sup>2</sup> lead. Approximately 75 total square feet (SF) of the terra cotta tile was identified in Fl. 02 Rm. TC2A.

Photo 20 – Test 18, lead containing tan terra cotta block walls in building 145 room TC2A.

The lead containing materials must be removed and properly disposed of by Environmental Protection Agency (EPA) Lead Renovation, Repair and Painting (RRP) trained and certified personnel.

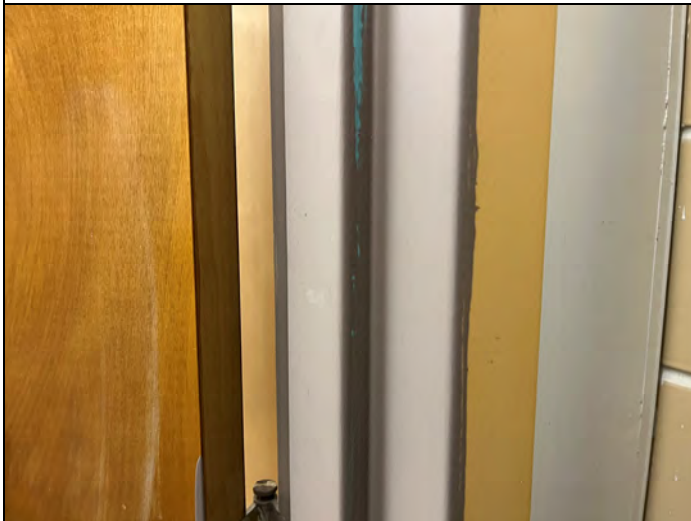
- Shot 25 - Photo 21 – Building 145, glazed tan terra cotta block walls were found to contain 1.60 mg/cm<sup>2</sup> lead. Approximately 75 total square feet (SF) of the terra cotta tile was identified in Fl. 03 Rm. TC3A.

Photo 21 – Test 25, lead containing tan terra cotta block walls in building 145 room TC3A.

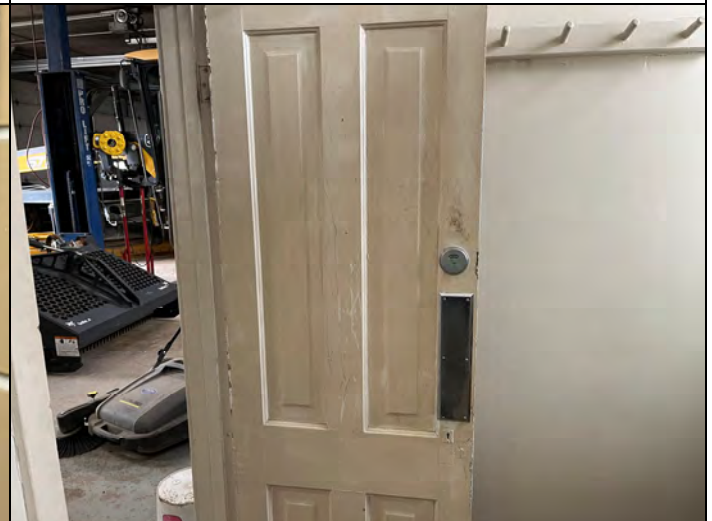
- Shot 75 - Photo 22 – Building T171, tan wood door/door frame were found to contain 27.90 mg/cm<sup>2</sup> lead. Approximately 27 total square feet (SF) of the wood door/door frame was identified in Fl. 01 Rm. 101B.

Photo 22 – Test 75, lead containing tan wood door and frame in building T171 room 101B.

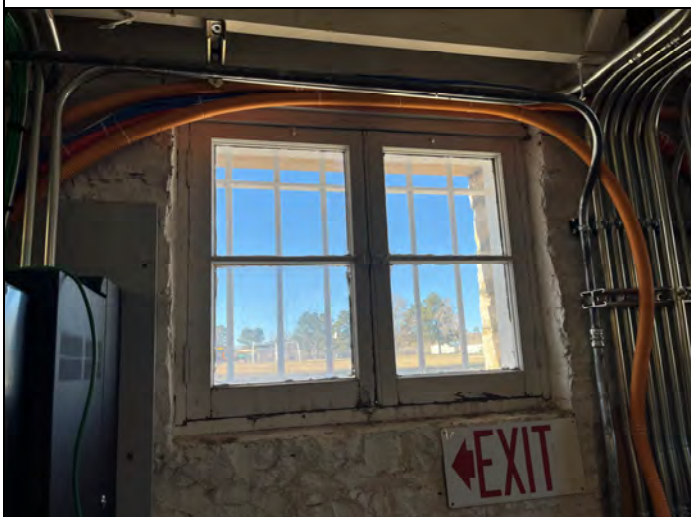
- Shot 80 - Photo 23 – Building 46, white wood window was found to contain 5.50 mg/cm<sup>2</sup> lead. Approximately 5 total square feet (SF) of the wood window was identified in Basement B101.

Photo 23 – Test 80, lead containing white wood window in building 46 room B101.

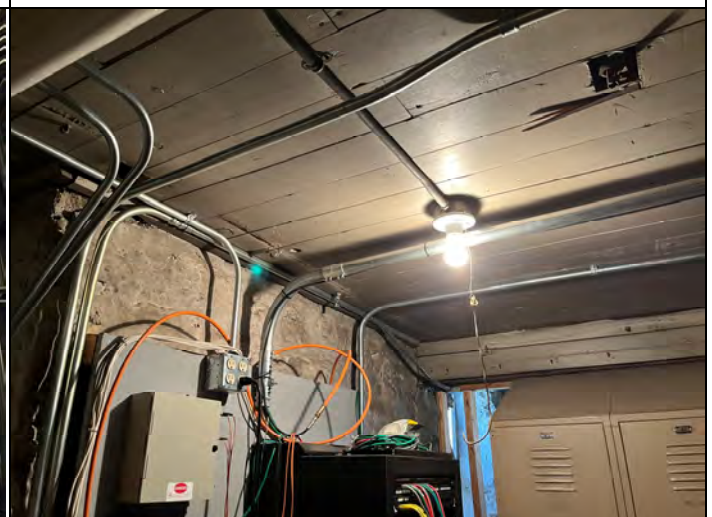
- Shot 96 - Photo 24 – Building 50, gray wood ceiling was found to contain 1.50 mg/cm<sup>2</sup> lead. Approximately 375 total square feet (SF) of the wood ceiling was identified in Basement B101.

Photo 24 – Test 96, lead containing gray wood ceiling in building 50 room B101.

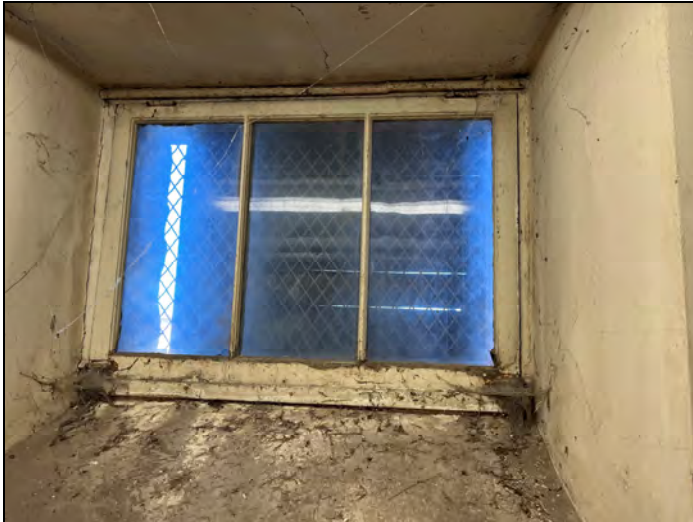
- Shot 105 - Photo 25 – Building 53 white wood window was found to contain 3.70 mg/cm<sup>2</sup> lead. Approximately 2 total square feet (SF) of the wood window was identified in Basement B108.

Photo 25 – Test 105, lead containing white window/frame in building 53 room B108.

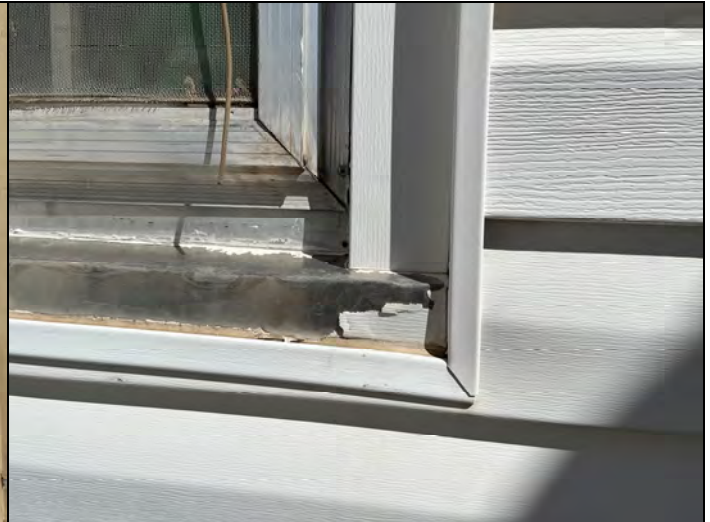
- Shot 117 - Photo 26 – Building T296, white metal window frame was found to contain 1.50 mg/cm<sup>2</sup> lead. Approximately 2 total square feet (SF) of the metal window frame was identified on the exterior of T296 laundry room.

Photo 26 – Test 117, lead containing white metal window frame on building T296 room exterior.

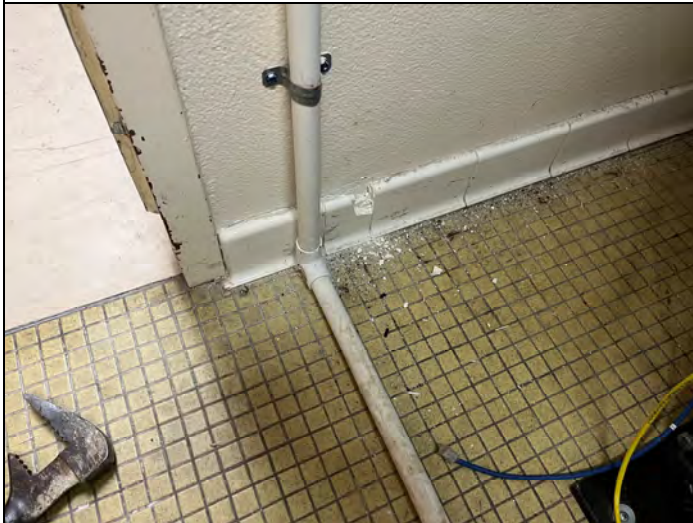
- Shot 133 - Photo 27 – Building 148, 4" white ceramic tile base cove was found to contain 3.20 mg/cm<sup>2</sup> lead. Approximately 11 total square feet (SF) of the ceramic base cove was identified in Fl. 01 Rm. ATC2.

Photo 27 – Test 133, lead containing 6" white ceramic base cove in building 148 room ATC2.

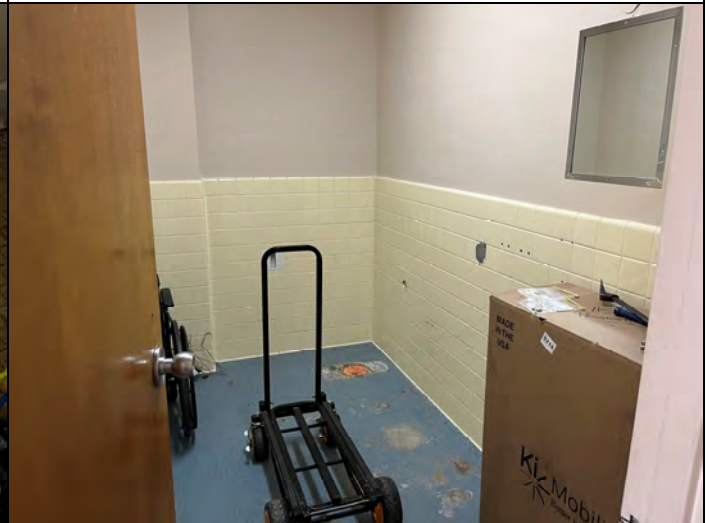
- Shot 221 - Photo 28 – Building 113, 4" light yellow ceramic wall tile was found to contain 6.80 mg/cm<sup>2</sup> lead. Approximately 128 total square feet (SF) of the ceramic wall tile was identified in Fl. 01 Rm. 169A.

Photo 28 – Test 221, lead containing 4" light yellow ceramic wall tile in building 113 room 169A.
