**LIMITED ASBESTOS
AND LEAD INSPECTION REPORT**

VA Black Hills Health Care System
113 Comanche Road
Fort Meade, SD 57741

AET Project No. P-0011150

April 8, 2022

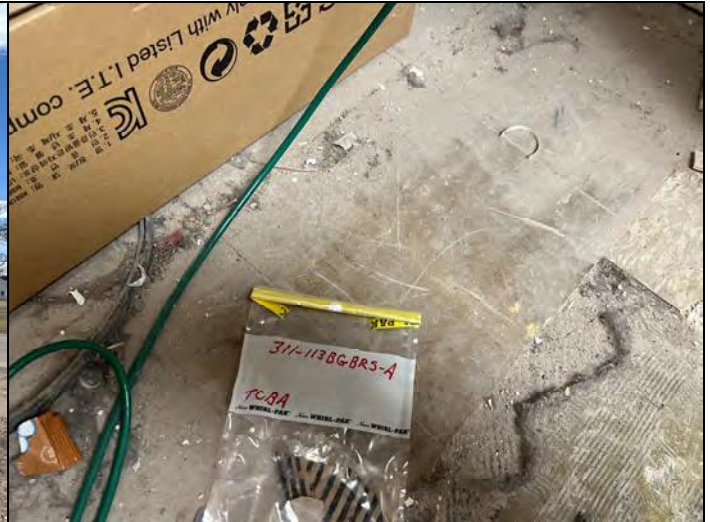
- 311-113BGBRS-A – Photo 2 – Building 113, 9”x9” beige with brown streaks floor tile and black mastic was found to contain 5% asbestos in the tile only, the mastic DOES NOT contain asbestos. Approximately 11 total square feet (SF) of the floor tile was identified in Basement Rm. TCBA.

Photo 2 – Sample 311-113GBRS-A, asbestos containing 9" beige with brown streaks floor tile in building 113, room TCBA. Only tile contains.

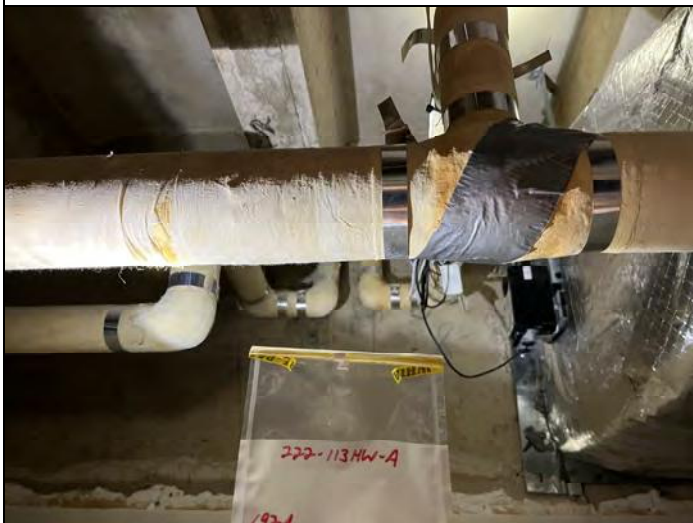
- 222113HW-A, B, C – Photo 3 – Building 113, 0-4” hard white fibrous pipe fittings were found to contain 10% asbestos. Approximately 15 total fittings (EA) were identified in Fl. 01 Rm. 192A.

Photo 3 – Samples 222-113HW-A, B, C, asbestos containing 0-4" hard white pipe fittings in building 113 room 192A.

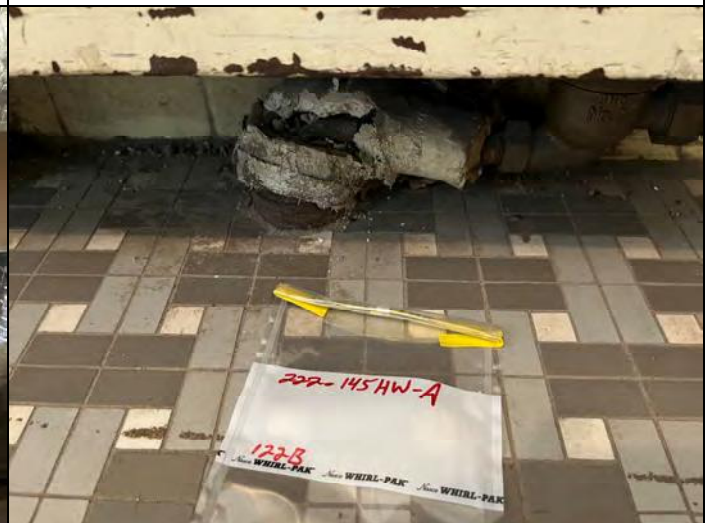
- 222-145HW-A, B, C – Photo 4 – Building 145, 0-4” hard white fibrous pipe fittings were found to contain 3% asbestos. Approximately 1 total fitting (EA) was identified in Fl. 01 Rm. 122B.

Photo 4 – Samples 222-145HW-A, B, C, asbestos containing 0-4" hard white pipe fittings in building 145 room 122B.

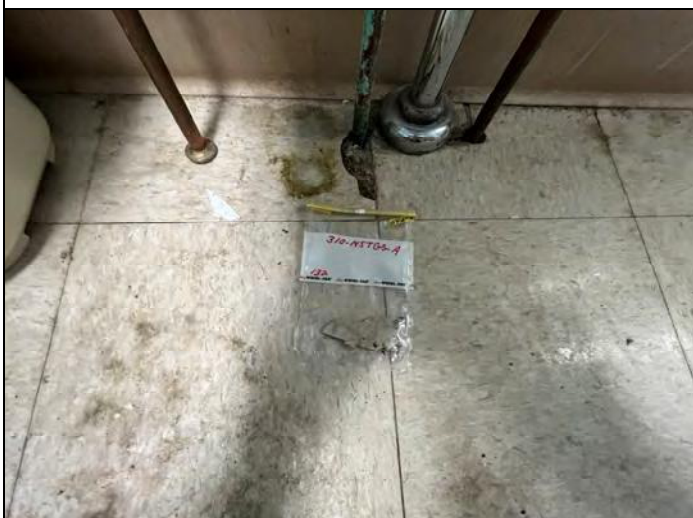
- 310-145TGS-A – Photo 5 – Building 145, 12”x12” tan with gray streaks floor tile and black mastic was found to contain 3% asbestos in the mastic only, the tile DOES NOT contain asbestos. Approximately 1,374 total square feet (SF) of the mastic was identified in Fl. 01 Rm. 132.

Photo 5 – Sample 310-145TGS-A, asbestos containing (ACM) 12" tan with gray streaks floor tile in building 145, room 132. Only mastic contains.

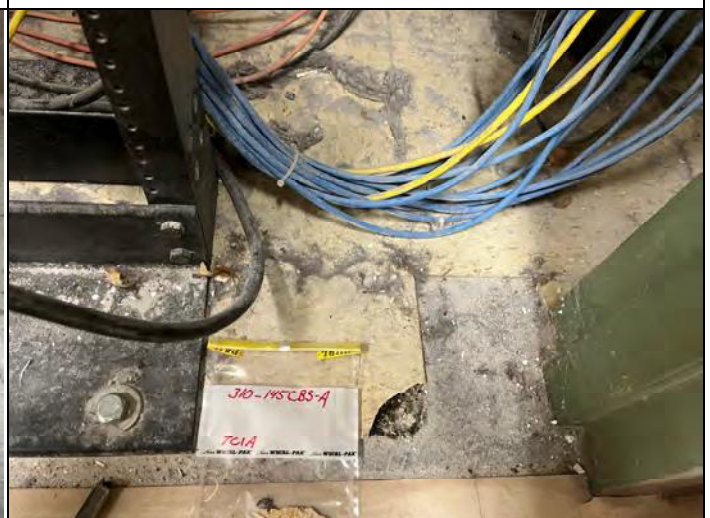
- 310-145CBS-A – Photo 6 – Building 145, 12”x12” cream with beige streaks floor tile and black mastic was found to contain 3% asbestos in the mastic only, the tile DOES NOT contain asbestos. Approximately 53 total square feet (SF) of the mastic was identified in Fl. 01 Rms. TC1A (17 SF) and 137C (36 SF).

Photo 6 – Sample 310-145CBS-A, asbestos containing 12" cream with brown streaks floor tile in building 145, rooms TC1A and 137C. Only mastic contains.

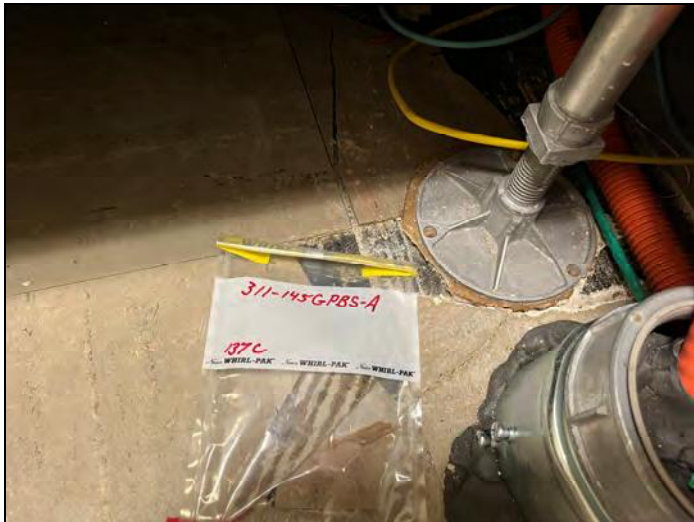
- 311-145GPBS-A – Photo 7 – Building 145, 9”x9” gray with pink and black streaks floor tile and black mastic was found to contain 8% asbestos in the tiles and 3% asbestos in the mastic. Approximately 666 total square feet (SF) of the floor tile and mastic was identified in Fl. 01 Rm. 137C.

Photo 7 – Sample 311-145GPBS-A, asbestos containing 12” gray with pink and black streaks floor tile and black mastic in building 145, room 137C. Both tile and mastic contain.

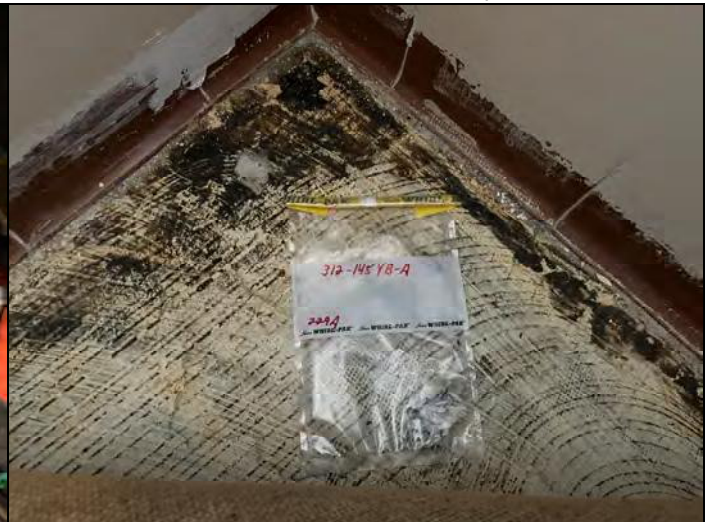
- 312-145YB-A – Photo 8 – Building 145, yellow and black floor tile mastic was found to contain 2% asbestos. Approximately 99 total square feet (SF) of the mastic was identified in Fl. 02 Rm. 229A.

Photo 8 – Sample 312-145YB-A, asbestos containing yellow and black mastic in building 145, room 229A.

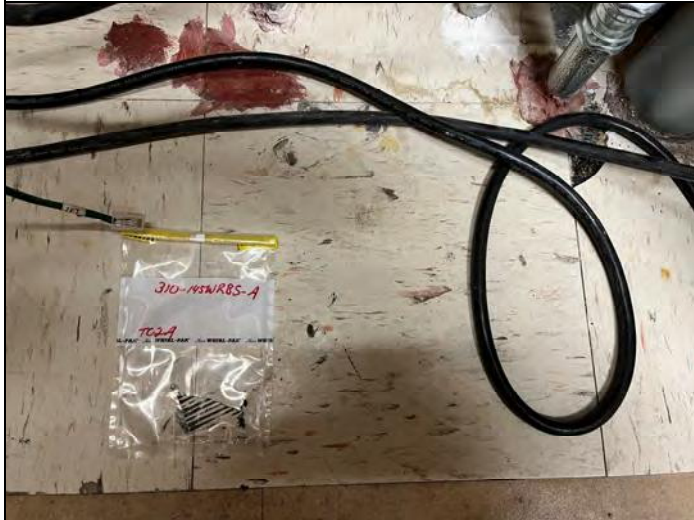
- 310-145WRBS-A – Photo 9 – Building 145, 12”x12” white with red and black streaks floor tile and black mastic was found to contain 3% asbestos in the mastic only, the tile DOES NOT contain asbestos. Approximately 9 total square feet (SF) of the mastic was identified in Fl. 02 Rm. TC2A.

Photo 9 – Sample 310-145WRBS-A, ACM 12” white w/ red and black streaks floor tile in bldg. 145, rm. TC2A. Only mastic contains.

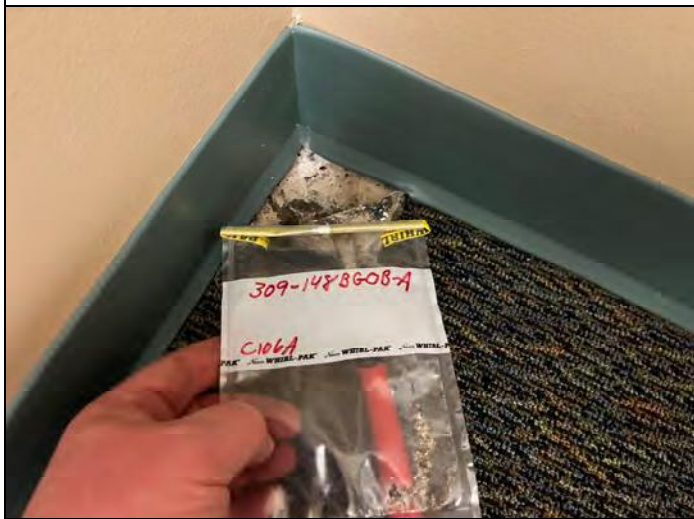
- 309-148BGOB-A – Photo 11 – Building 148, beige over black carpet mastic was found to contain 2% asbestos. Approximately 176 total square feet (SF) of the mastic was identified in Fl. 01 Rm. C106A.

Photo 11 – Sample 309-148T-A, asbestos containing beige over black carpet mastic in building 148, room C106A.

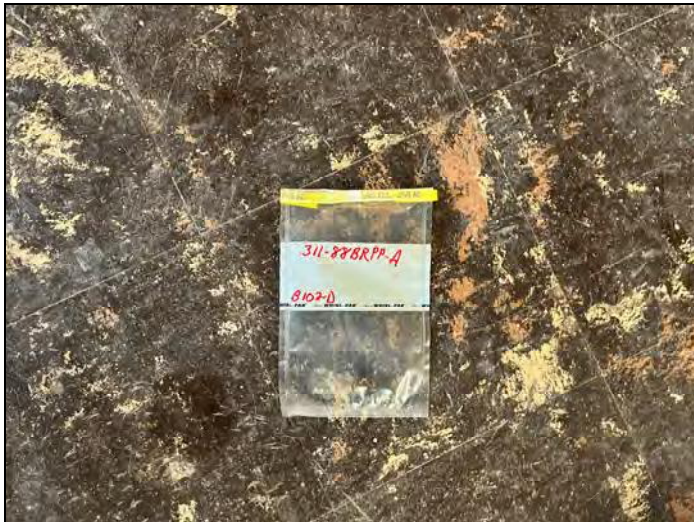
- 311-88BRPP-A – Photo 13 – Building 88, 9”x9” brown with pink patches floor tile and black mastic was found to contain 10% asbestos in the tiles and 3% asbestos in the mastic. Approximately 144 total square feet (SF) of the floor tile and mastic was identified in Fl. 01 Rm. B102D.

Photo 13 – Sample 311-88BRPP-A, asbestos containing 9” brown w/ pink patches floor tile bldg. 88, room B102D. Tile and mastic contain.

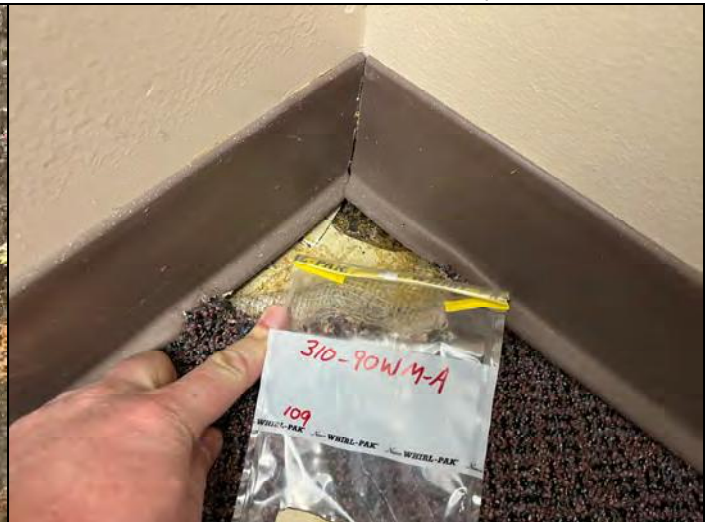
- 310-90WM-A – Photo 14 – Building 90, 12”x12” white mottled floor tile and black mastic was found to contain 3% asbestos in the mastic only, the tile DOES NOT contain asbestos. Approximately 110 total square feet (SF) of the mastic was identified in Fl. 01 Rm. 109.

Photo 14 – Sample 310-90WM-A, asbestos containing 12” white mottled floor tile in building 90, room 109. Only mastic contains.

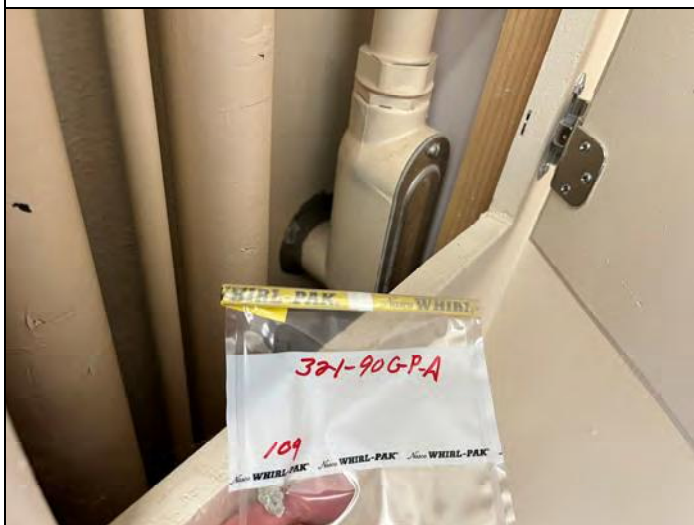
- 321-90GP-A – Photo 15 – Building 90, gray penetration caulk was found to contain 10% asbestos. Approximately 1 total square feet (SF) of the caulk was identified in Fl. 01 Rm. 109.

Photo 15 – Sample 321-90GP-A, asbestos containing gray penetration caulking in building 90, room 109.

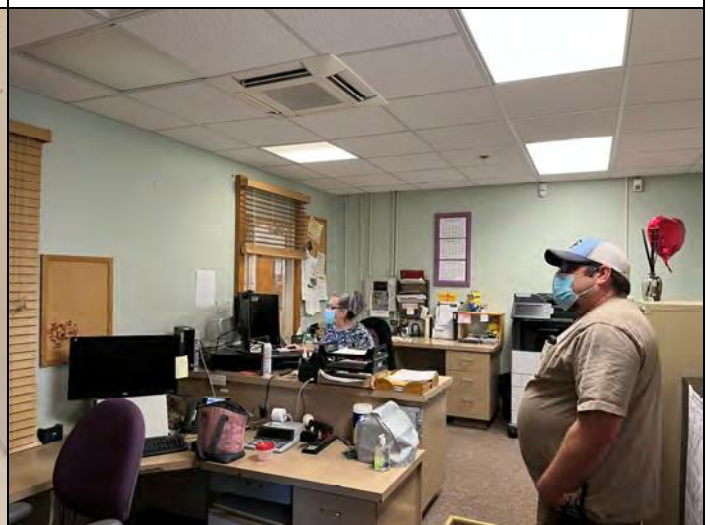
Photo 16 – Material 509-113BRF, presumed asbestos containing black raised floor adhesive in building 113, room 192A.

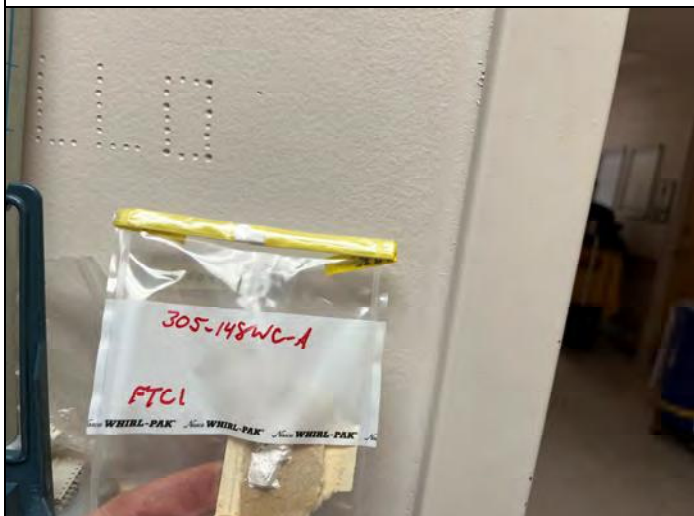
- 305-148WC-A - Photo 17 – Building 148, sheetrock and taping compound walls and ceilings was found to contain 0.5% asbestos. Approximately 240 total square feet (SF) of the sheetrock and taping compound was identified in Fl. 01 Rm. FTC1.
- 107-90BPY-A, B, C - Photo 18 – Building 90, bumpy textured walls were found to contain 0.25% asbestos. Approximately 420 total square feet (SF) of the bumpy texturing was identified in Fl. 01 Rm. 109.
- 305-T171WC-A, B - Photo 19 – Building T171, sheetrock and taping compound walls and ceilings was found to contain 0.25% asbestos. Approximately 420 total square feet (SF) of the sheetrock and taping compound was identified in Fl. 01 Rms. 100 (60 SF) and 101B (360 SF).

Photo 17 – Sample 305-148WC-A, less than 1% asbestos containing sheetrock and taping compound walls and ceilings in building 148 room FTC1.

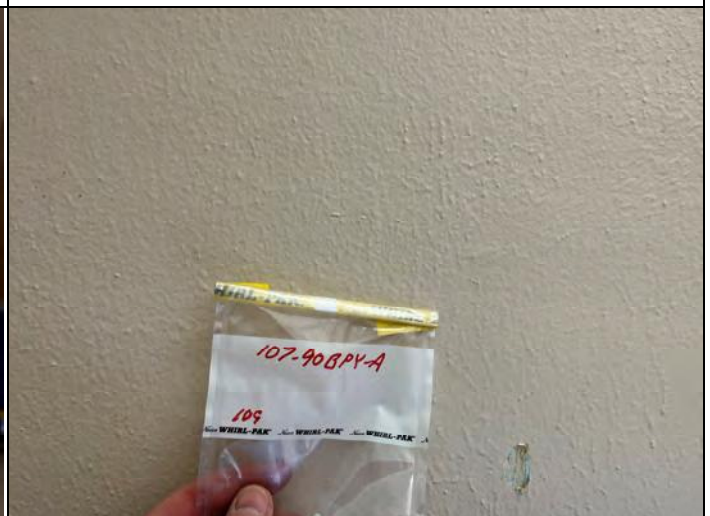
Photo 18 – Samples 107-90BPY-A, B, C, less than 1% asbestos containing bumpy textured walls in building 90 room 109.

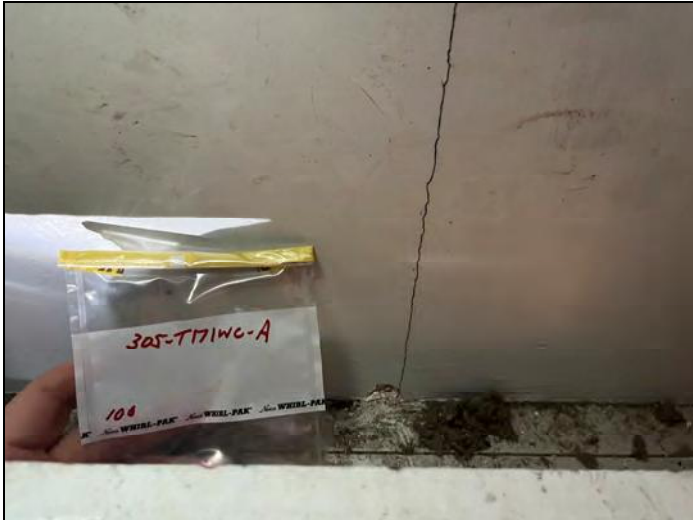
Photo 19 – Sample 305-T171WC-A, less than 1% asbestos containing sheetrock and taping compound walls and ceilings in building T171 room 100.

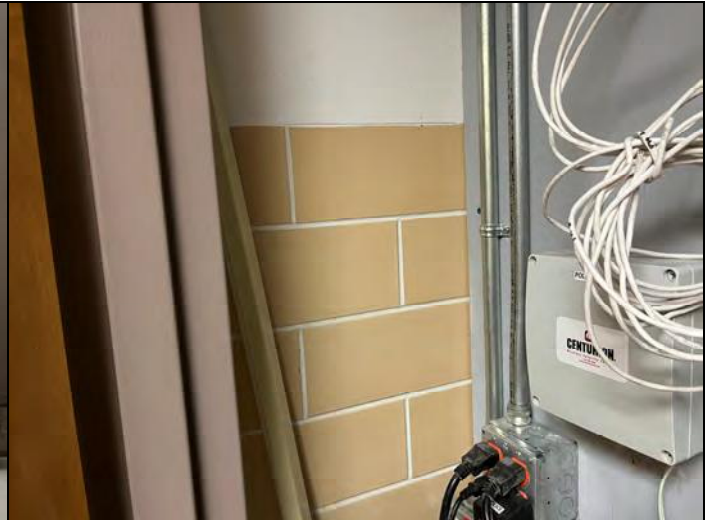
- Shot 18 - Photo 20 – Building 145, glazed tan terra cotta block walls were found to contain 1.50 mg/cm² lead. Approximately 75 total square feet (SF) of the terra cotta tile was identified in Fl. 02 Rm. TC2A.

Photo 20 – Test 18, lead containing tan terra cotta block walls in building 145 room TC2A.

The lead containing materials must be removed and properly disposed of by Environmental Protection Agency (EPA) Lead Renovation, Repair and Painting (RRP) trained and certified personnel.

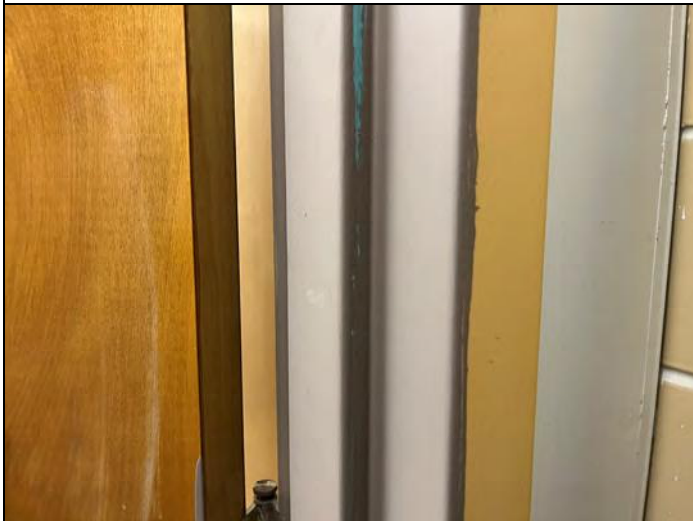
- Shot 25 - Photo 21 – Building 145, glazed tan terra cotta block walls were found to contain 1.60 mg/cm² lead. Approximately 75 total square feet (SF) of the terra cotta tile was identified in Fl. 03 Rm. TC3A.

Photo 21 – Test 25, lead containing tan terra cotta block walls in building 145 room TC3A.

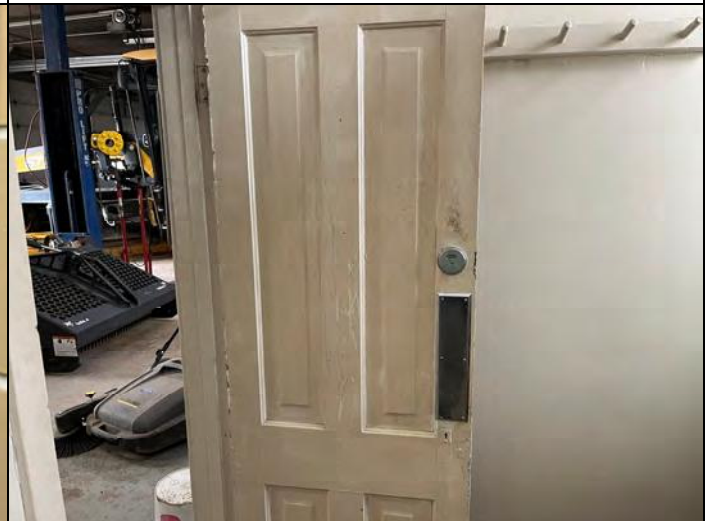
- Shot 75 - Photo 22 – Building T171, tan wood door/door frame were found to contain 27.90 mg/cm² lead. Approximately 27 total square feet (SF) of the wood door/door frame was identified in Fl. 01 Rm. 101B.

Photo 22 – Test 75, lead containing tan wood door and frame in building T171 room 101B.

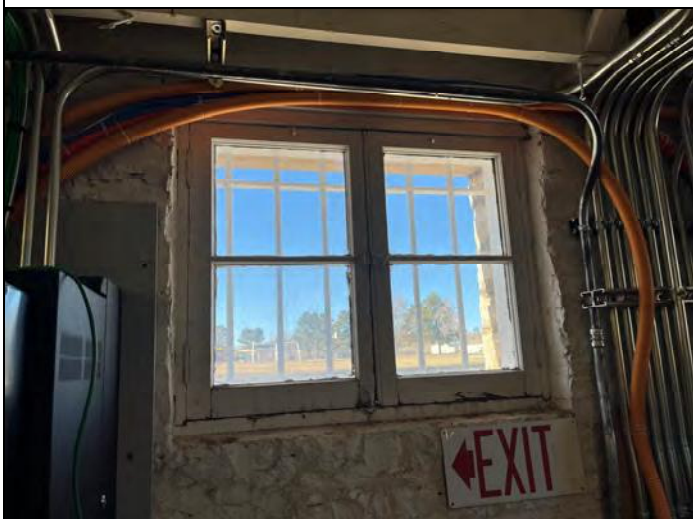
- Shot 80 - Photo 23 – Building 46, white wood window was found to contain 5.50 mg/cm² lead. Approximately 5 total square feet (SF) of the wood window was identified in Basement B101.

Photo 23 – Test 80, lead containing white wood window in building 46 room B101.

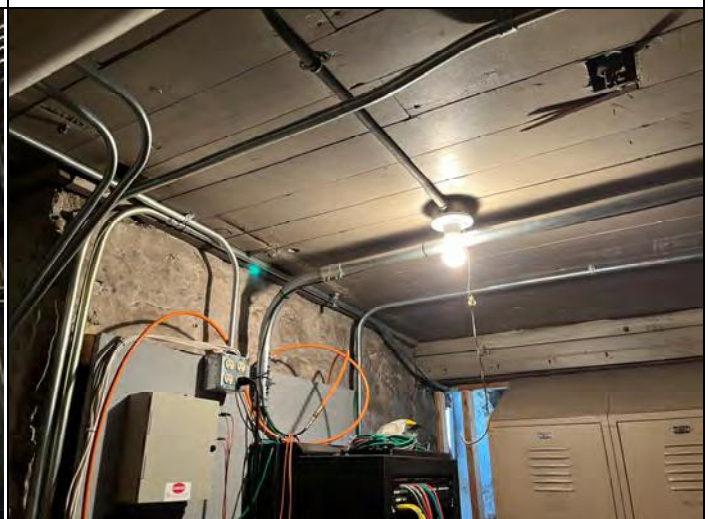
- Shot 96 - Photo 24 – Building 50, gray wood ceiling was found to contain 1.50 mg/cm² lead. Approximately 375 total square feet (SF) of the wood ceiling was identified in Basement B101.

Photo 24 – Test 96, lead containing gray wood ceiling in building 50 room B101.

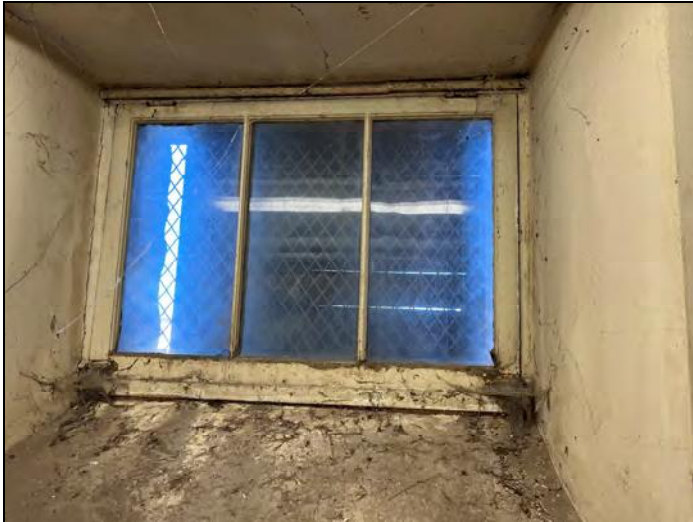
- Shot 105 - Photo 25 – Building 53 white wood window was found to contain 3.70 mg/cm² lead. Approximately 2 total square feet (SF) of the wood window was identified in Basement B108.

Photo 25 – Test 105, lead containing white window/frame in building 53 room B108.

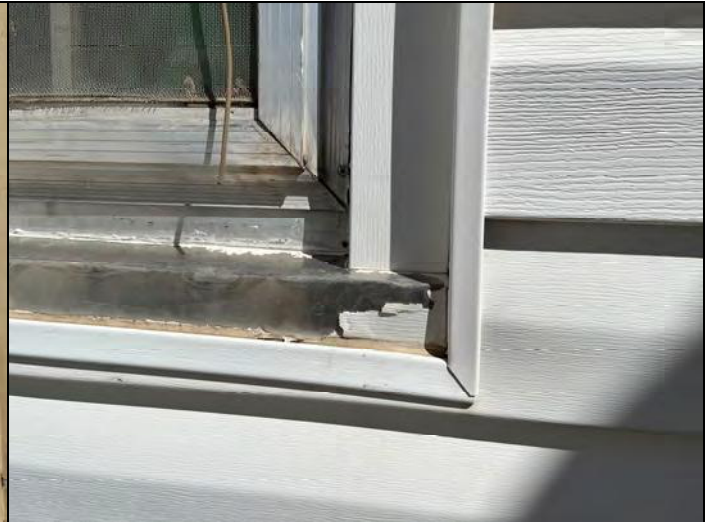
- Shot 117 - Photo 26 – Building T296, white metal window frame was found to contain 1.50 mg/cm² lead. Approximately 2 total square feet (SF) of the metal window frame was identified on the exterior of T296 laundry room.

Photo 26 – Test 117, lead containing white metal window frame on building T296 room exterior.

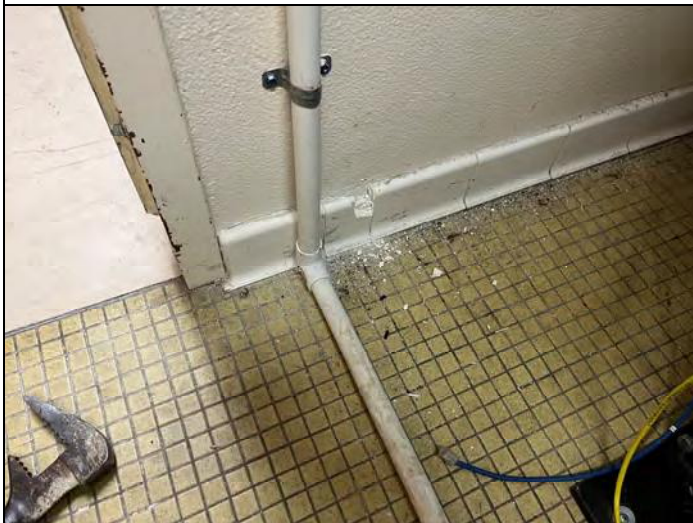
- Shot 133 - Photo 27 – Building 148, 4” white ceramic tile base cove was found to contain 3.20 mg/cm² lead. Approximately 11 total square feet (SF) of the ceramic base cove was identified in Fl. 01 Rm. ATC2.

Photo 27 – Test 133, lead containing 6" white ceramic base cove in building 148 room ATC2.

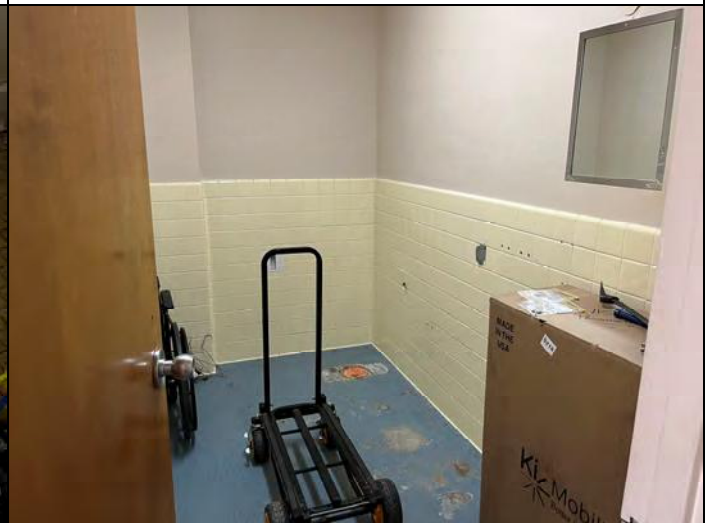
- Shot 221 - Photo 28 – Building 113, 4” light yellow ceramic wall tile was found to contain 6.80 mg/cm² lead. Approximately 128 total square feet (SF) of the ceramic wall tile was identified in Fl. 01 Rm. 169A.

Photo 28 – Test 221, lead containing 4" light yellow ceramic wall tile in building 113 room 169A.
