## Remodel Building 51-1 Eastside St. Cloud VAMC VA PROJECT NUMBER: 656-19-307

APPENDIX A Report: Asbestos and Lead Inspection Profile

## ASBESTOS & LEAD INSPECTION PROFILE

Building  $51 - 1^{st}$  Floor East Side Building  $48 - 1^{st}$  Floor West Side

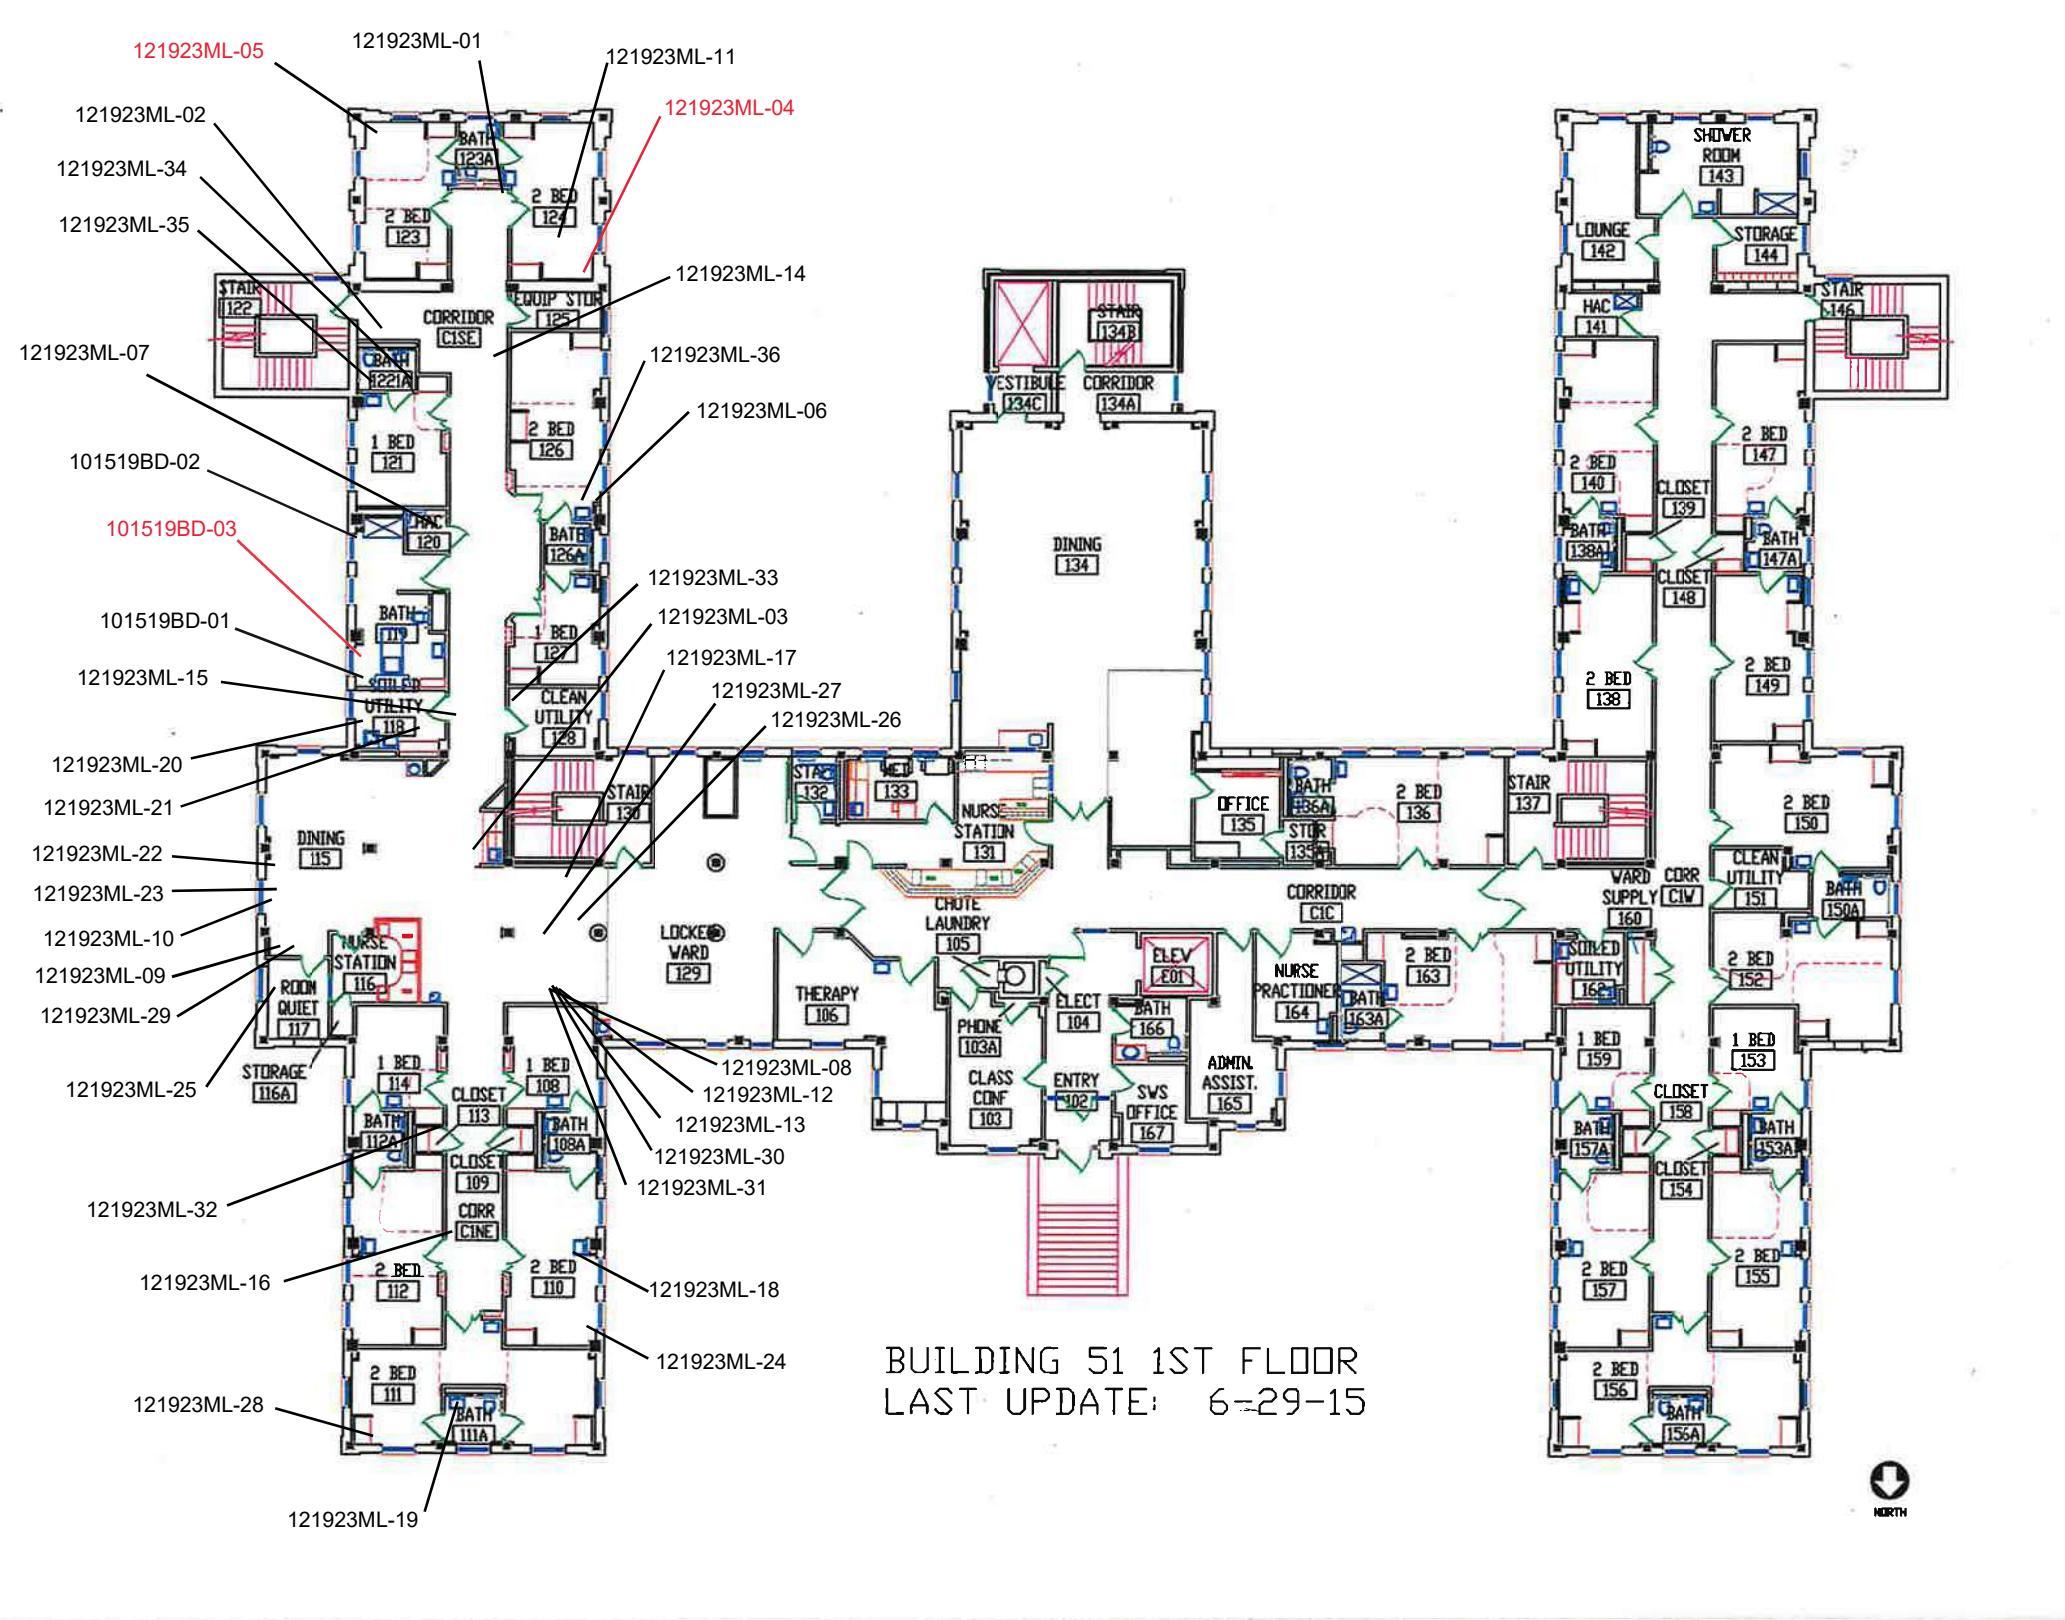
Asbestos Bulk Sample Locations Drawing

Asbestos sample location map can be found in Section II. Asbestos laboratory report can be found in Section III
