CONSULTANT 	ARCHITECT/ENGINEER OF RECORD 		Office of Construction and Facilities Management 	Drawing Title FOURTH LEVEL FLOOR PLAN - BUILDING 5 - AREA C	Phase 35% CONSTRUCTION DOCUMENT REVIEW	Project Title VAMC SIOUX FALLS EHRM INFRASTRUCTURE UPGRADES	Project Number 438-20-910																						
Revisions:

Analysis Report
prepared for
Landmark Environmental

Project Name: EHRM Update

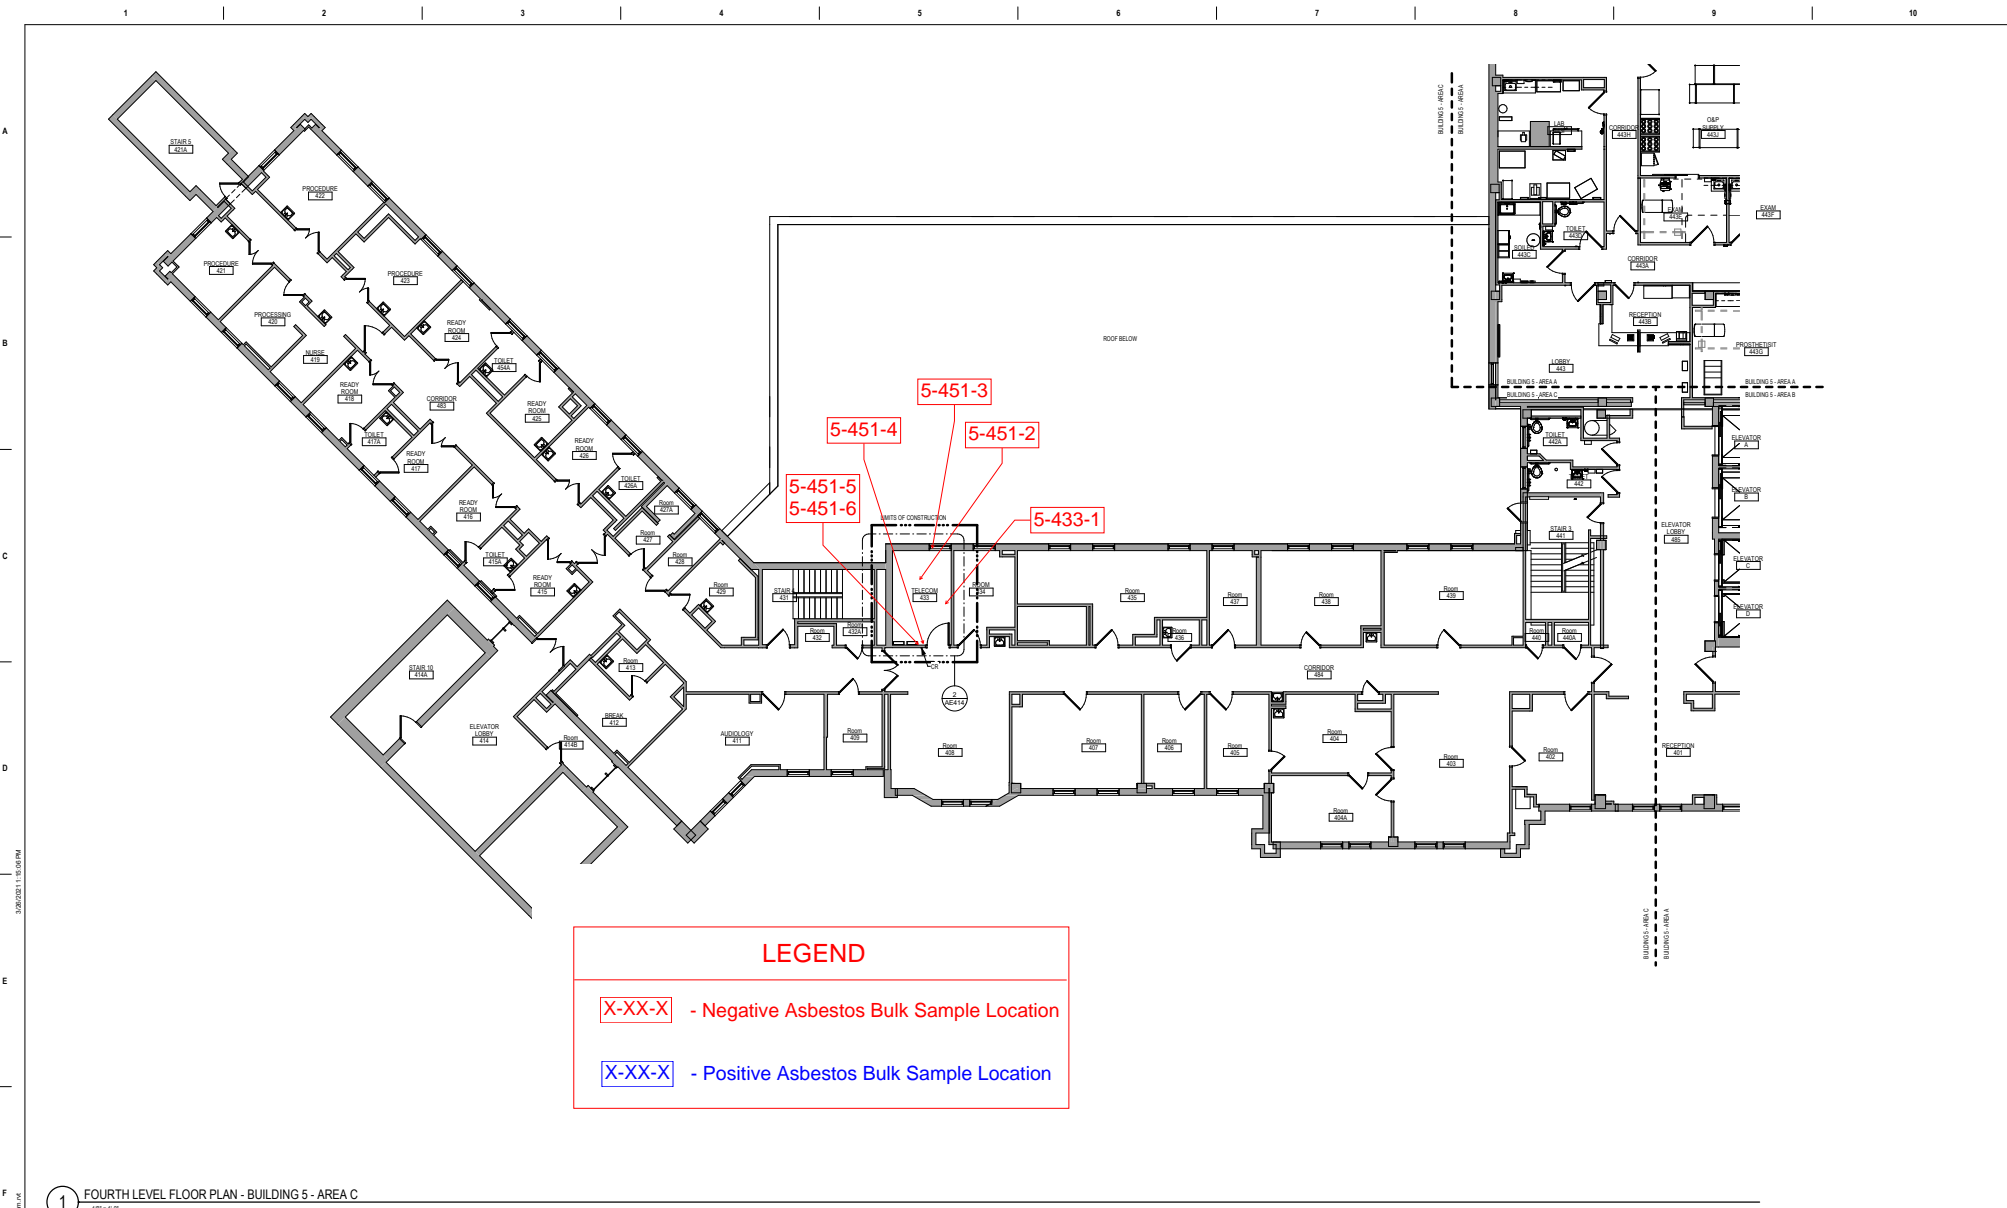
1 FOURTH LEVEL FLOOR PLAN - BUILDING 5 - AREA C
18" = 1'-0"

X-XX-X - Negative Asbestos Bulk Sample Location
X-XX-X - Positive Asbestos Bulk Sample Location
