## **LIMITED ASBESTOS AND LEAD INSPECTION REPORT**

VA Black Hills Health Care System  
113 Comanche Road  
Fort Meade, SD 57741

**AET Project No. P-0011150**

April 8, 2022

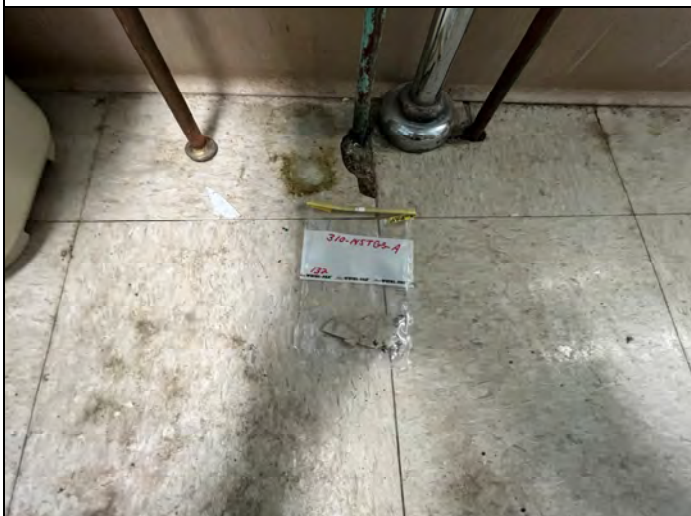
- 310-145TGS-A – Photo 5 – Building 145, 12”x12” tan with gray streaks floor tile and black mastic was found to contain 3% asbestos in the mastic only, the tile DOES NOT contain asbestos. Approximately 1,374 total square feet (SF) of the mastic was identified in Fl. 01 Rm. 132.

Photo 5 – Sample 310-145TGS-A, asbestos containing (ACM) 12" tan with gray streaks floor tile in building 145, room 132. Only mastic contains.

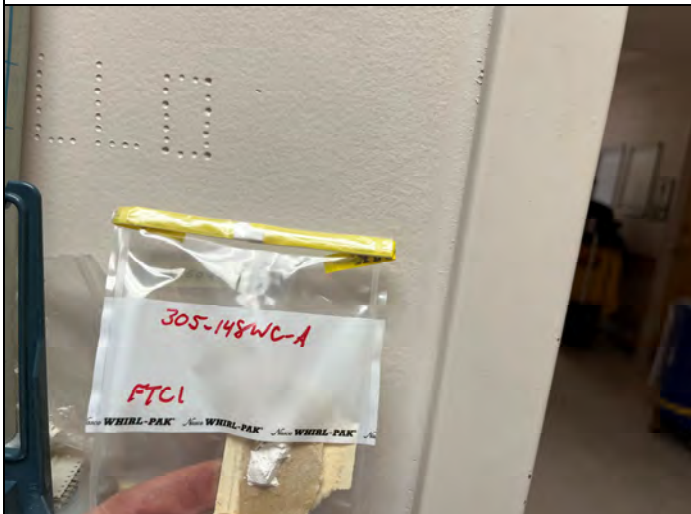
- 305-148WC-A - Photo 17 – Building 148, sheetrock and taping compound walls and ceilings was found to contain 0.5% asbestos. Approximately 240 total square feet (SF) of the sheetrock and taping compound was identified in Fl. 01 Rm. FTC1.
- 107-90BPY-A, B, C - Photo 18 – Building 90, bumpy textured walls were found to contain 0.25% asbestos. Approximately 420 total square feet (SF) of the bumpy texturing was identified in Fl. 01 Rm. 109.
- 305-T171WC-A, B - Photo 19 – Building T171, sheetrock and taping compound walls and ceilings was found to contain 0.25% asbestos. Approximately 420 total square feet (SF) of the sheetrock and taping compound was identified in Fl. 01 Rms. 100 (60 SF) and 101B (360 SF).

Photo 17 – Sample 305-148WC-A, less than 1% asbestos containing sheetrock and taping compound walls and ceilings in building 148 room FTC1.
