**GENERAL NOTES**  
 1. The scope of this project is to repair hail damage to various buildings. The work consists of replacement of damaged clay tile, replacement of broken windows, and replacement of existing awning of Building 43.

VA BLACK HILLS HEALTH CARE SYSTEM – HOT SPRINGS

SCALE: AS SHOWN OR NTS	Drawing Title Site Plan Repairs	Project Title Repairs of Storm Damage Hot Springs	Project Number 568A4-22-206	Off Cons and Man

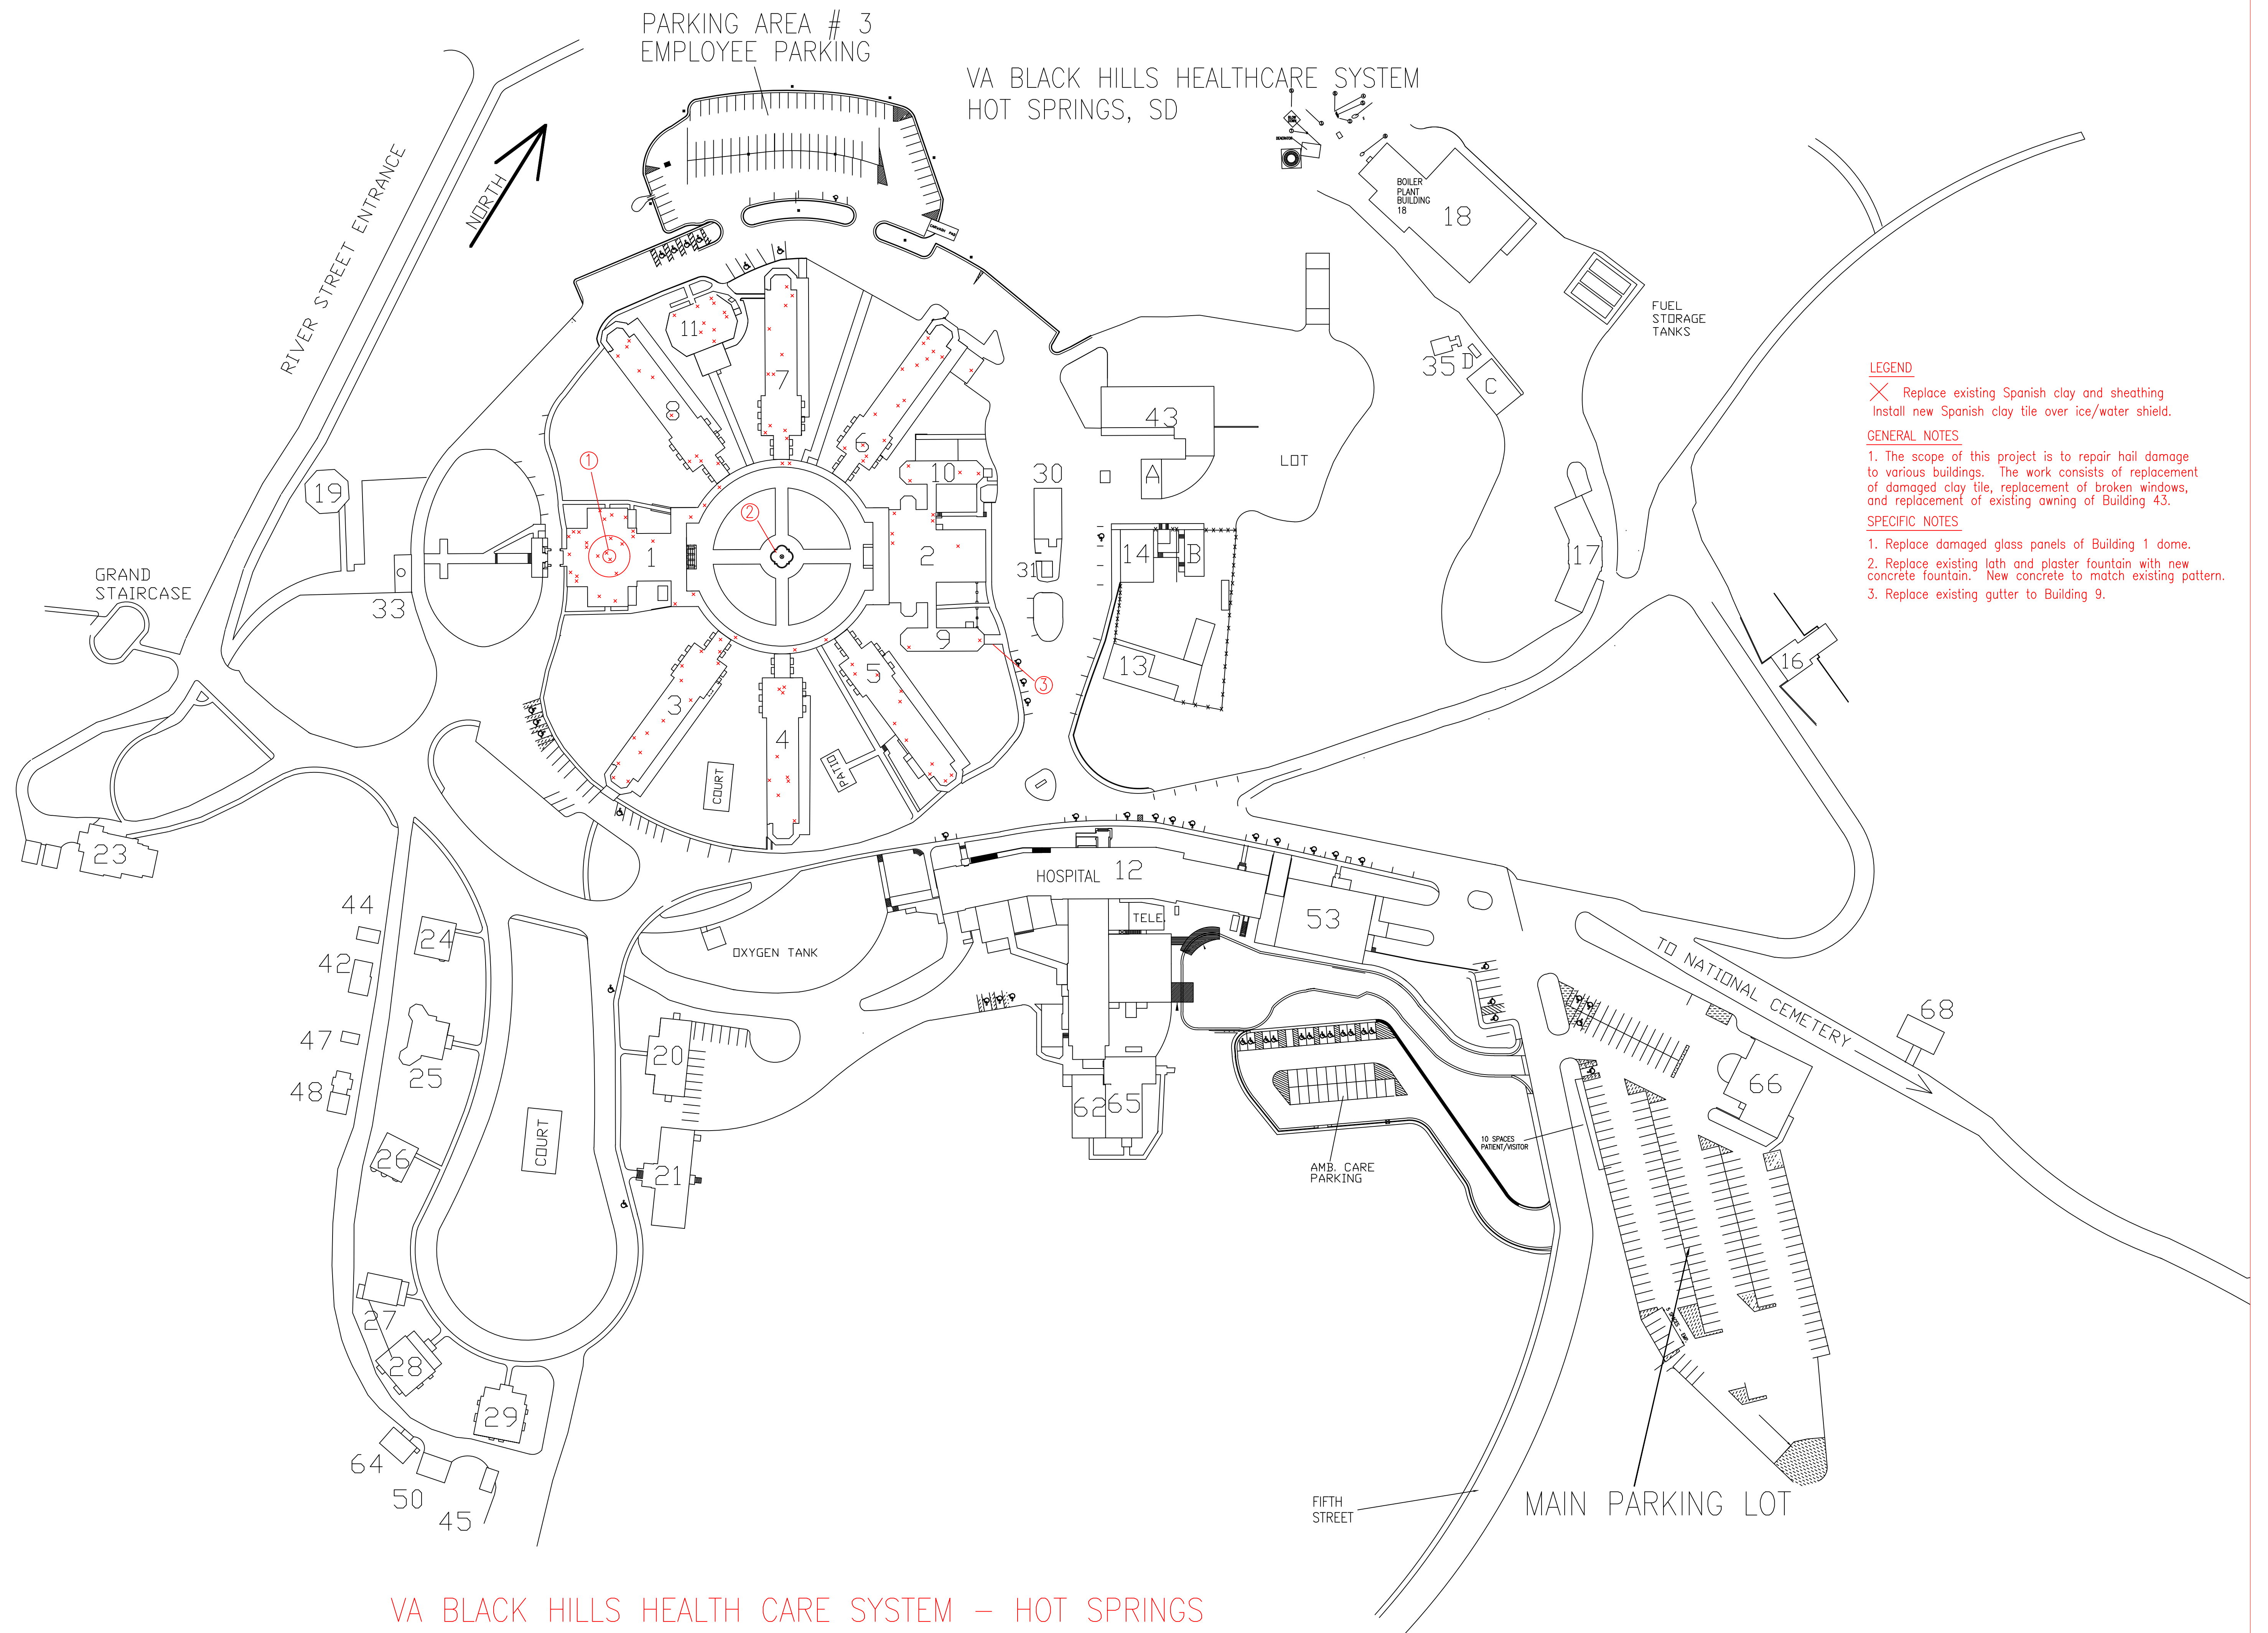
**SPECIFIC NOTES**  
 1. Replace damaged glass panels of Building 1 dome.  
 2. Replace existing lath and plaster fountain with new concrete fountain. New concrete to match existing pattern.  
 3. Replace existing gutter to Building 9.

1. Replace existing window panels on Building 1 dome.
2. Replace existing Building 43 awning with 26 gauge corrugated steel, approximately 84'.
3. Replace existing damaged fountain plaster new concrete, match existing pattern.

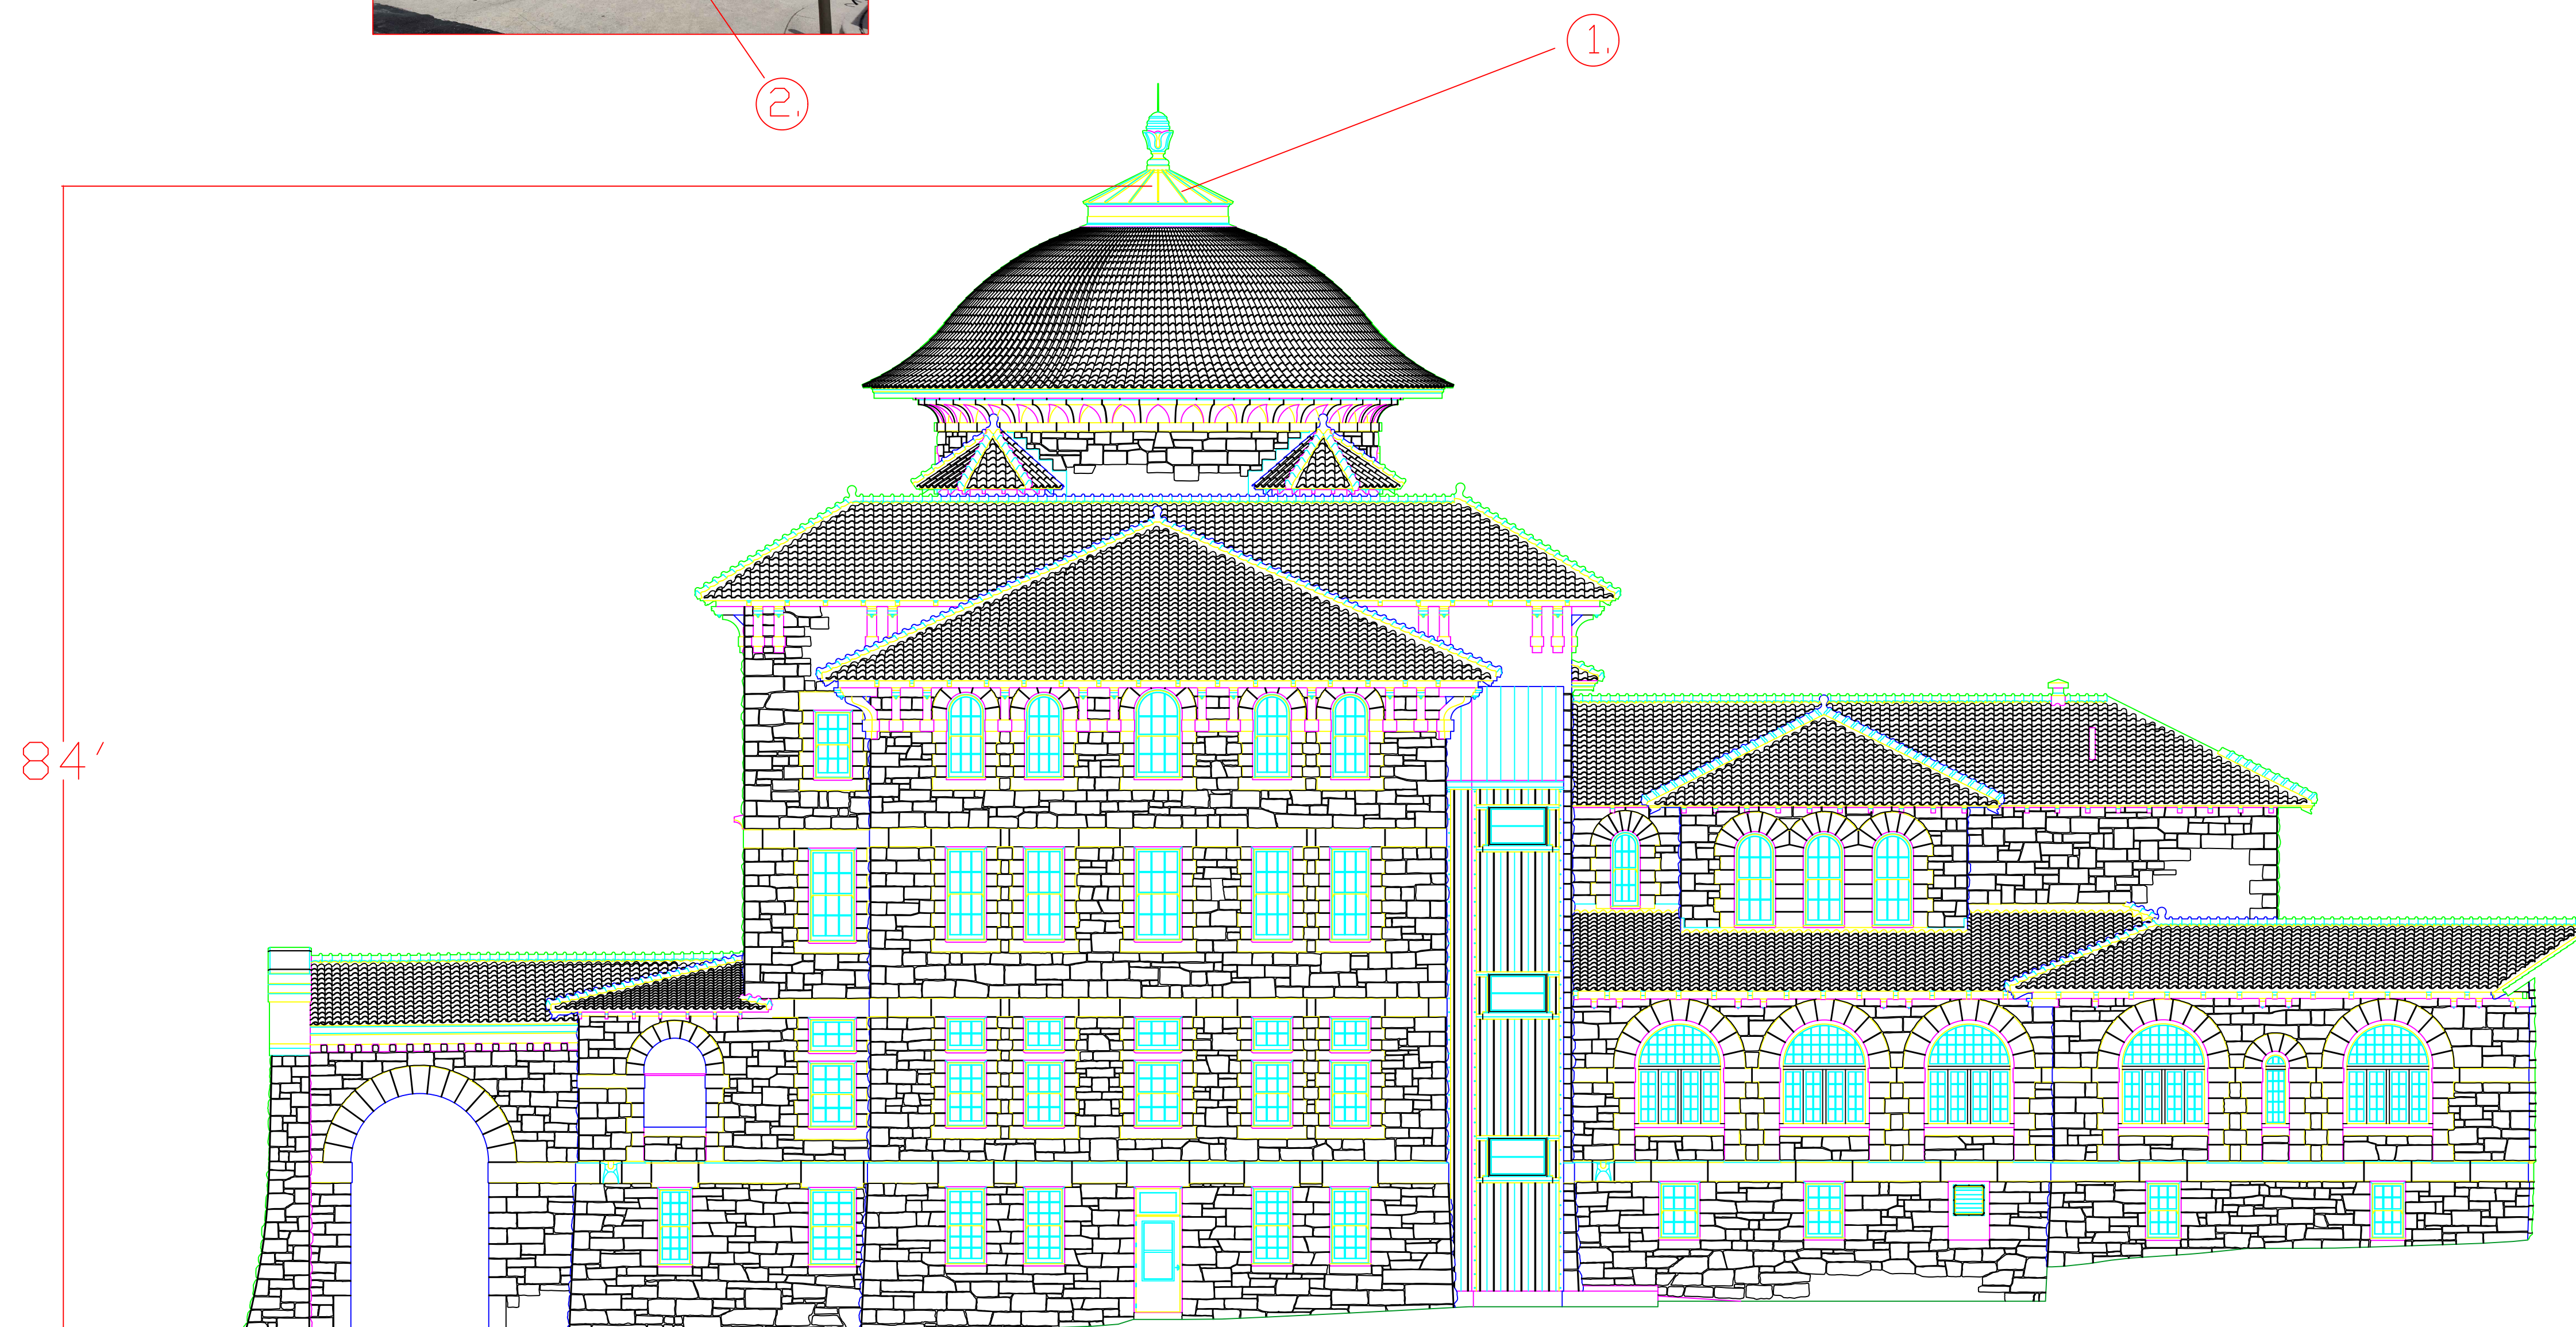
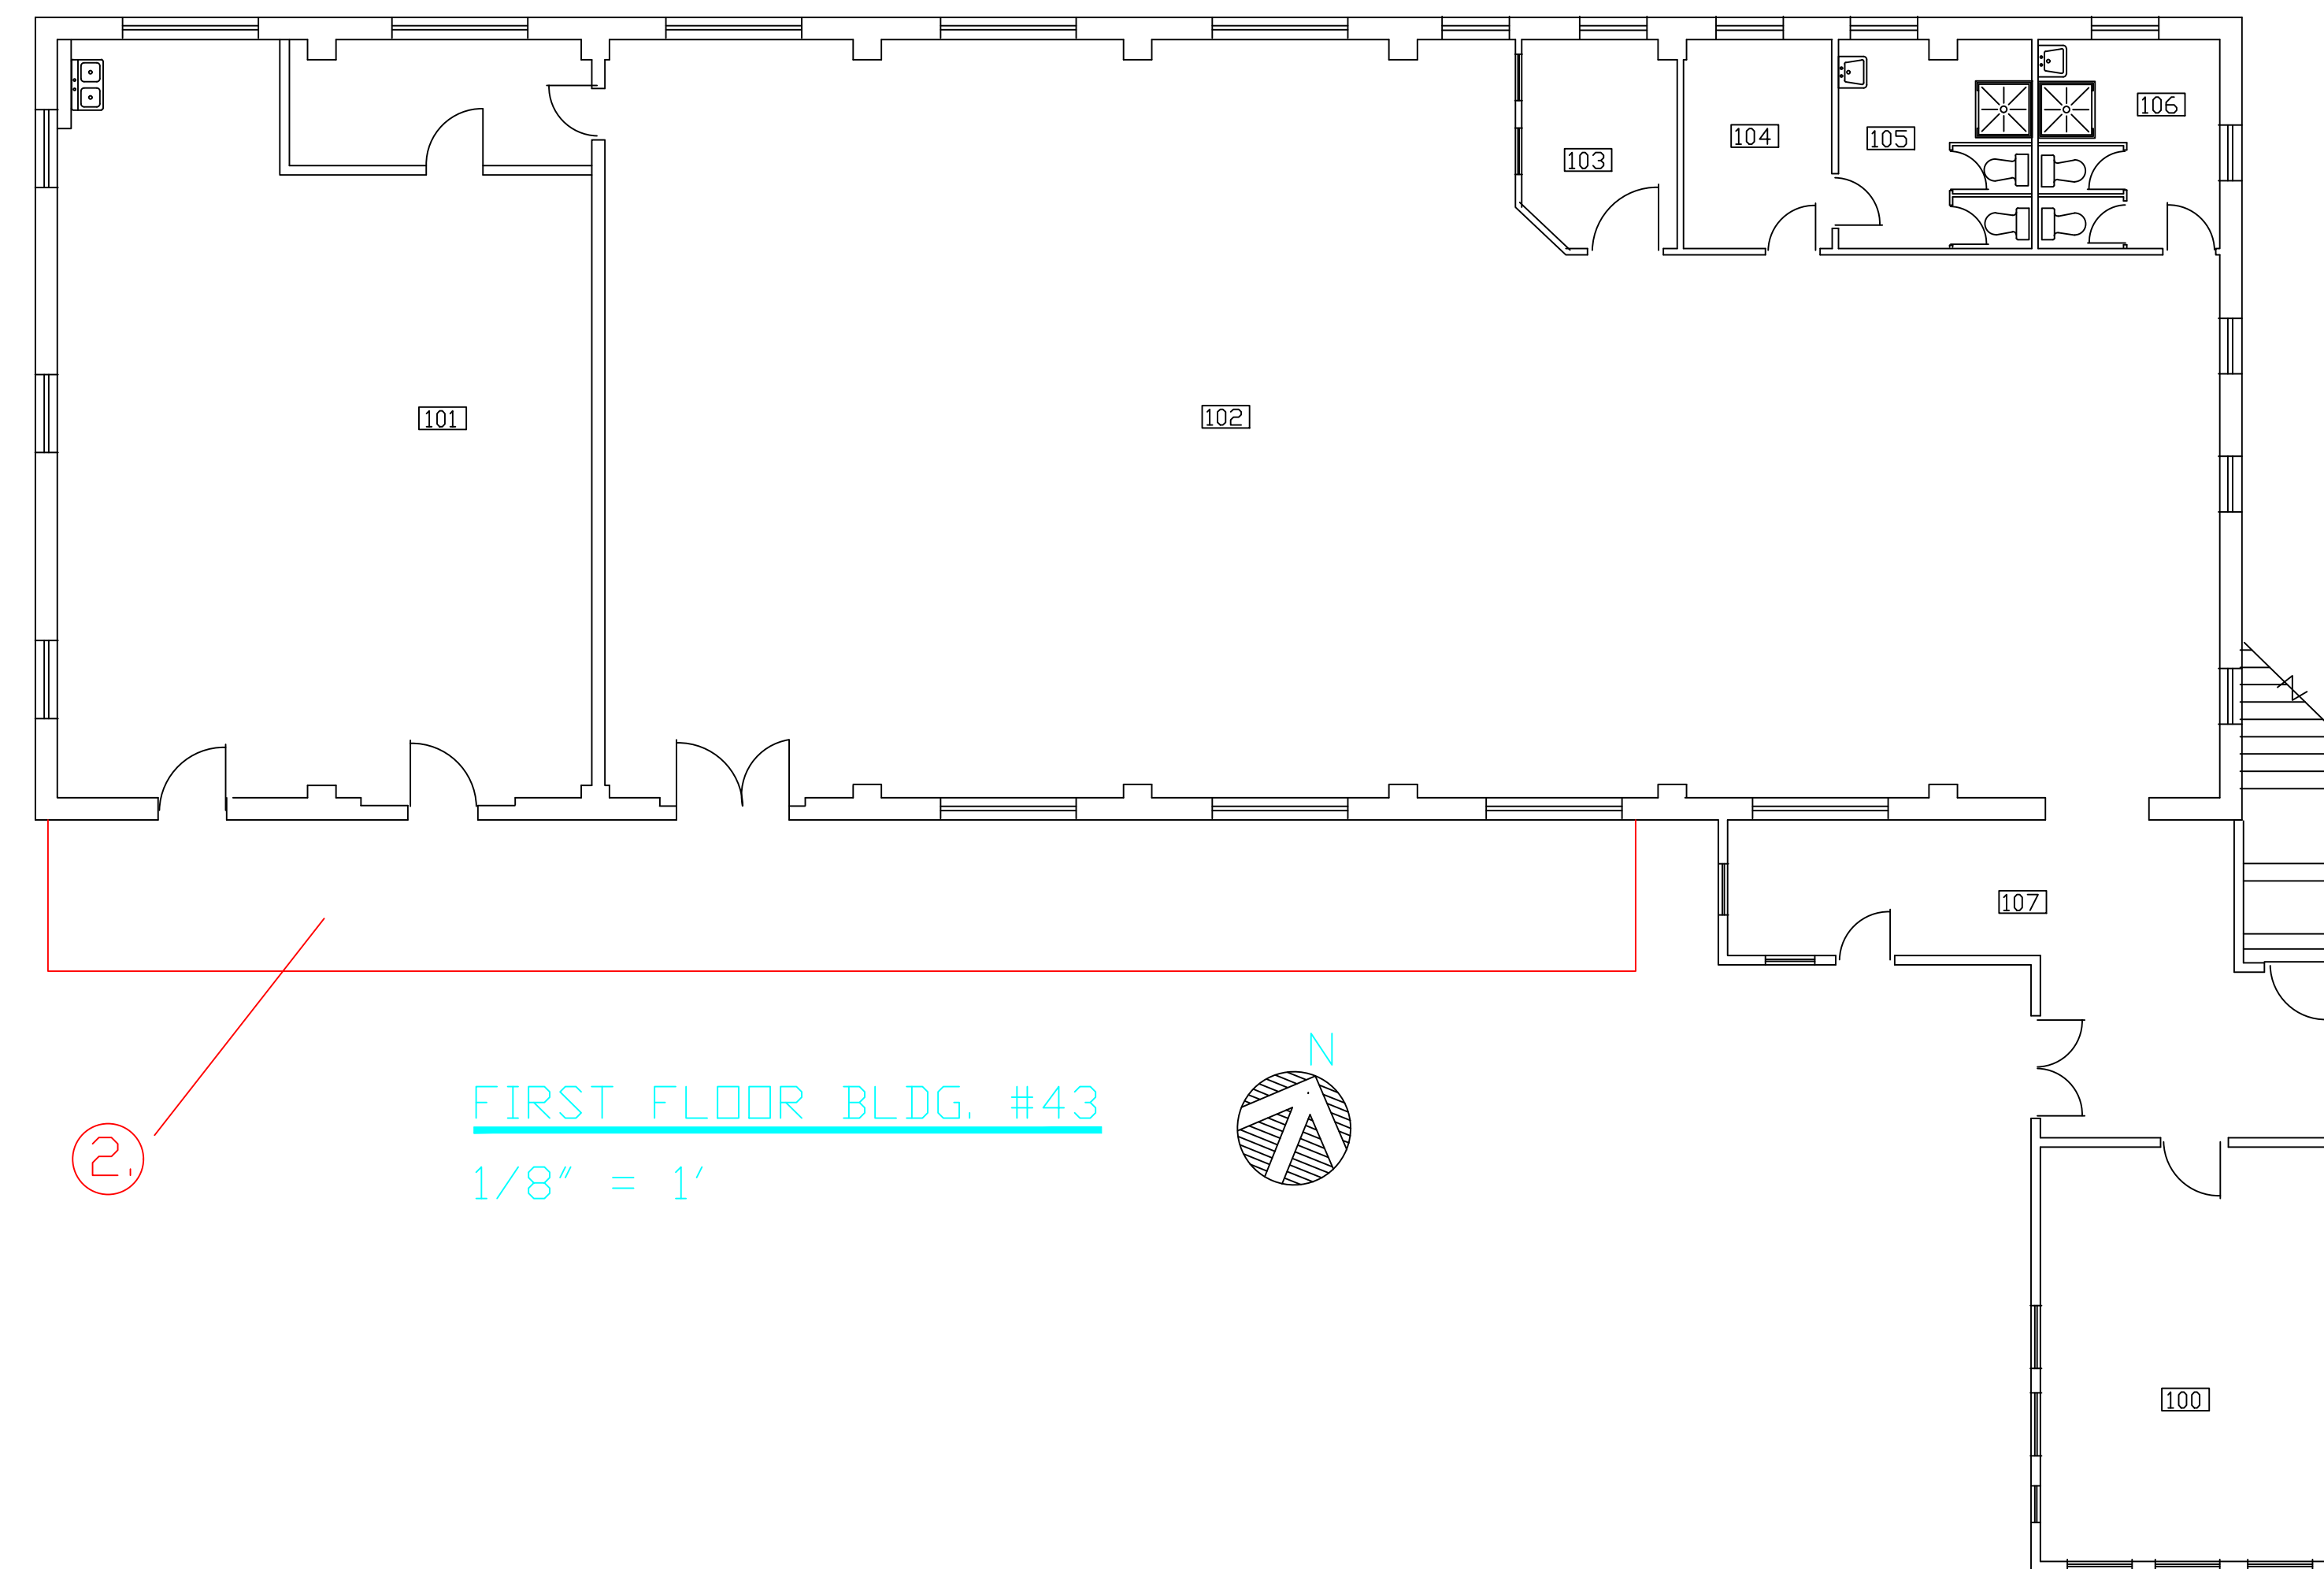
✕ Replace existing Spanish clay tile and sheathing. Install new Spanish clay tile over ice/water shield.

- ① Replace approximately 4 damaged clay tiles.
- ② Replace approximately 6 damaged clay tiles.

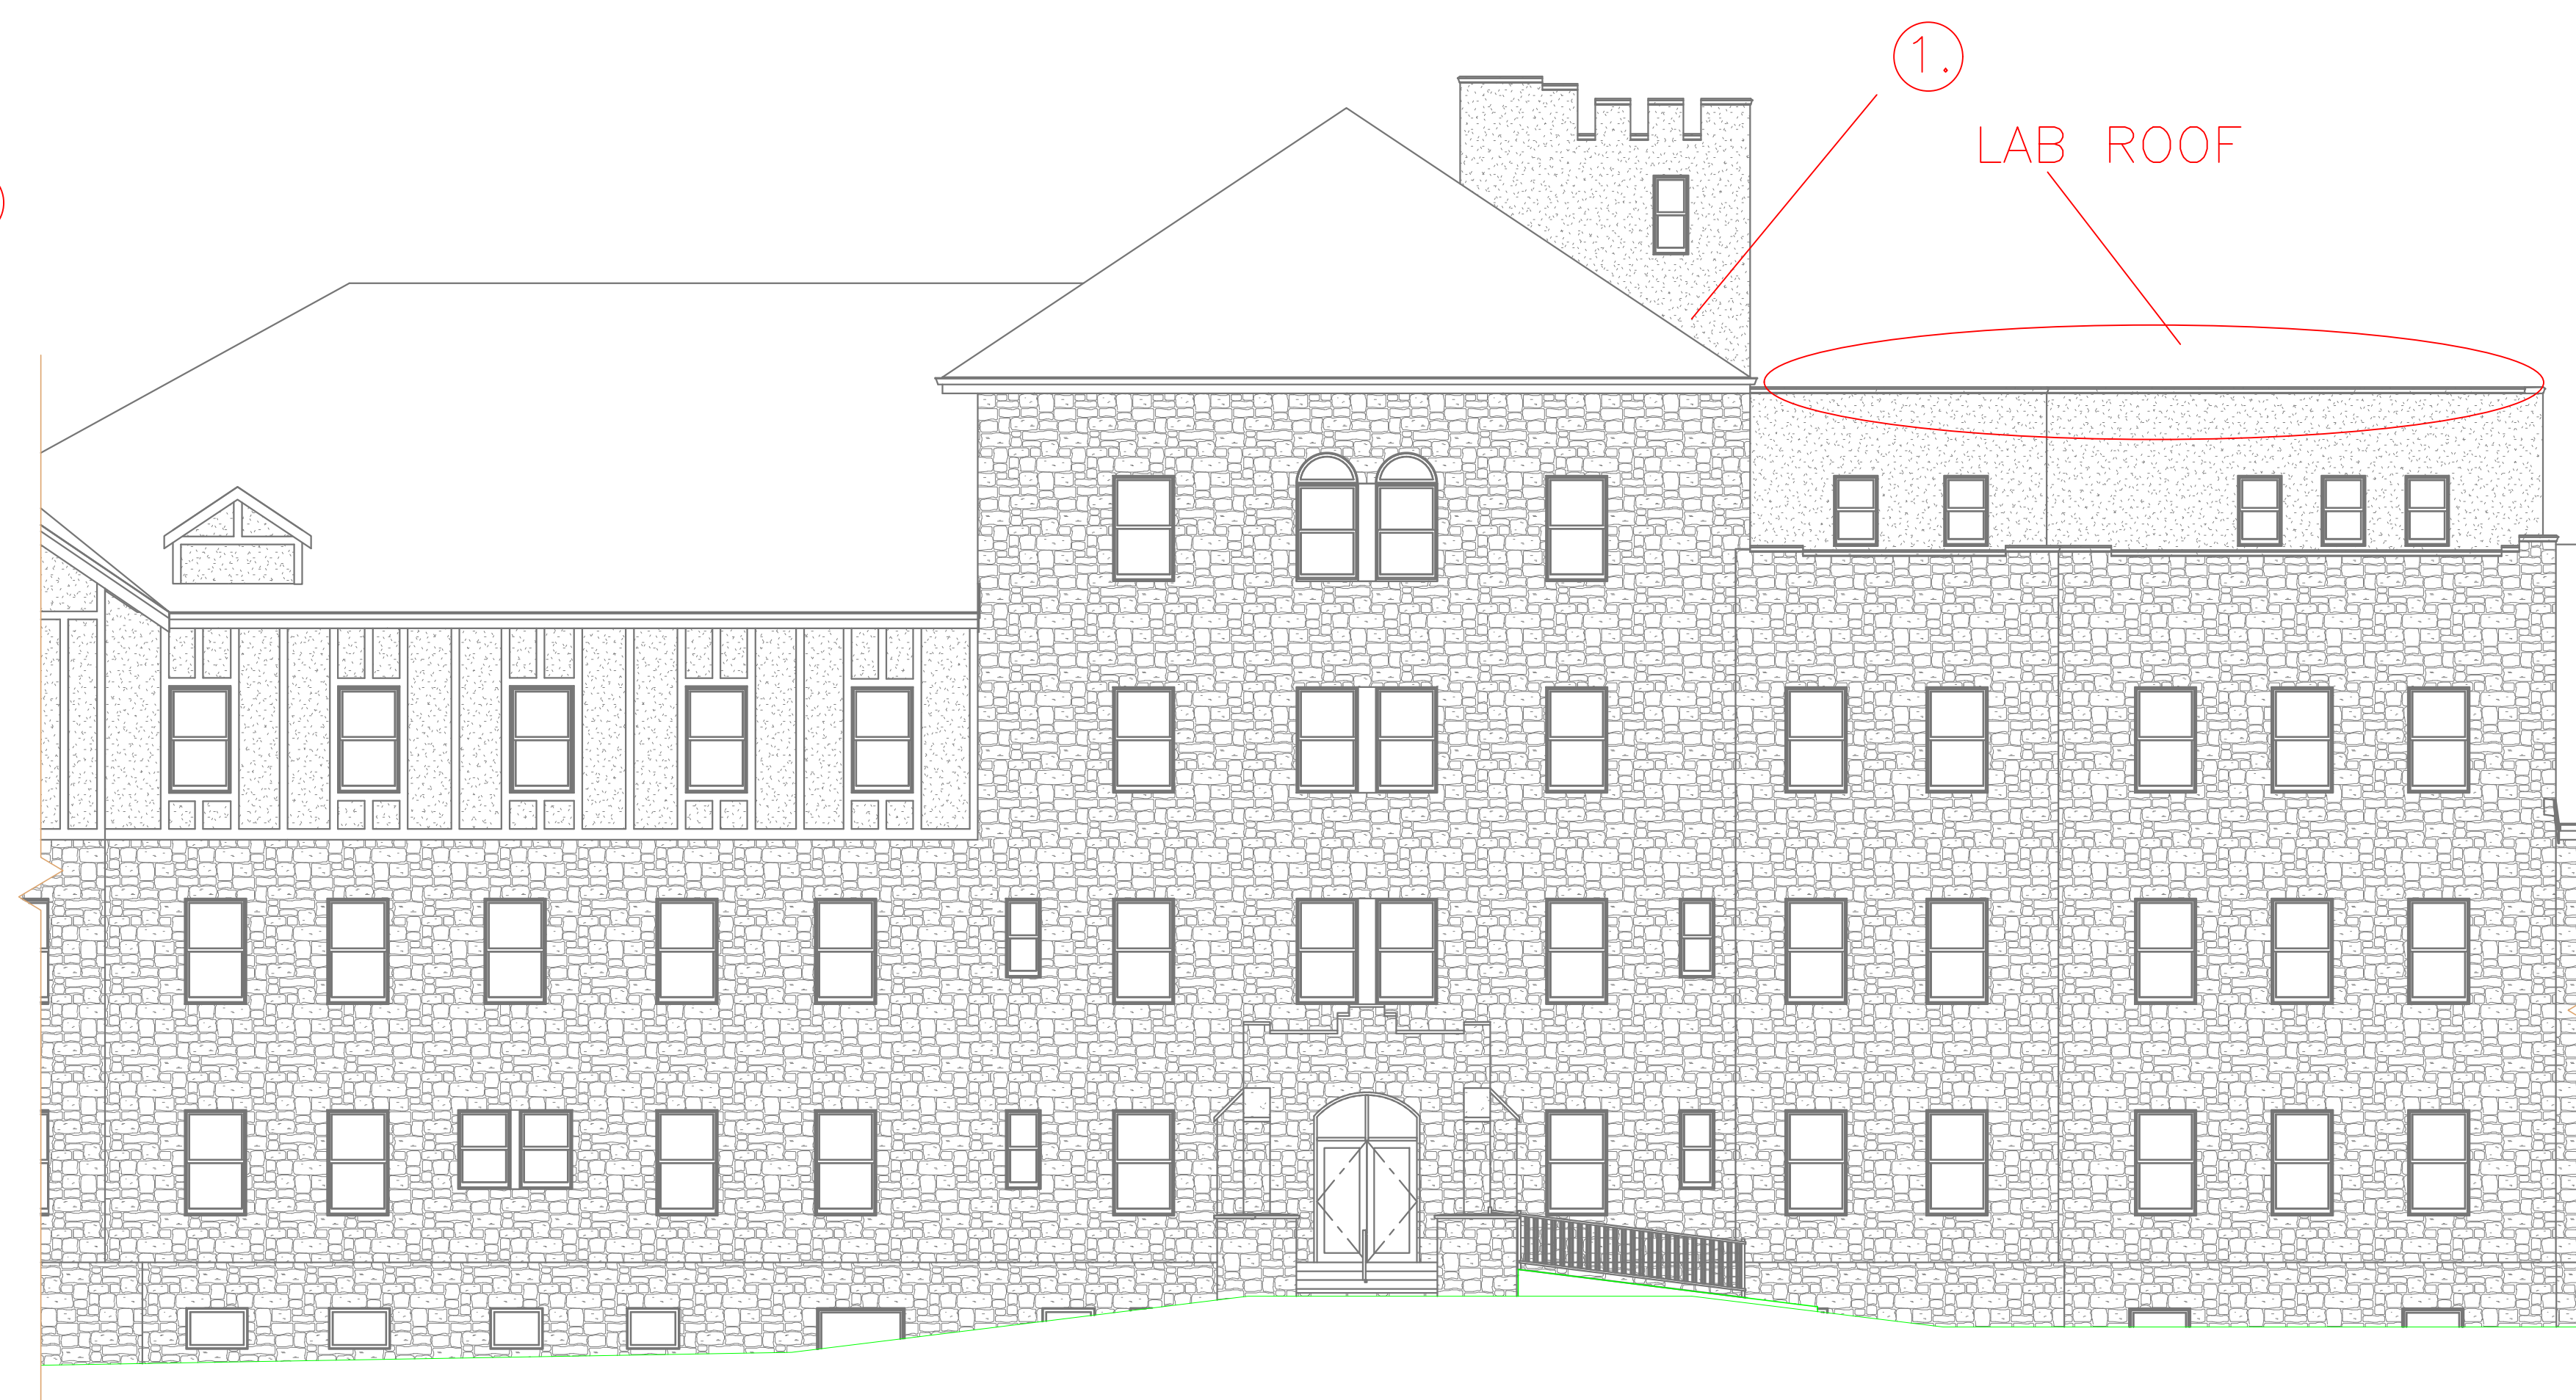
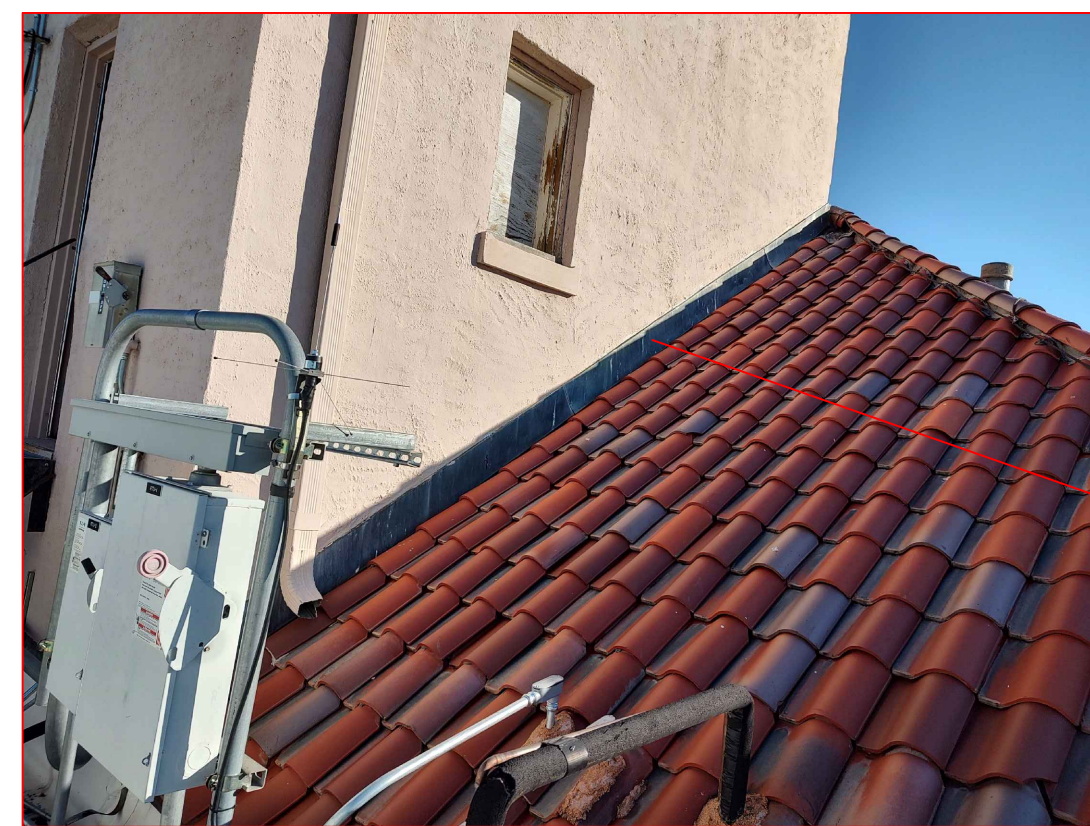
BUILDING 12 HOSPITAL  
NORTH ELEVATION

- 1. Replace existing flashing.
