# ASBESTOS REINSPECTION REPORT 2019

LOCATION:  
**ST. CLOUD VA MEDICAL CENTER  
4801 VETERANS DRIVE  
ST. CLOUD, MN 56303**

**VA PROJECT #: 656-C90115  
SOLICITATION #: 36C26319Q0714**

INSPECTION DATES:  
**NOVEMBER 4-6, 2019  
JULY 13, 2020**

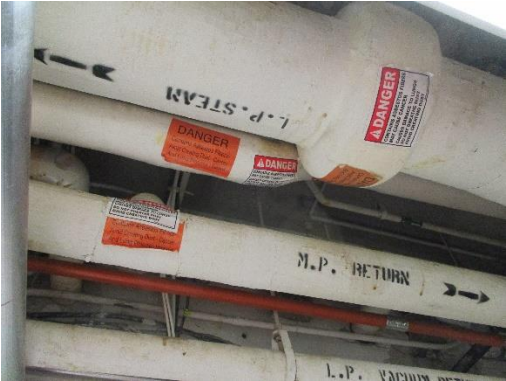
<p><b>Photo 1-1</b> Pipe insulation – Mud fittings on fiberglass insulated lines</p>

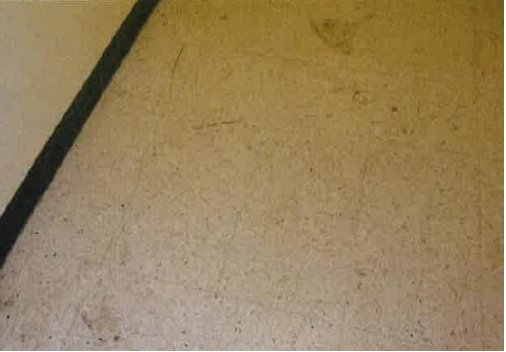
A photograph showing a close-up of a floor. There is a section of orange vinyl floor tile on the left, and a section of black mastic on the right. The mastic is dark and appears to be a thick, adhesive material.
<p><b>Photo 1-4</b> 12" vinyl floor tile and black mastic</p>

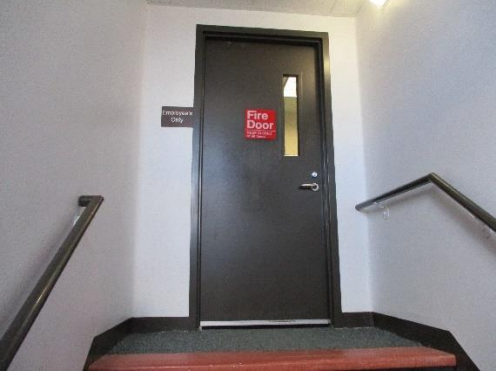
<p><b>Photo 1-5</b> Fire Doors</p>

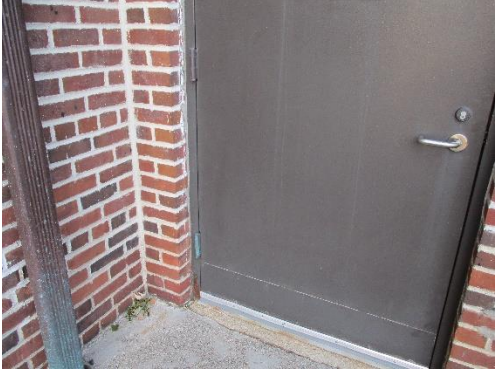
<p><b>Photo 1-6</b> Exterior caulking on brick wall joints</p>

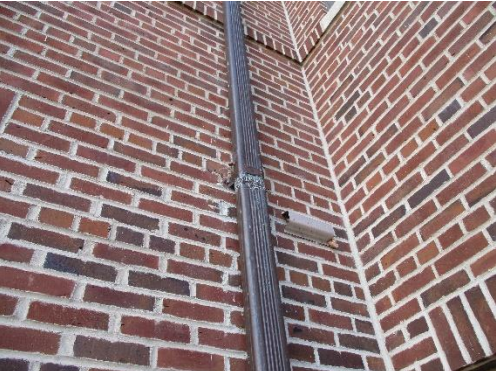
<p><b>Photo 1-7</b> Exterior tar on downspouts</p>

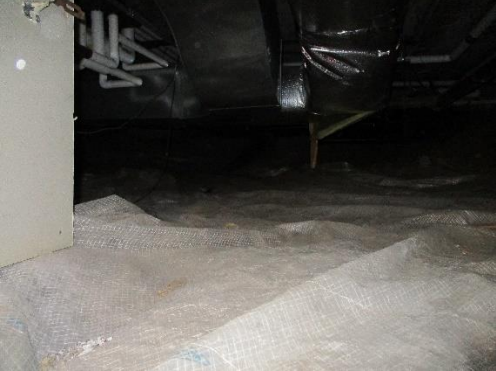
<p><b>Photo 2-1</b> Contaminated soil in crawlspace</p>

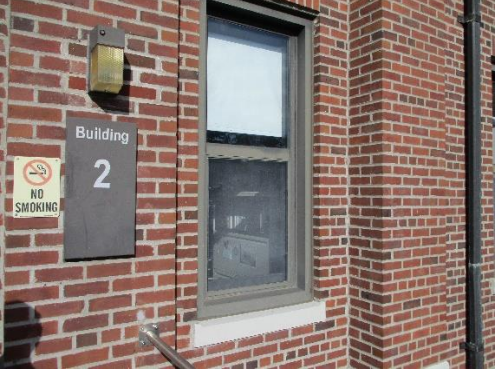
<p><b>Photo 2-2</b> Exterior window frame caulk</p>

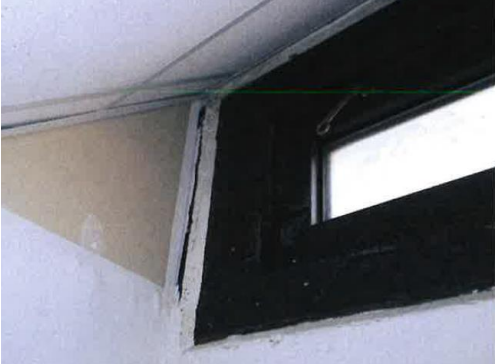
<p><b>Photo 2-3</b> Black wall waterproofing</p>

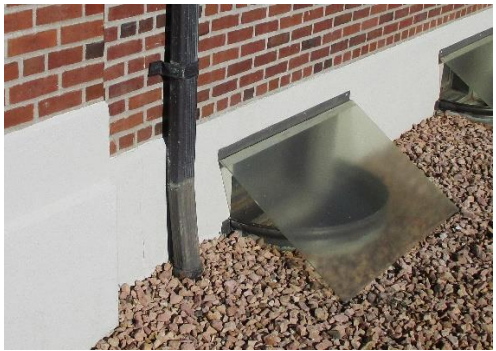
<p><b>Photo 2-4</b> Exterior tar on downspouts</p>

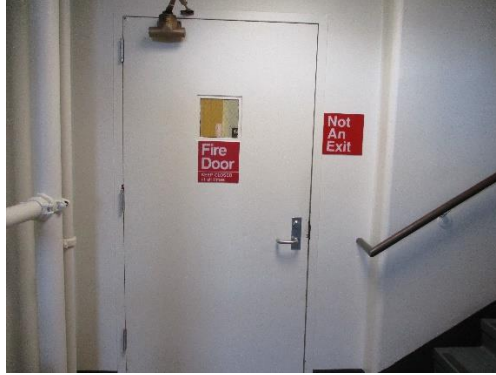
### Photo 2-5

Fire Doors

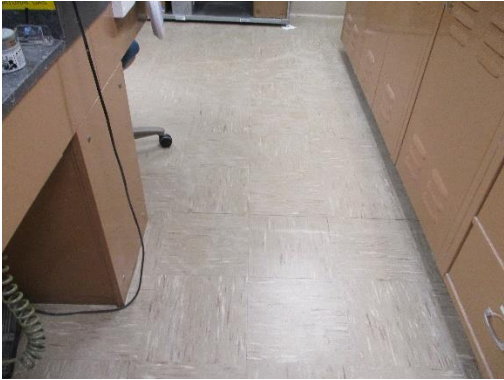
<p><b>Photo 3-1</b> 12" vinyl floor tile and black mastic</p>

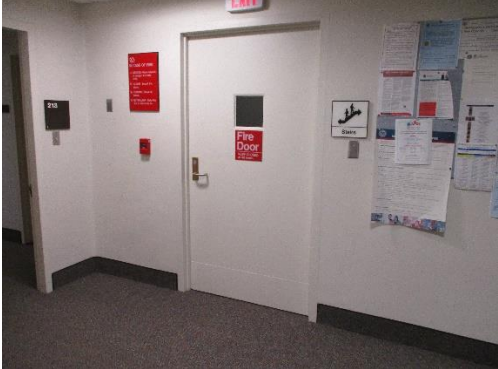
<p><b>Photo 3-2</b> Fire Doors</p>

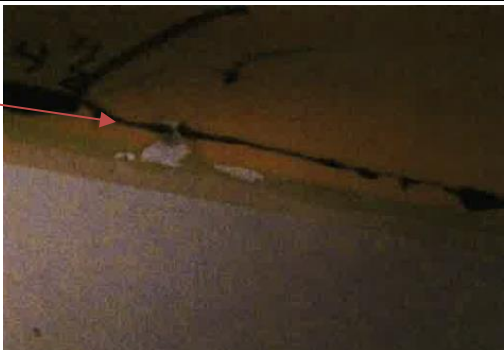
<p><b>Photo 3-4</b> Black wall mastic above ceiling tiles on exterior walls</p>

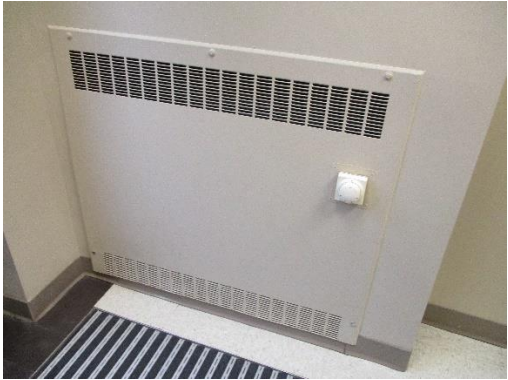
<p><b>Photo 3-5</b> Transite inside convectors under windows</p>

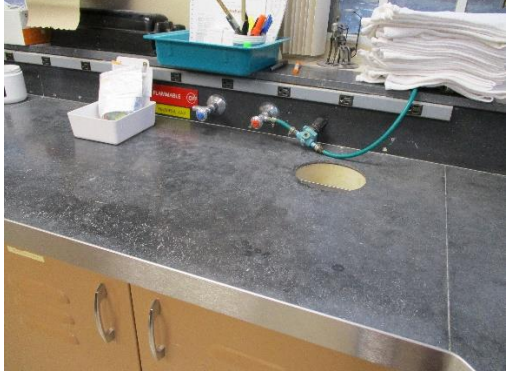
<p><b>Photo 3-6</b> Black ebony lab table tops and upper shelves</p>

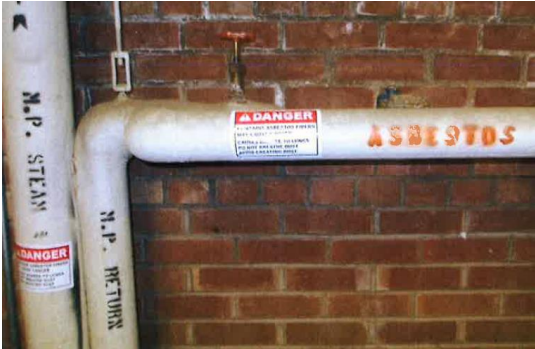
<p><b>Photo 4-1</b> Pipe insulation – Mag block</p>

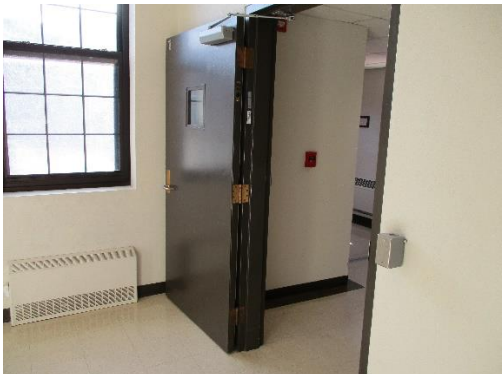
<p><b>Photo 4-4</b> Fire Doors</p>

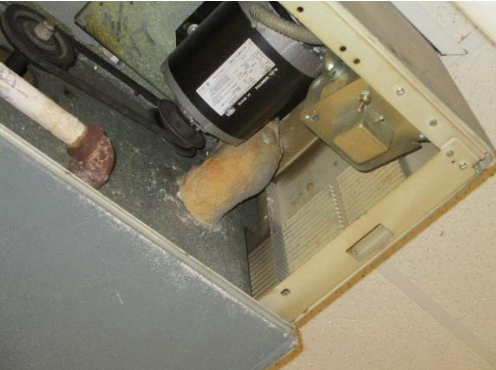
<p><b>Photo 6-1</b> Pipe insulation mud fittings on fiberglass insulated pipes</p>

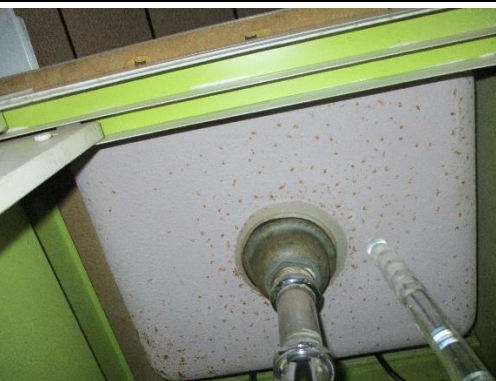
A photograph showing a brick building with a roof overhang. The overhang is supported by wooden brackets and has a layer of tar or roofing material on top. The roof is made of asphalt shingles.
<p><b>Photo 6-4</b> Sink undercoating</p>

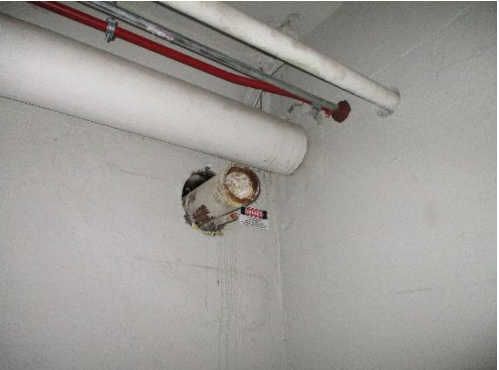
<p><b>Photo 7-1</b> Pipe insulation</p>

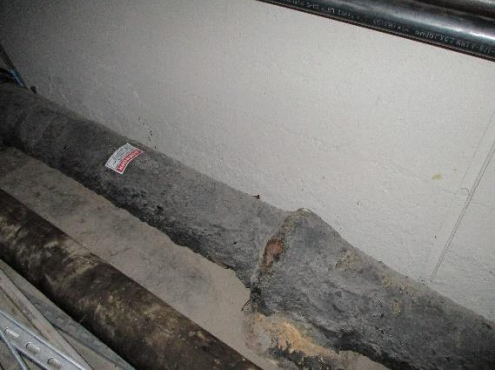
A photograph showing several large white pipes wrapped in white insulation. A red fire alarm pull station is visible on the wall to the right of the pipes.
<p><b>Photo 7-2</b> Tar/asphalt on drain pipe at floor</p>

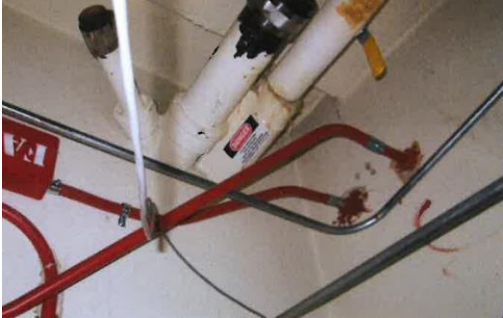
<p><b>Photo 8-1</b> Pipe insulation – Mag block</p>

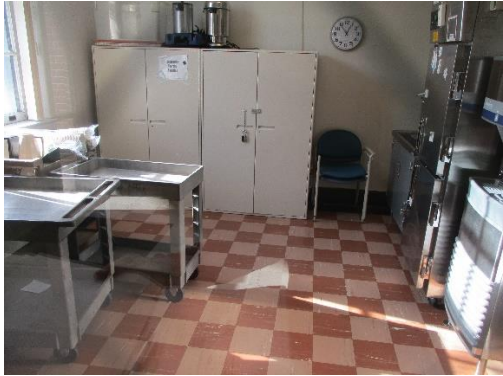
<p><b>Photo 8-2</b> 9" vinyl floor tile</p>

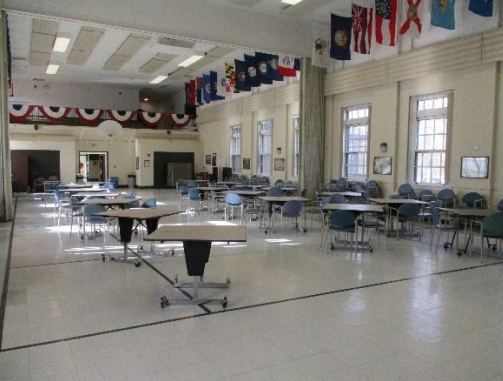
<p><b>Photo 8-3</b> 12" vinyl floor tile and black mastic</p>

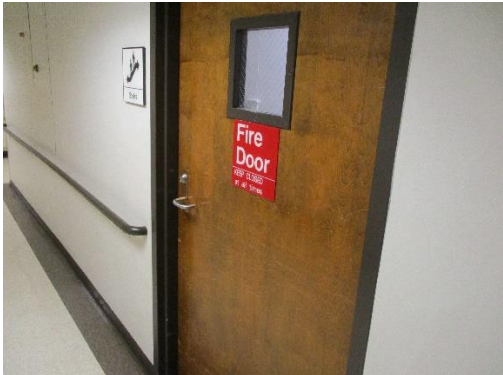
<p><b>Photo 8-4</b> Fire Doors</p>

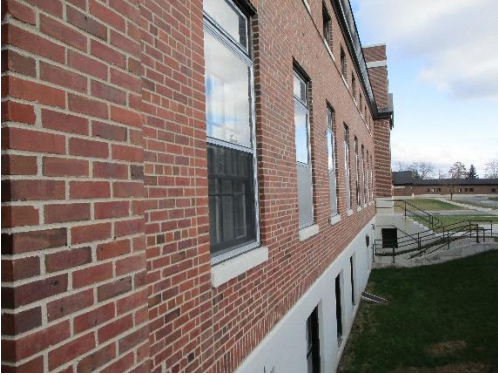
<p><b>Photo 8-5</b> Exterior window glazing &amp; caulking</p>

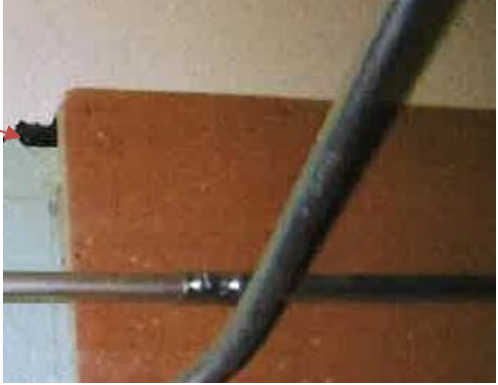
A photograph showing the exterior of a brick building. The focus is on a window with white glazing and caulking. The brickwork is red, and the sky is blue with some clouds. A grassy area and a walkway are visible in the background.
<p><b>Photo 8-6</b> Black adhesive on walls</p>

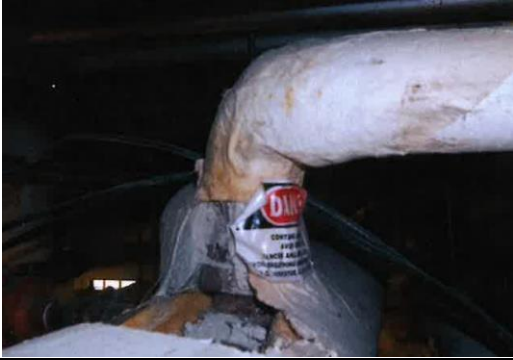
<p><b>Photo 9-1</b> Pipe insulation mud fitting on fiberglass insulated piping</p>

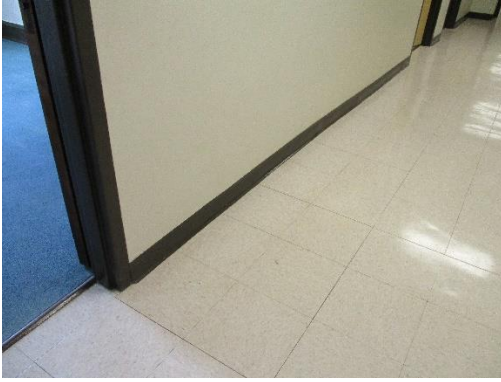
<p><b>Photo 9-2</b> 12" vinyl floor tile and black mastic</p>

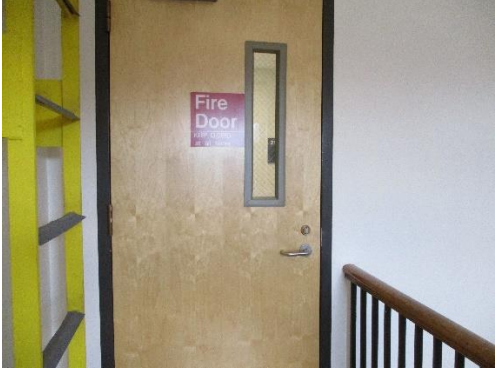
<p><b>Photo 9-3</b> Fire Doors</p>

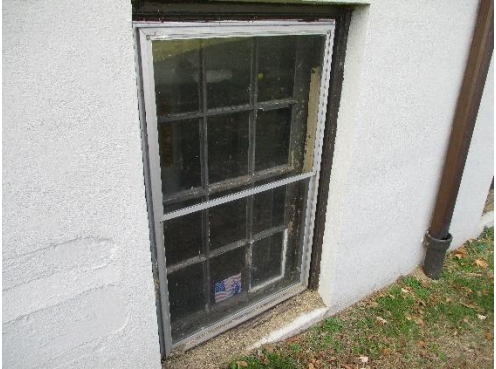
<p><b>Photo 9-4</b> Exterior window caulking</p>

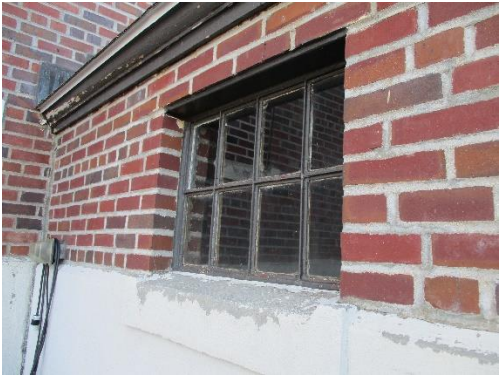
<p><b>Photo 13-2</b> Window glazing</p>

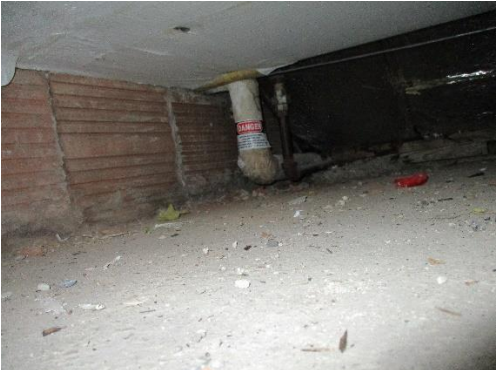
<p><b>Photo 28-1</b> Pipe insulation in attic</p>

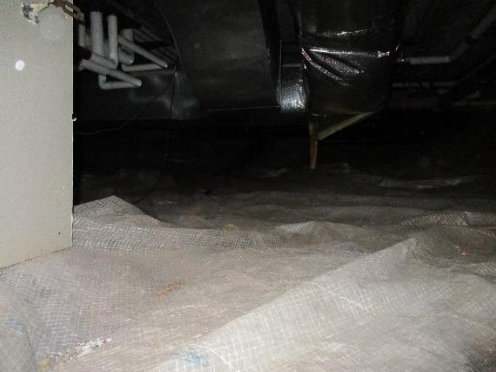
A photograph of an attic space. A large pipe is wrapped in yellow insulation. The floor is covered with debris and dust. A brick wall is visible on the left.
<p><b>Photo 28-2</b> Contaminated soil in crawlspace</p>

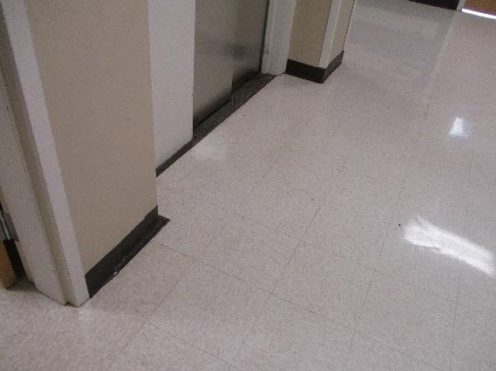
A photograph of a crawlspace. The floor is covered with a layer of soil and debris. A black plastic sheet is visible in the background.
<p><b>Photo 28-3</b> 12" vinyl floor tile and black mastic</p>

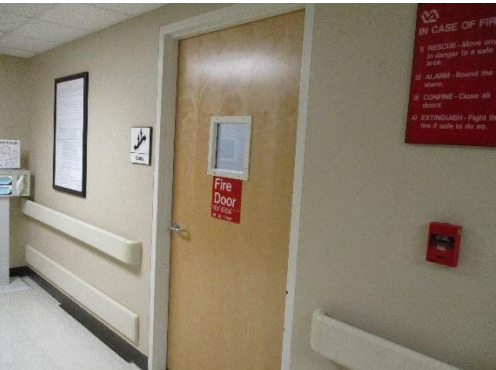
A photograph of a hallway. The floor is covered with light-colored vinyl floor tiles. A black mastic is visible along the base of the wall.
<p><b>Photo 28-4</b> Fire Doors</p>

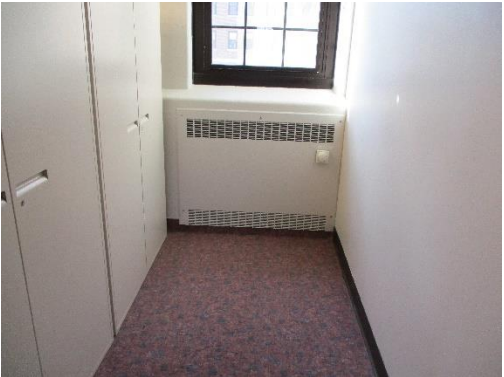
<p><b>Photo 28-5</b> Transite inside convectors under windows</p>

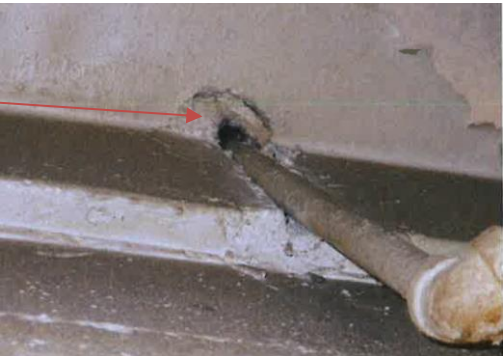
<p><b>Photo 28-6</b> Pipe insulation in pipe penetration above ceiling in basement</p>

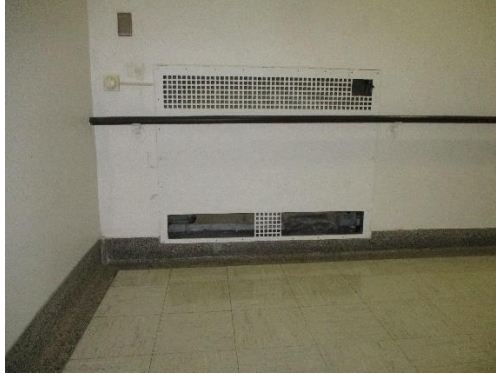
**Photo 29-5**

Transite inside convectors  
under windows

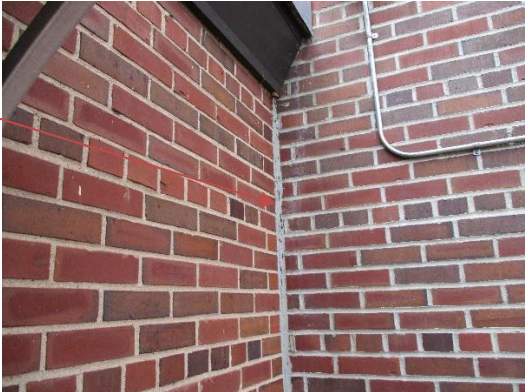
<p><b>Photo 48-5</b> Exterior brick seam caulk</p>

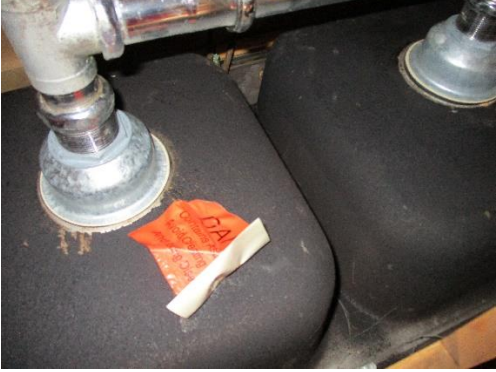
<p><b>Photo 49-9</b> Black sink undercoating in basement</p>

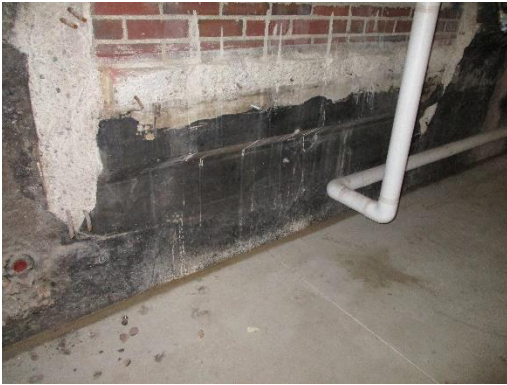
<p><b>Photo 49-10</b> Black tar wall waterproofing</p>

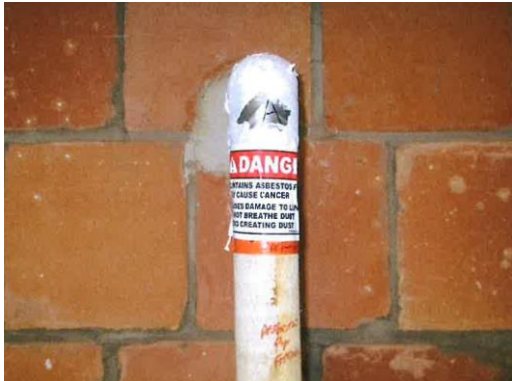
<p><b>Photo 50-1</b> Pipe insulation – Mag block</p>

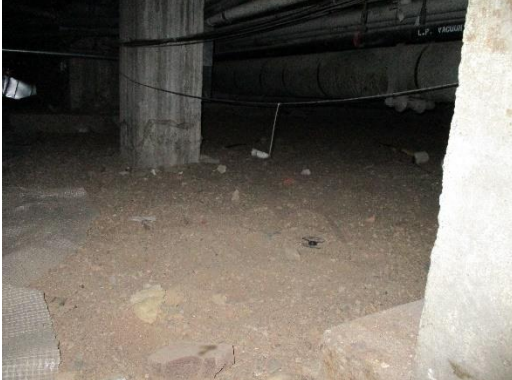
<p><b>Photo 50-2</b> Contaminated soil in crawlspace</p>

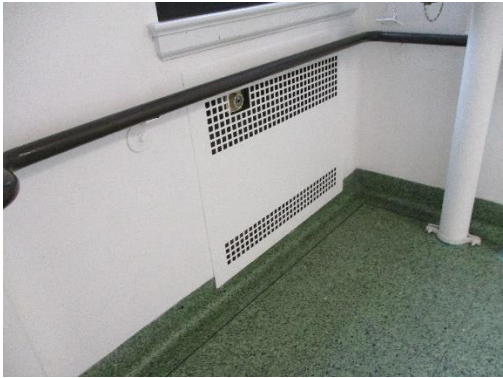
<p><b>Photo 50-5</b> Transite inside convectors under windows</p>

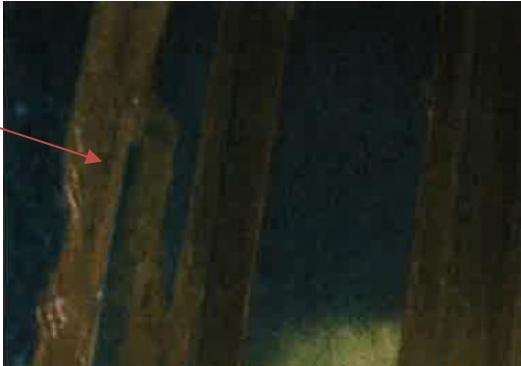
<p><b>Photo 50-6</b> Tan duct sealant/mastic</p>

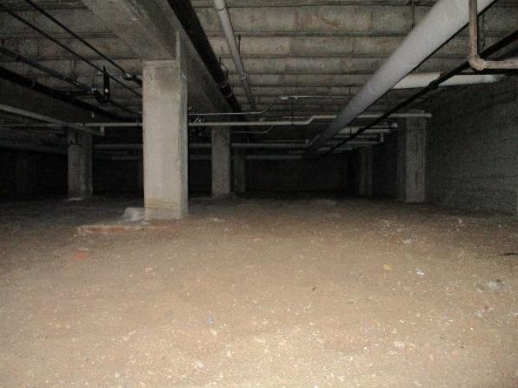
<p><b>Photo 51-2</b> Contaminated soil in crawlspace</p>

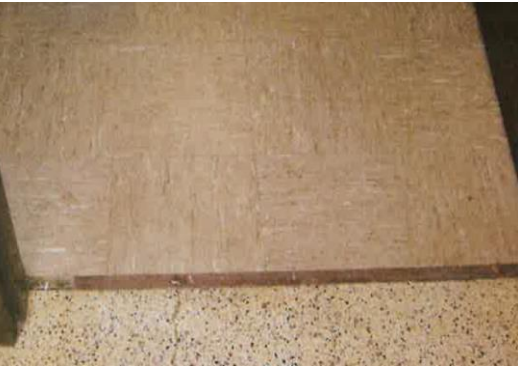
<p><b>Photo 51-3</b> 12" vinyl floor tile and black mastic</p>

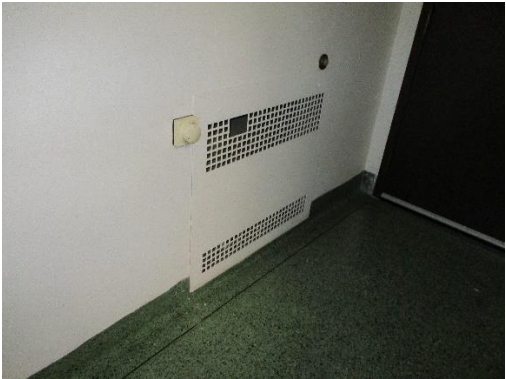
<p><b>Photo 51-5</b> Transite inside convectors under windows</p>

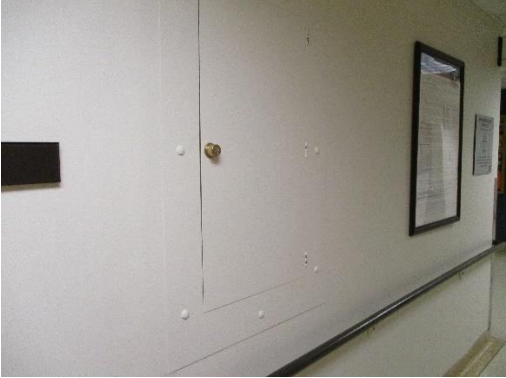
<p><b>Photo 51-6</b> Paper inside electrical switch box</p>

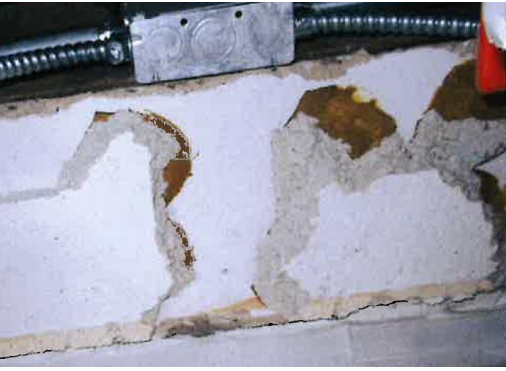
<p><b>Photo 51-7</b> Glue pods for 12" ceiling tile</p>

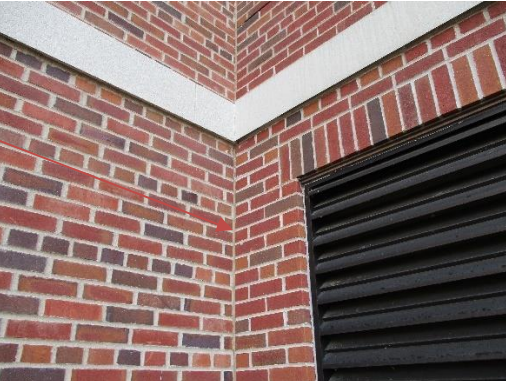
<p><b>Photo 51-8</b> Caulking on exterior brick walls</p>

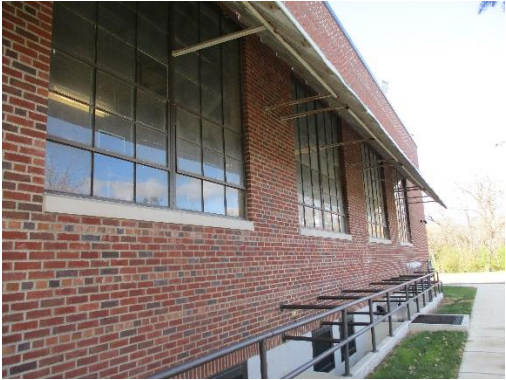
<p><b>Photo 59-5</b> Exterior window glazing and caulking</p>

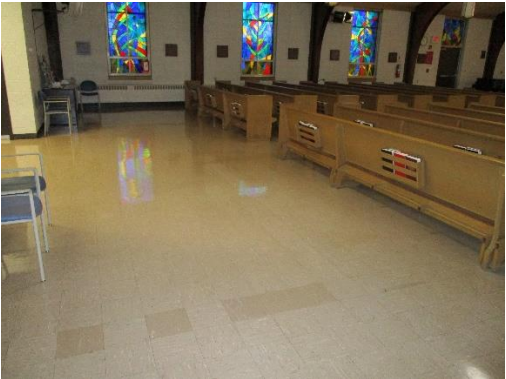
<p><b>Photo 88-1</b> 9" vinyl floor tile and black mastic</p>

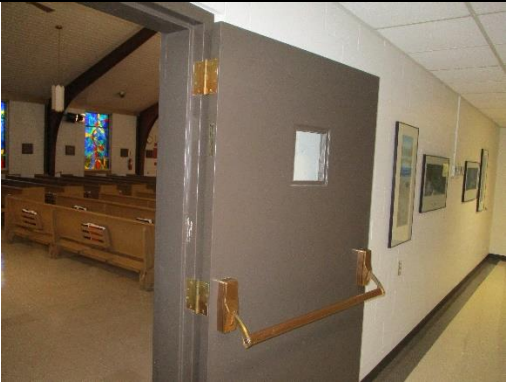
<p><b>Photo 88-2</b> Fire Doors</p>

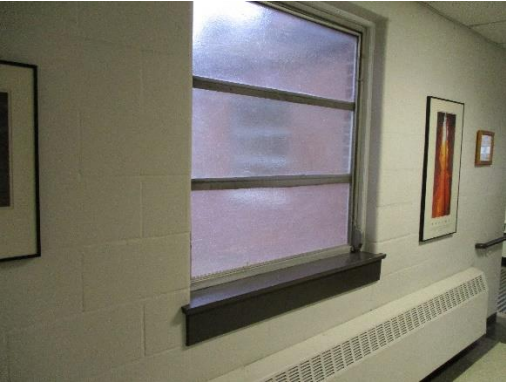
<p><b>Photo 88-3</b> Exterior window glazing</p>

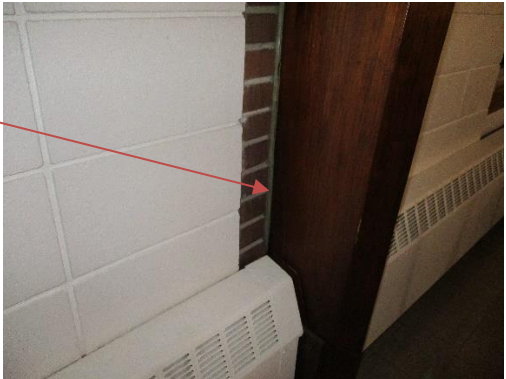
<p><b>Photo 88-4</b> Expansion joint caulk</p>

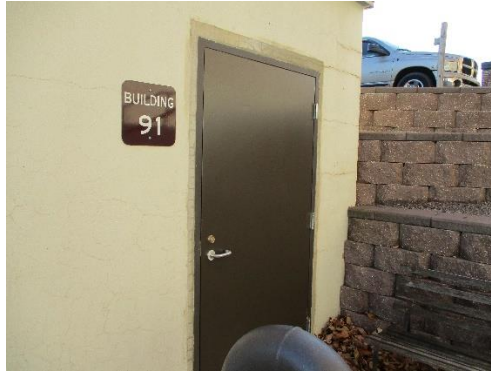
**Photo 91-1**  
Fire door

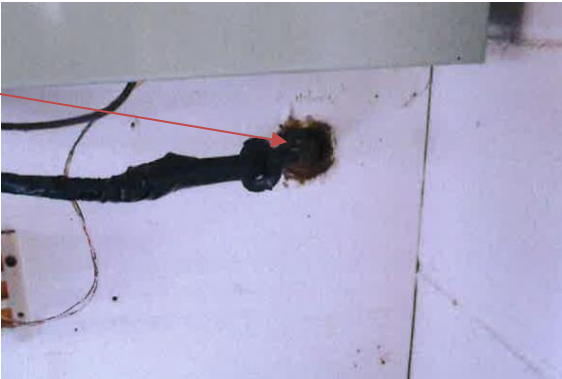
<p><b>Photo 92-1</b> Pipe penetration hole filler</p>

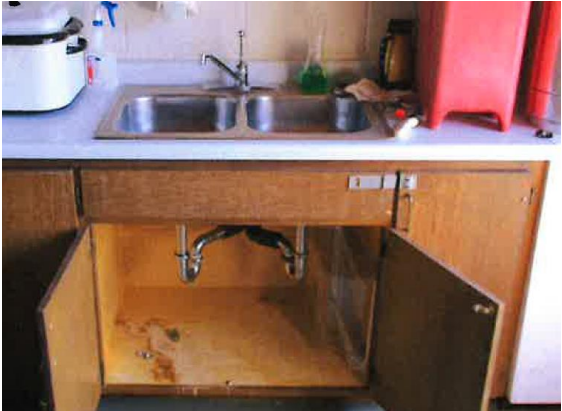
<p><b>Photo 92-2</b> Black sink undercoating</p>

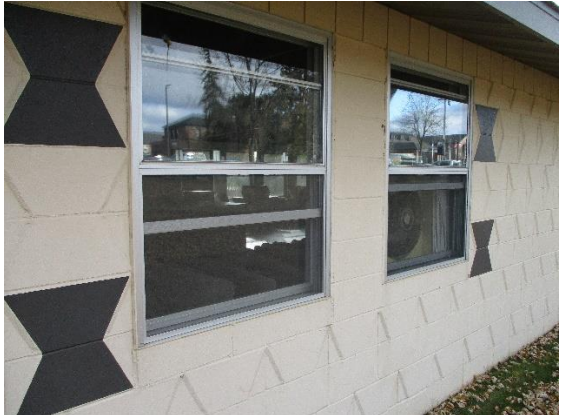
<p><b>Photo 92-3</b> Window frame caulk</p>

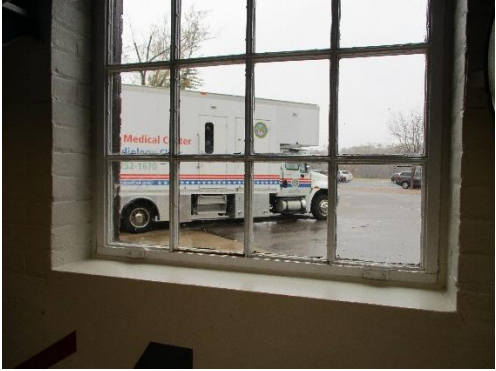
<p><b>Photo CC-1</b> Window glazing</p>

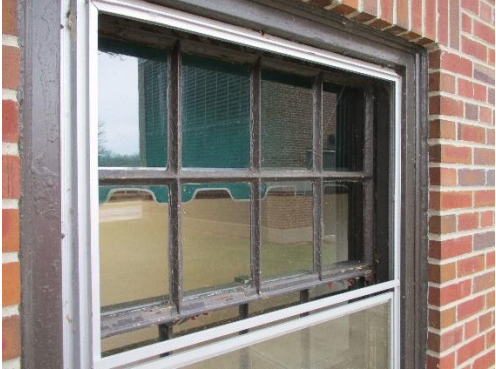
<p><b>Photo CC-2</b> Window frame caulk</p>

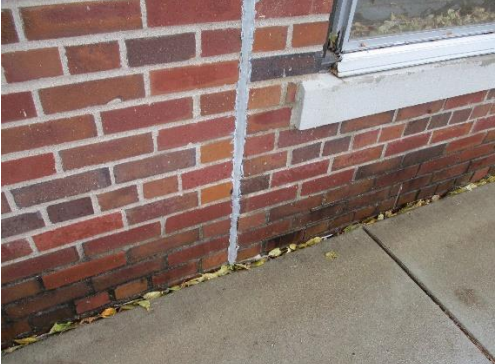
<p><b>Photo CC-3</b> Exterior brick expansion joint caulking</p>

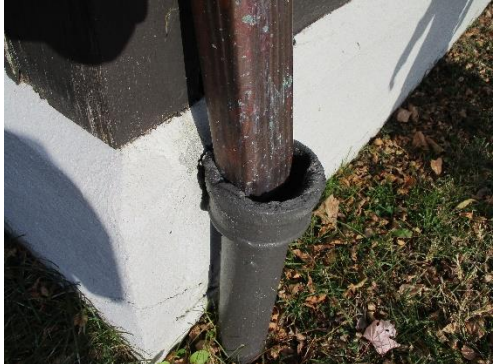
<p><b>Photo CC-4</b> Black tar on gutter downspouts</p>

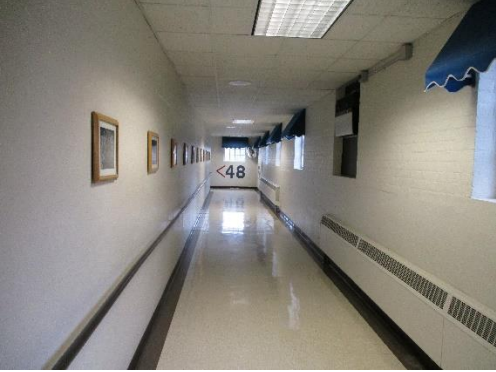
<p><b>Photo CC-5</b> Mastic under floor tile</p>

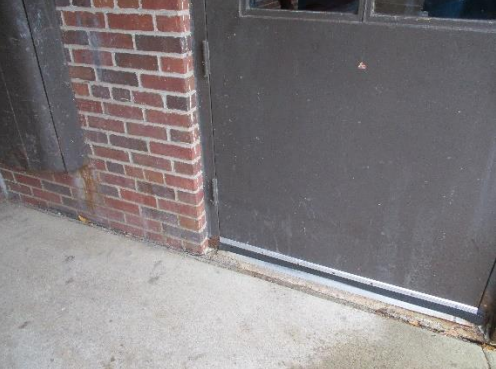
<p><b>Photo CC-6</b> Door frame caulk</p>

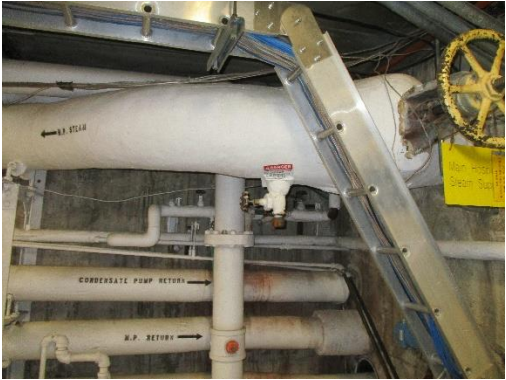
<p><b>Photo T-1</b> Mud fittings on fiberglass insulated pipes</p>

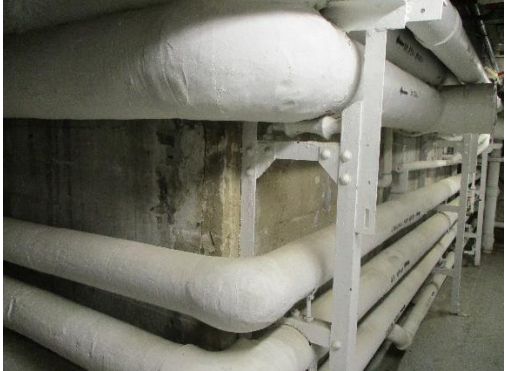
<p><b>Photo T-2</b> Mud fittings on fiberglass insulated pipes</p>

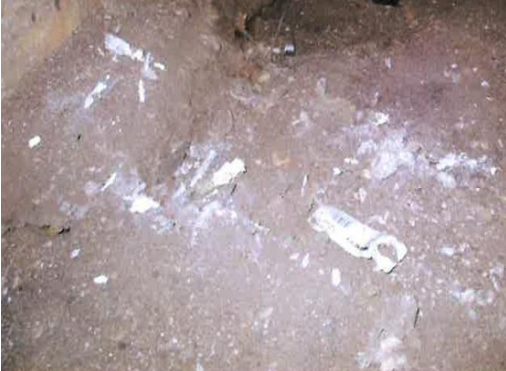
<p><b>Photo T-3</b> Contaminated soils in crawl space with asbestos debris</p>

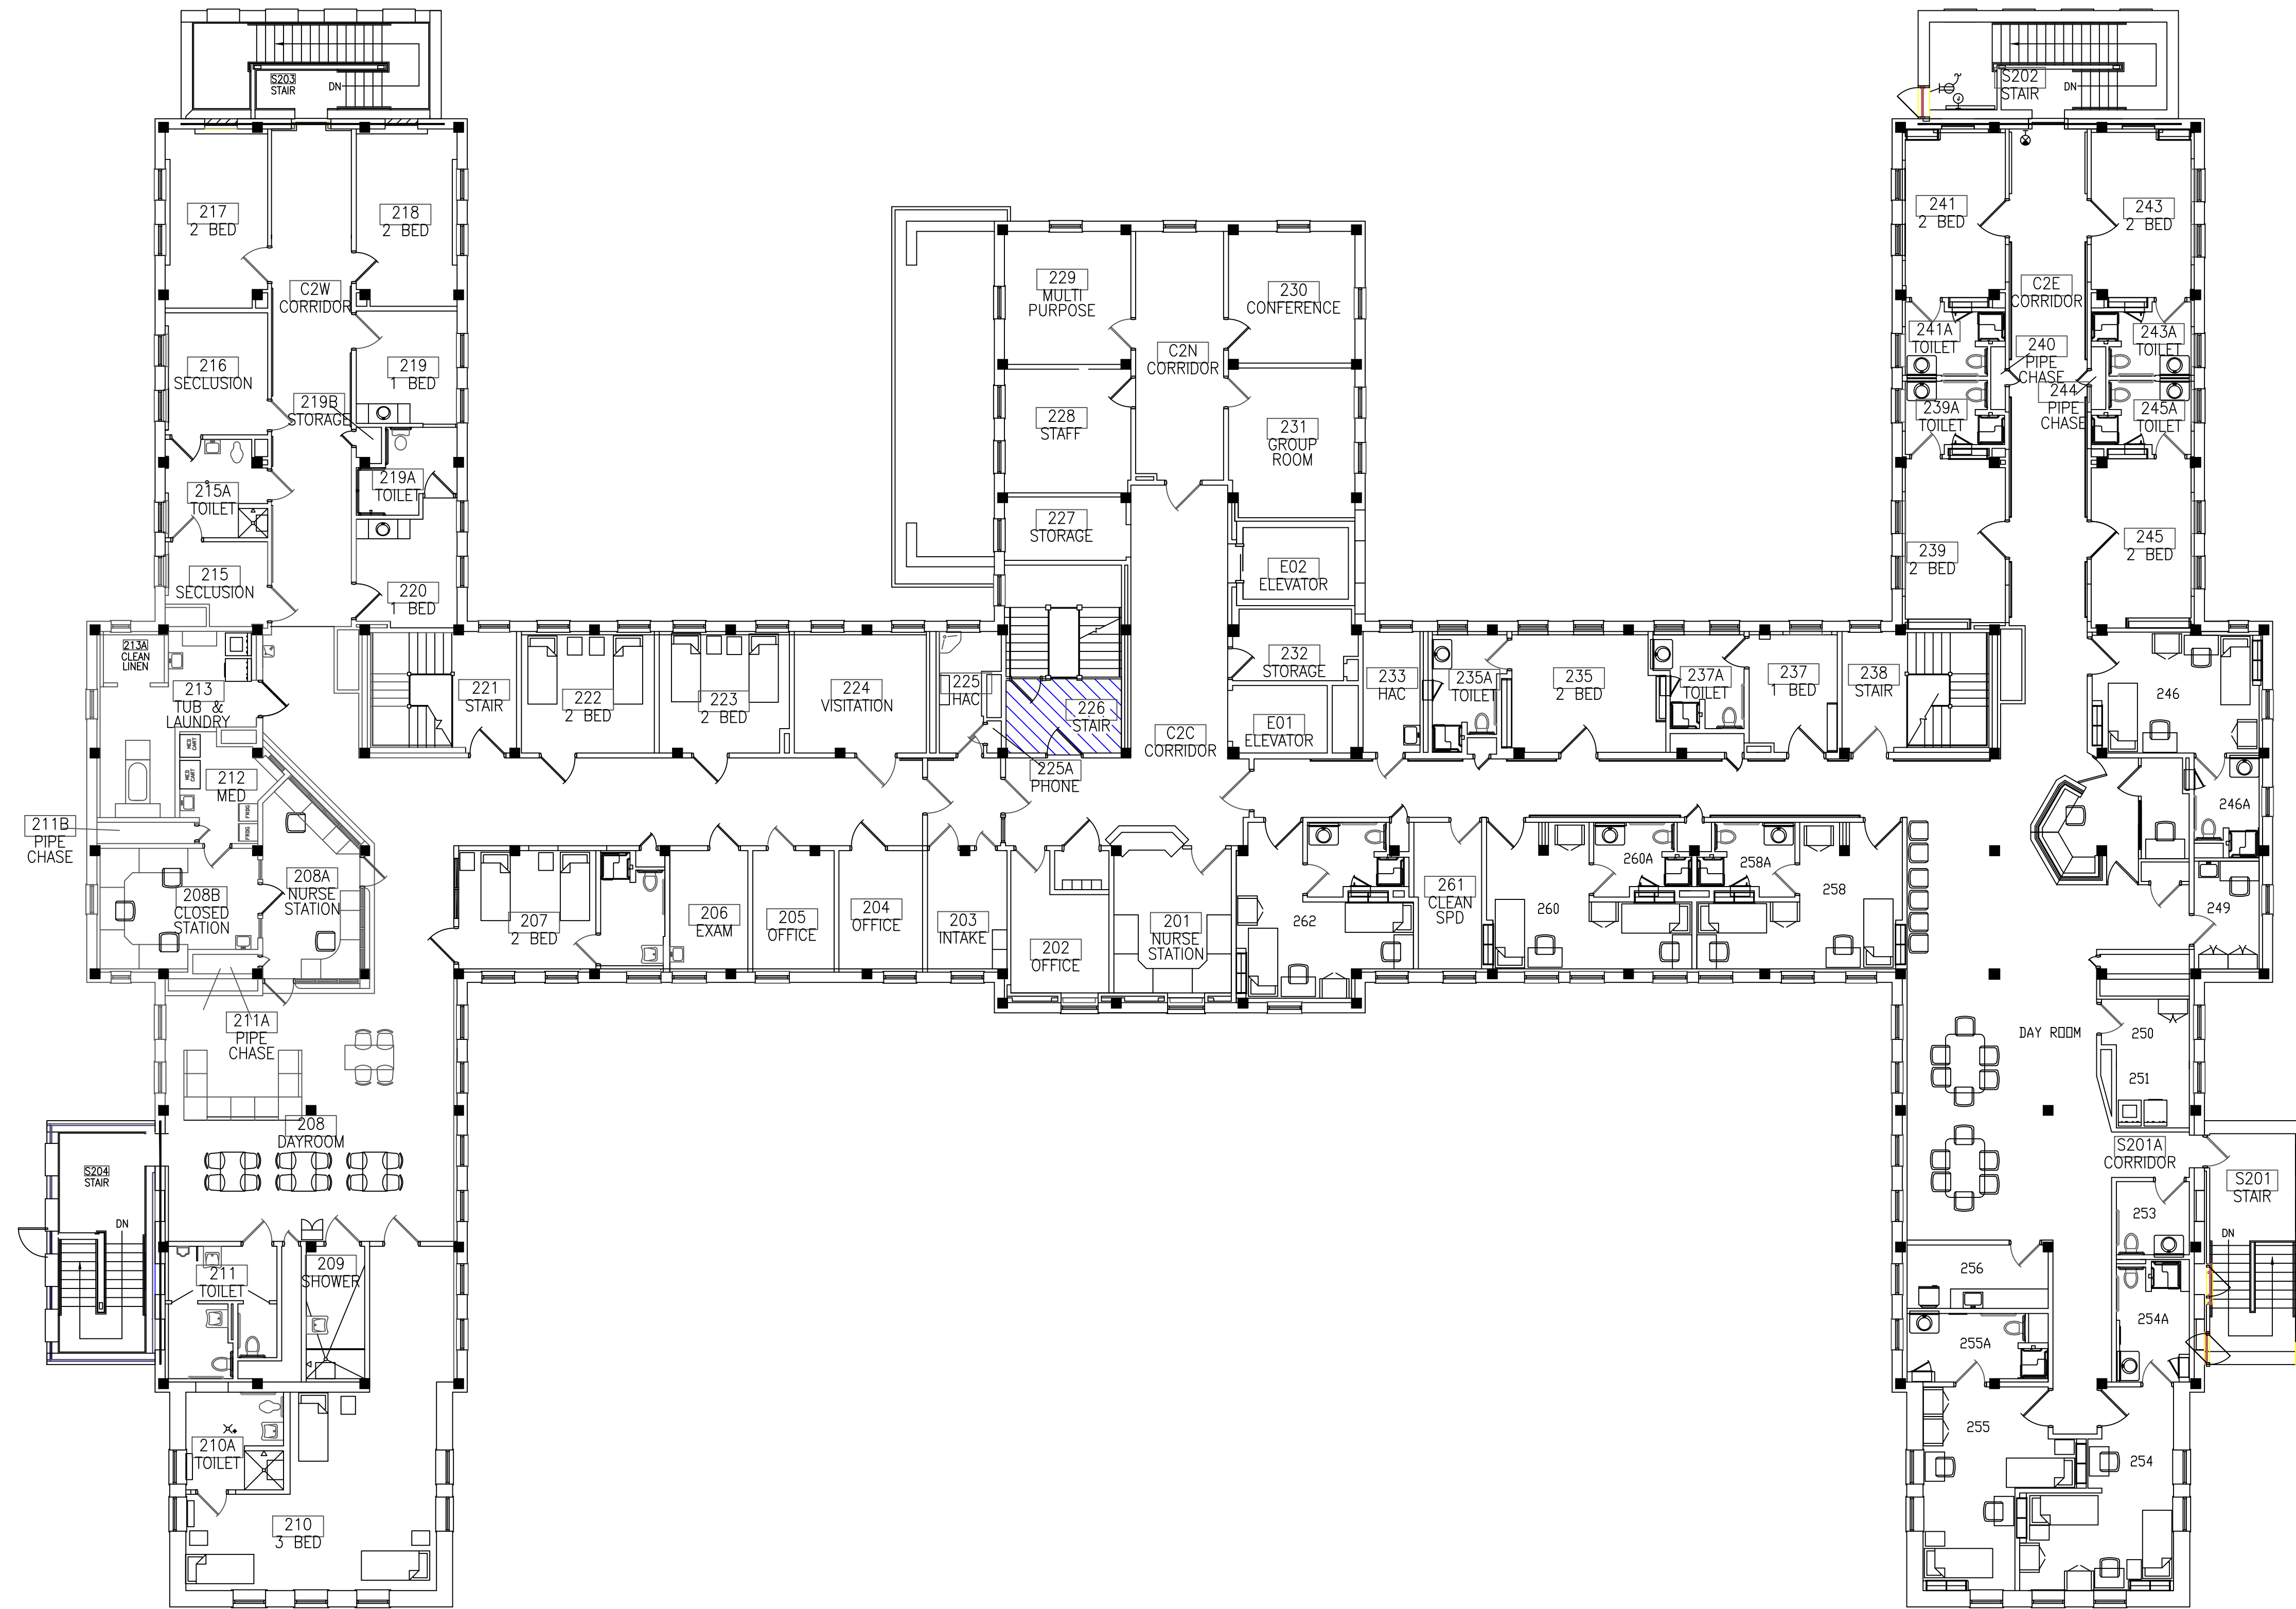
### BUILDING #28 - SECOND FLOOR PLAN

**LEGEND**  
-ASBESTOS-CONTAINING MASTIC UNDER 12"x12" FLOOR TILE
