HAZARDOUS BUILDING MATERIALS INSPECTION REPORT

Sioux Falls VA Medical Center

**New SPS Addition
Sioux Falls, South Dakota**

May 22, 2019

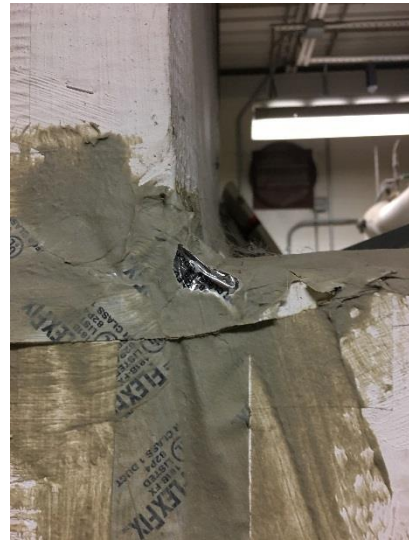
PHOTO 2 Gray Mastic – Duct in below grade mechanical room

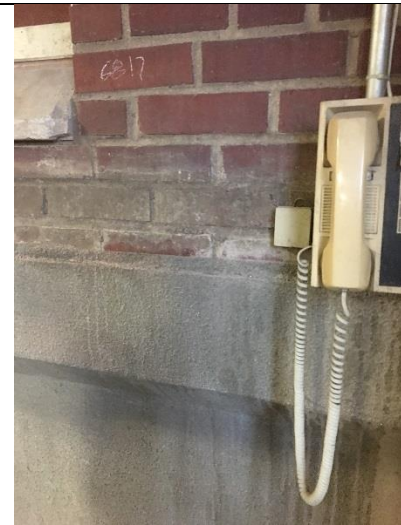
PHOTO 4 EFIS Surfacing – Mech. Room & Entry Area

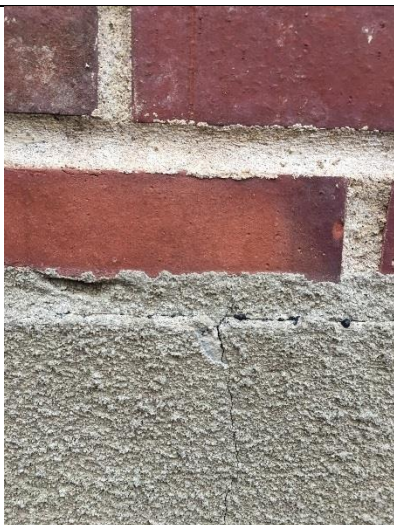
PHOTO 5 EFIS Surfacing – Mech. Room & Entry Area

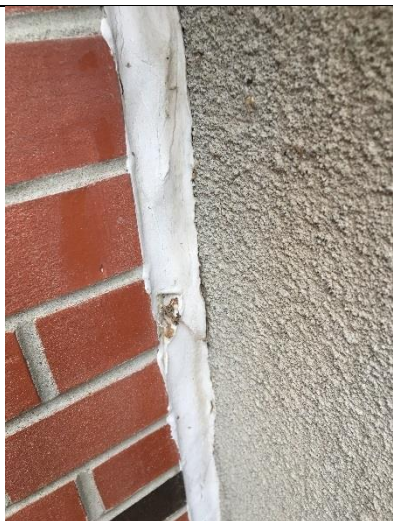
PHOTO 9 White Joint Caulk – Entry to Mech. Room

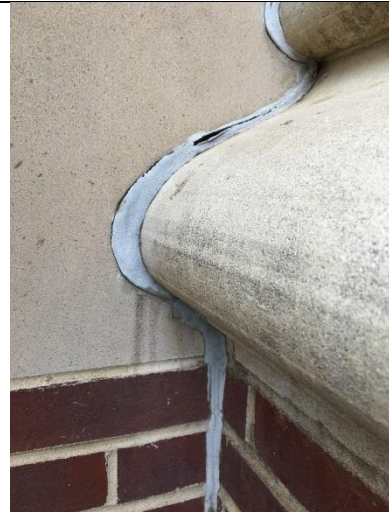
PHOTO 14 Gray Joint Caulk - Exterior

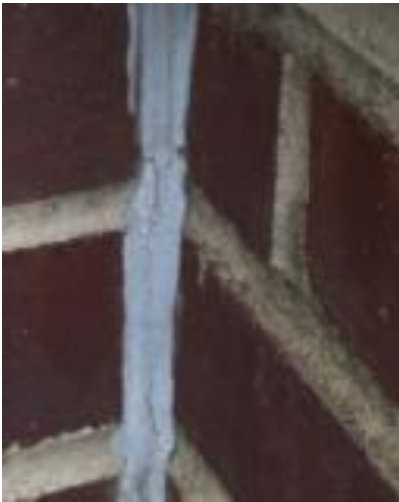
PHOTO 15 Gray Joint Caulk - Exterior

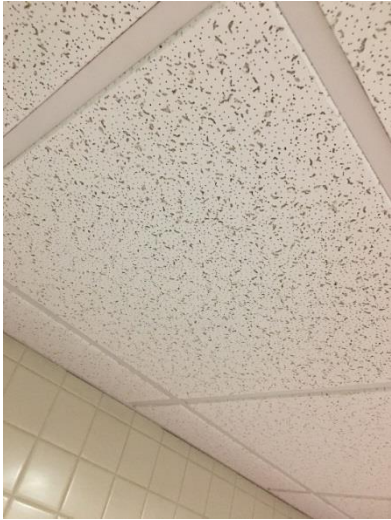
PHOTO 19 | 2' x 2' Ceiling Tile D-17

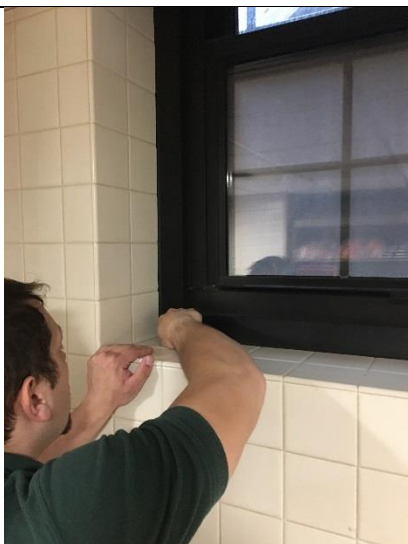
PHOTO 23 | Black Window Caulk – Windows Throughout

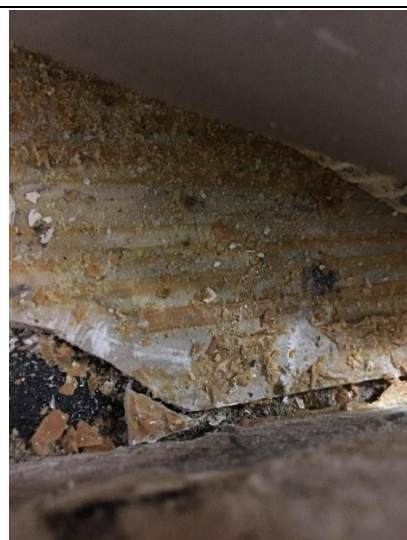
PHOTO 30 Beige VFT Black Mastic (under carpet) – D 21

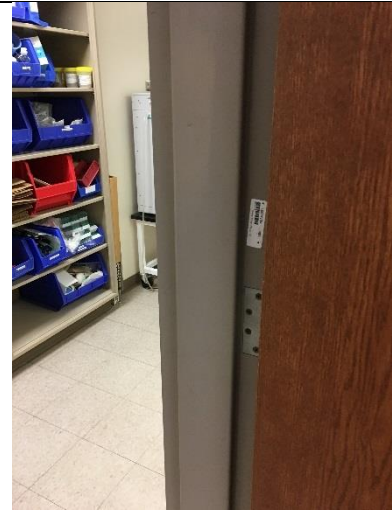
PHOTO 32 12" x 12" Beige VFT – D-27 (throughout space)

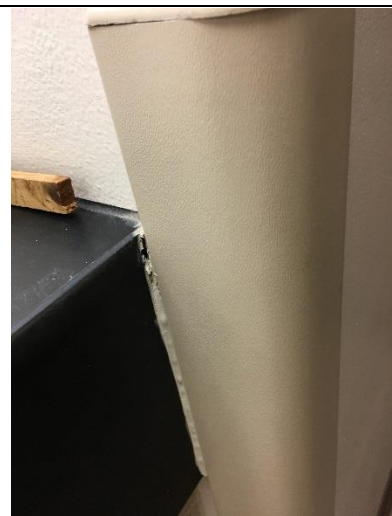
PHOTO 36 White Mastic – Lab Base Cabinets

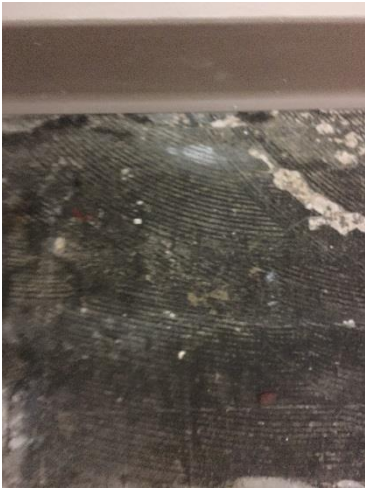
PHOTO 43 Black Mastic – D-20
5% Chrysotile

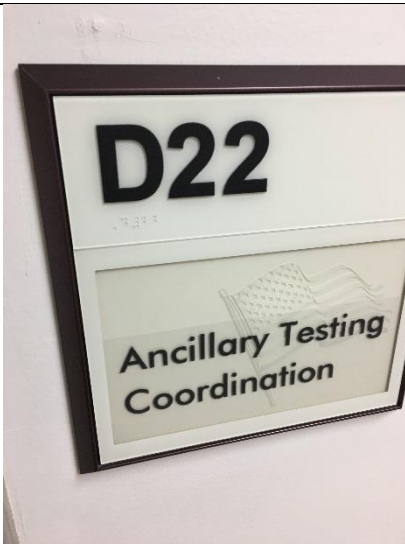
PHOTO 49

12" x 12" VFT Tan/Black Mastic
Under Carpet D-22

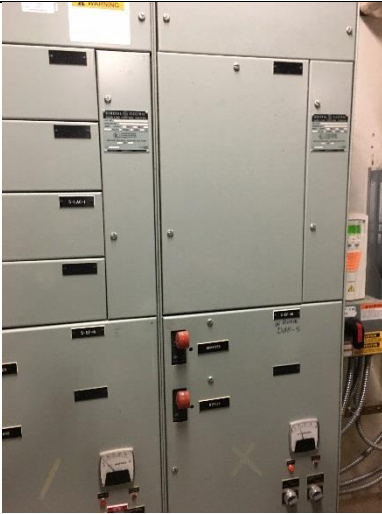
PHOTO 1 Electrical Panel – Below Grade Mechanical Room
<1mg/cm² lead

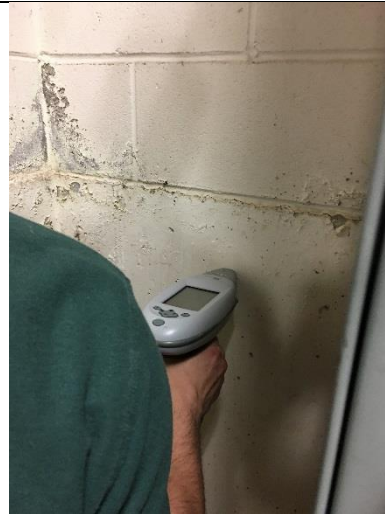
PHOTO 2 White Painted wall - Below Grade Mech. Room
<1mg/cm² lead

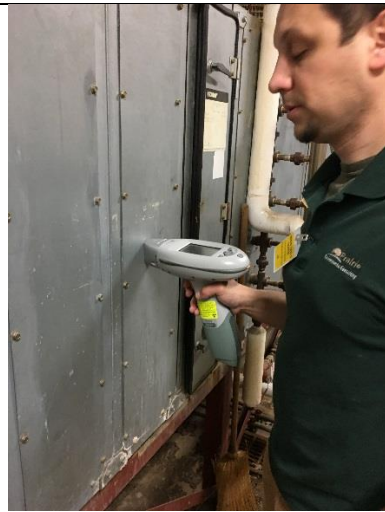
PHOTO 4 Electrical Panel – Below Grade Mechanical Room
<1mg/cm² lead

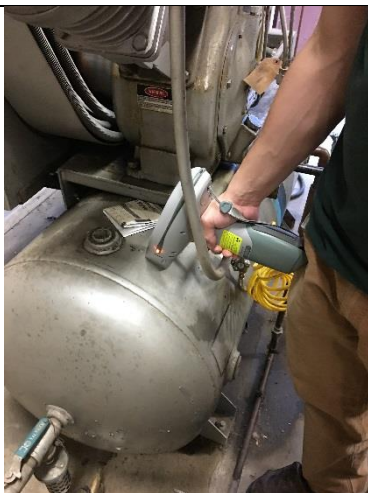
PHOTO 7 Silver Painted Tank – Below Grade Mech. Room
<1mg/cm² lead

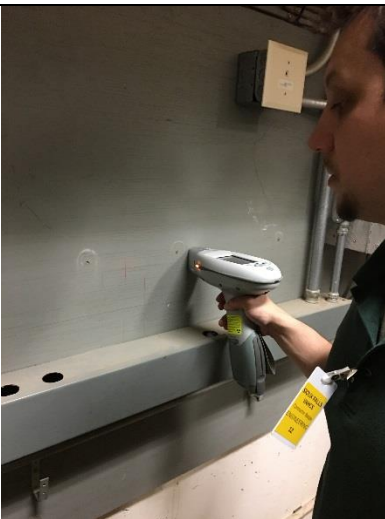
PHOTO 9 Gray Painted Wood Panel – Below Grade Mechanical Room
<1mg/cm² lead

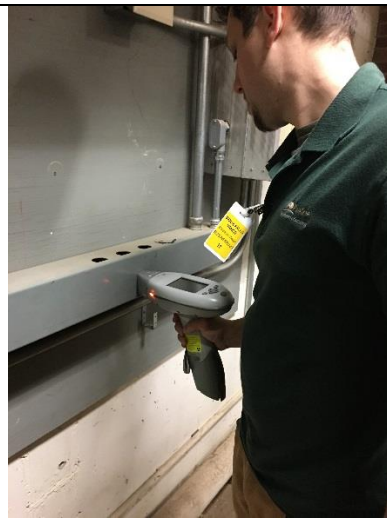
PHOTO 10 Gray Painted Casing – Below Grade Mechanical Room
<1mg/cm² lead

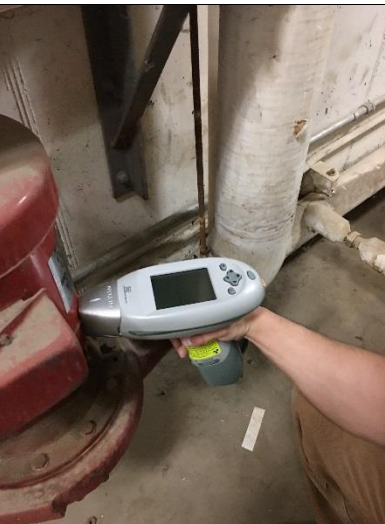
PHOTO 11 Red Painted Mixing Chamber – Below Grade Mech. Room
<1mg/cm² lead

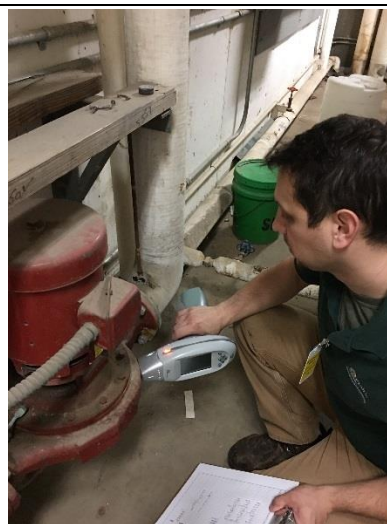
PHOTO 12 Red Painted Valve – Below Grade Mech. Room
<1mg/cm² lead

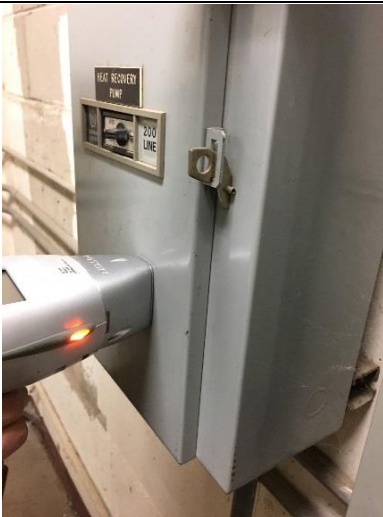
PHOTO 13 Gray Breaker Box – Below Grade Mech. Room
<1mg/cm² lead

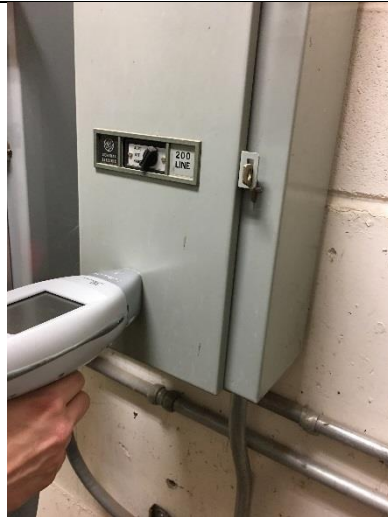
PHOTO 14 Gray Breaker Box – Below Grade Mech. Room
<1mg/cm² lead

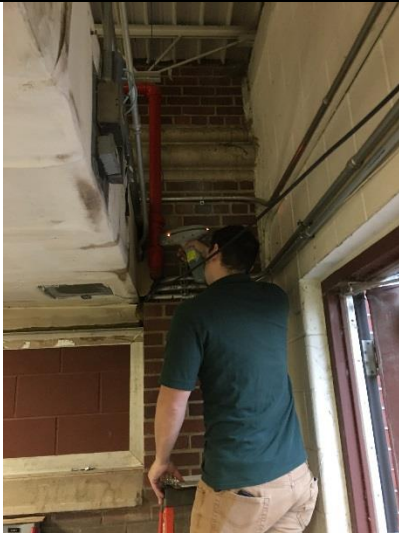
PHOTO 15 Red Painted Pipe – Below Grade Mech. Room
<1mg/cm² lead

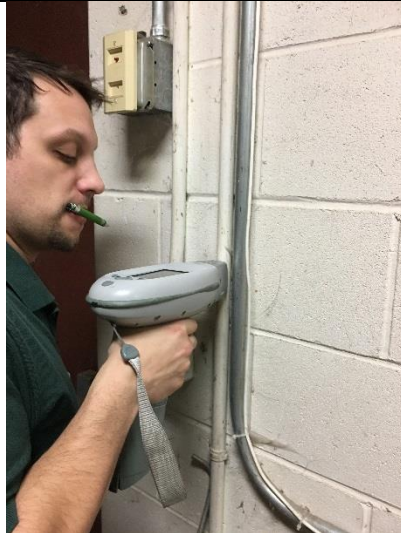
PHOTO 16 White Painted Conduit – Below Grade Mech. Room
<1mg/cm² lead

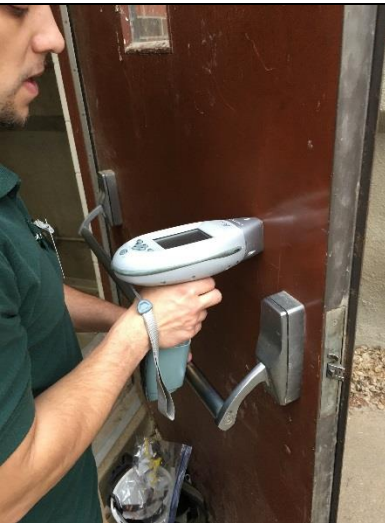
PHOTO 21 Red Mech. Room Door (Inside)
<1mg/cm² lead

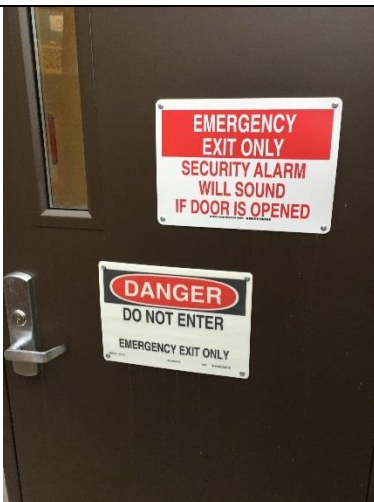
PHOTO 23 Brown Door (Outside)
<1mg/cm² lead

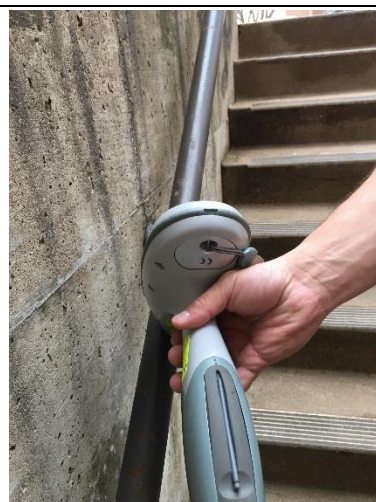
PHOTO 24 Brown Hand Railing-Stairs to Mech. Room
1.7 mg/cm² lead

Based on the initial lead paint testing results, AMIE recommends TCLP testing be conducted on the existing building materials, painted and unpainted, prior to the start of renovation or demolition activity. In addition, trade contractors who work in the facility should also be notified of the presence of lead so that they can appropriately monitor and protect their workers against lead exposure.

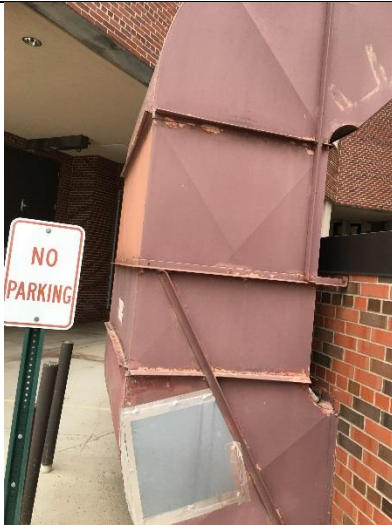
PHOTO 27 Red Ventilation Duct - Exterior
<1mg/cm² lead

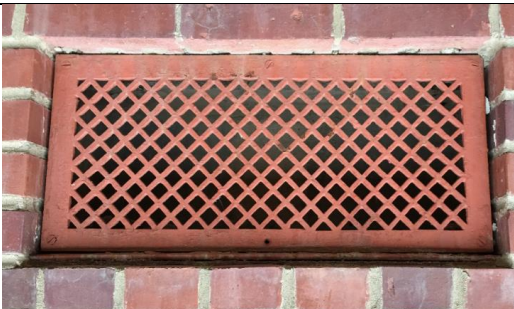
PHOTO 29 Red Decorative Grate on vertical wall - exterior
10.2 mg/cm² lead

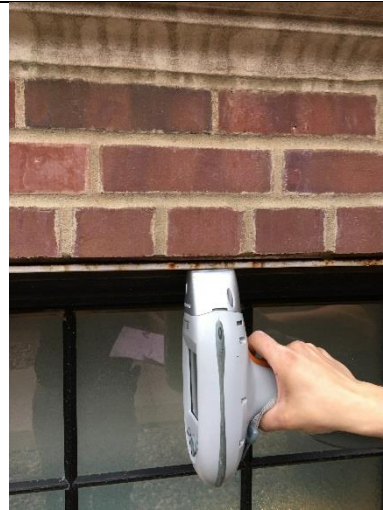
PHOTO 32 White Top Plate – Exterior Window
15 mg/cm² lead

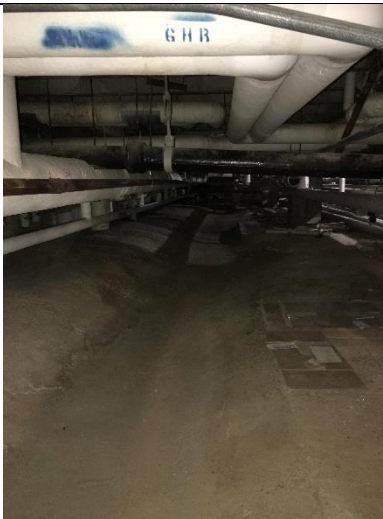
PHOTO 34 Black Pipe – Tunnel
<1mg/cm² lead

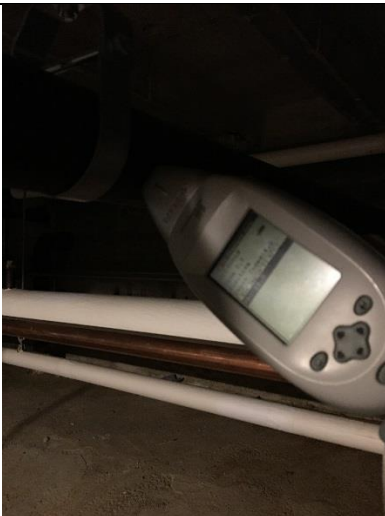
PHOTO 35 Black Pipe – Tunnel
<1mg/cm² lead

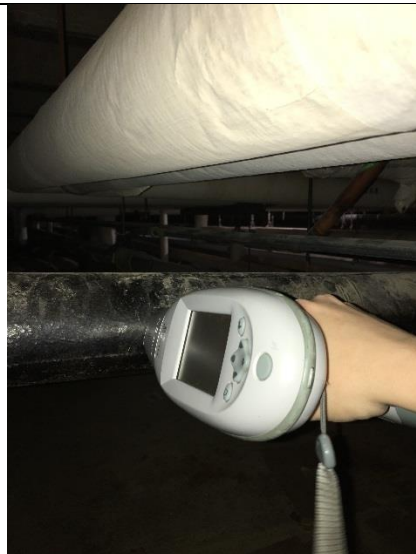
PHOTO 36 Black Pipe – Tunnel
<1mg/cm² lead

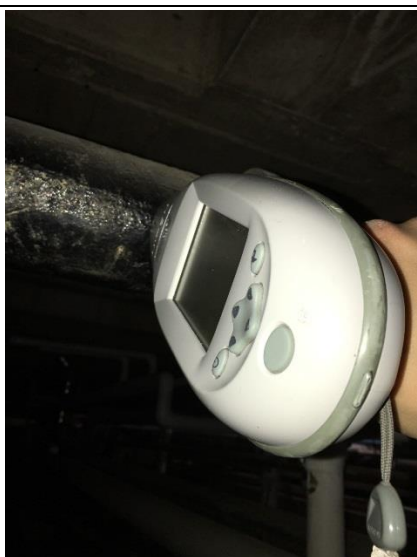
PHOTO 37 Black Pipe – Tunnel
 $<1\text{ mg/cm}^2$ lead

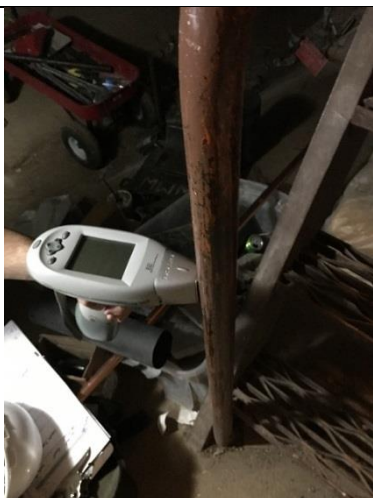
PHOTO 39 Brown Hand Railing-Stairs to Tunnel
 3.8 mg/cm^2 lead

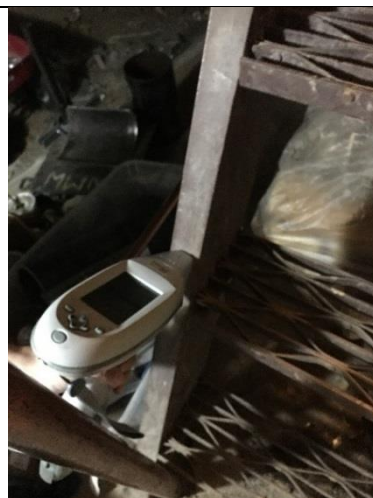
PHOTO 40 Brown Stairs to Tunnel
 2.9 mg/cm^2 lead

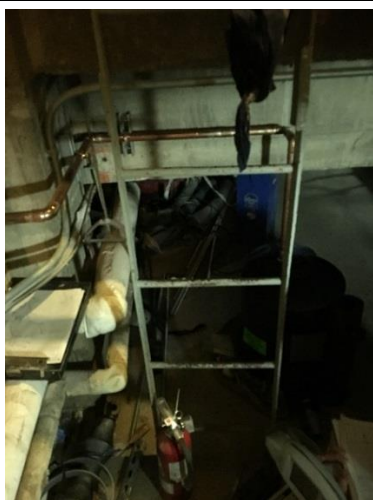
PHOTO 41 Gray ladder in Tunnel
 3.1 mg/cm^2 lead

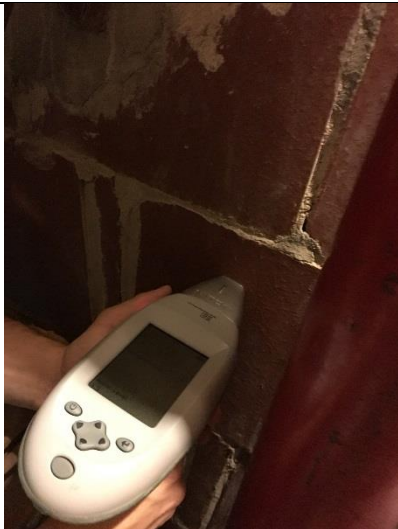
PHOTO 45

Metal Door Frame to East Stairwell Tower 3
<1mg/cm² lead

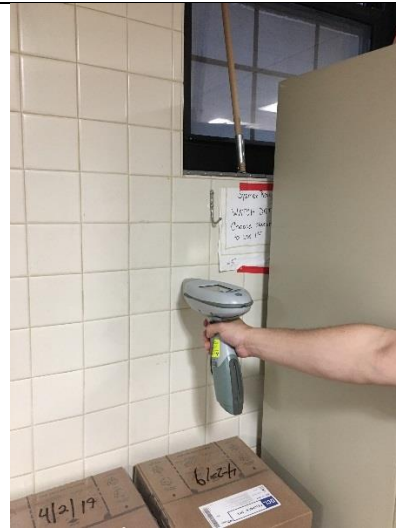
PHOTO 46

Cream Ceramic Tile – D-17
<1mg/cm² lead

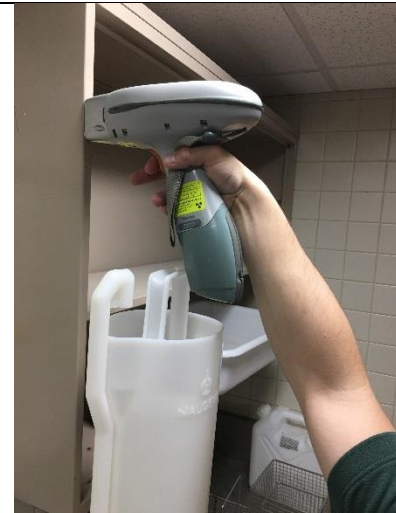
PHOTO 48

Beige Upper Cabinet – D-17
<1mg/cm² lead

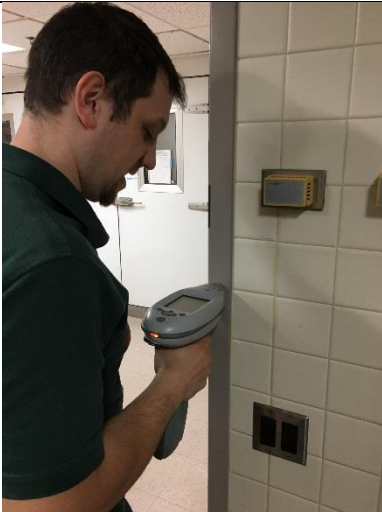
PHOTO 49 Beige Door Frame – D-17
<1mg/cm² lead

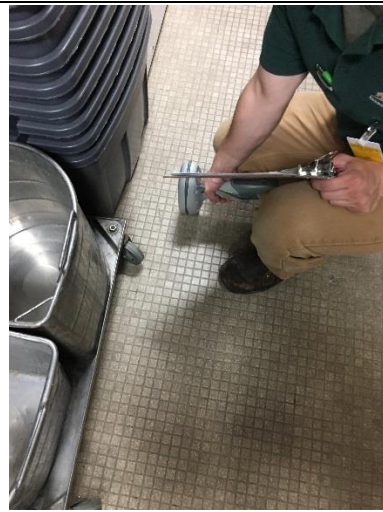
PHOTO 50 Beige Ceramic Tile Floor – D-17
<1mg/cm² lead

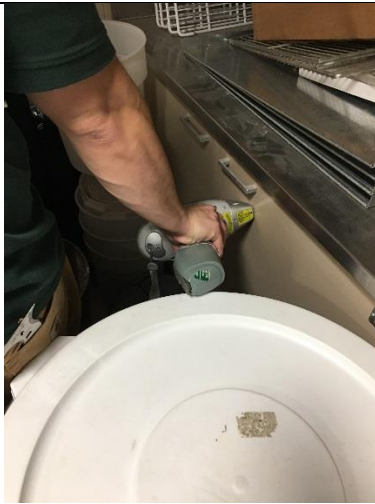
PHOTO 51 Beige Base Cabinet – D-17
<1mg/cm² lead

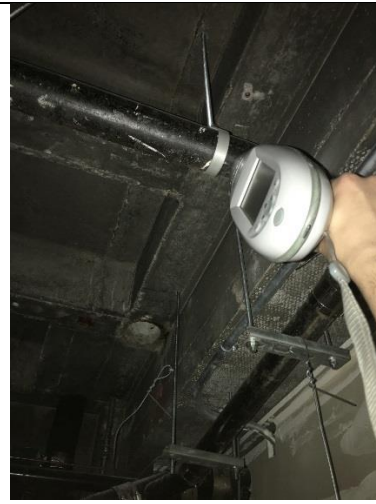
PHOTO 52 Black Pipe D-17 Hallway
<1mg/cm² lead

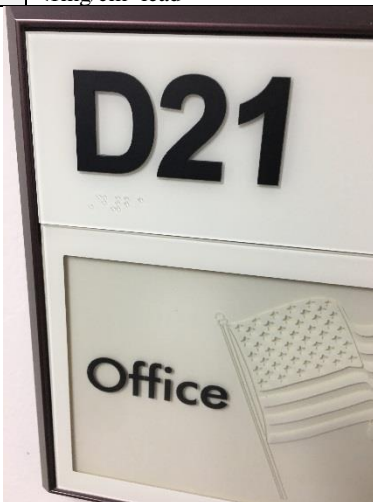
PHOTO 59 Cream Painted Sheetrock Wall – Room D-21
<1mg/cm² lead

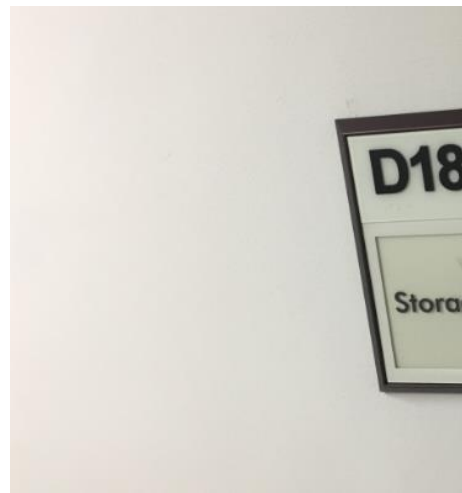
PHOTO 60 Cream Painted Sheetrock Wall - Hallway
<1mg/cm² lead

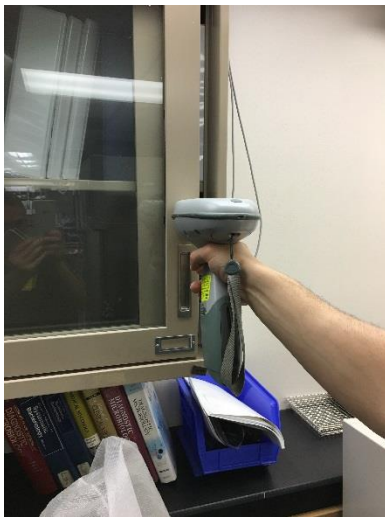
PHOTO 67 Beige Metal Cabinet – S End
<1mg/cm² lead

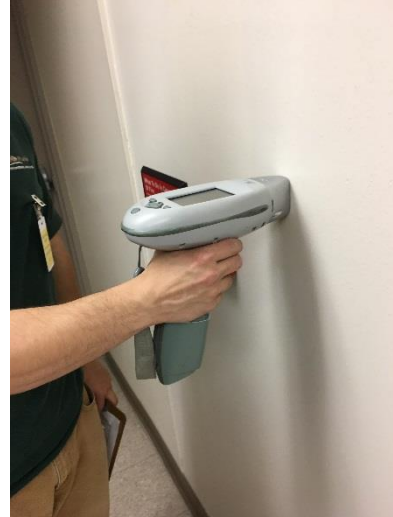
PHOTO 68 White Painted Sheetrock – West Wall
<1mg/cm² lead

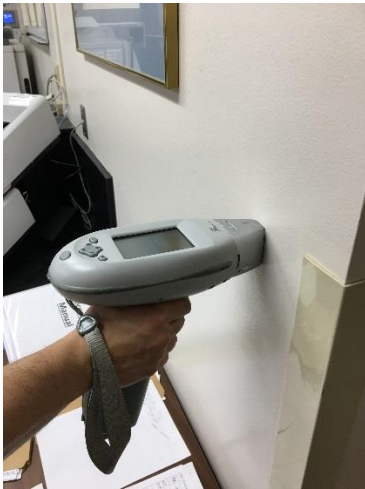
PHOTO 73 White Painted Sheetrock Wall - Lab
<1mg/cm² lead

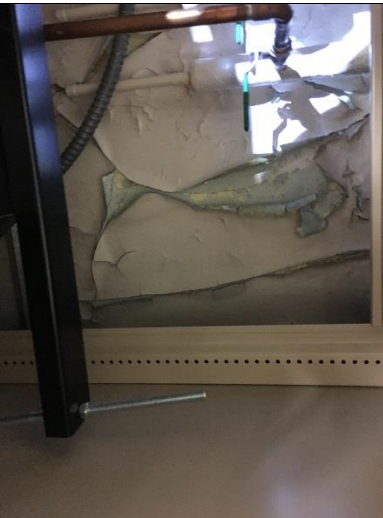
PHOTO 75 Peeling White Paint Under Sink
<1mg/cm² lead

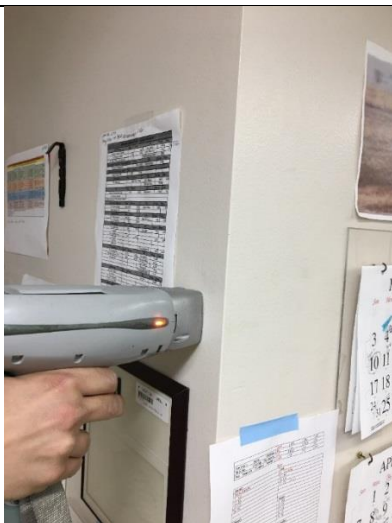
PHOTO 77 White Paint on Sheetrock - Lab
<1mg/cm² lead

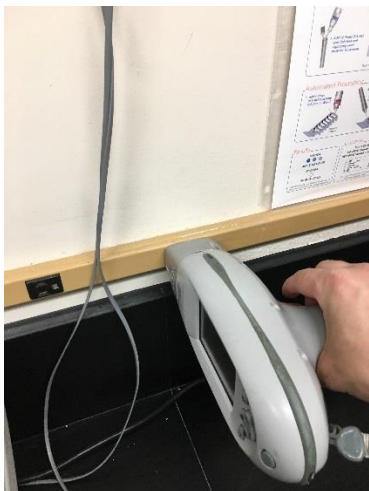
PHOTO 79 Metal Power Strip - Lab
<1mg/cm² lead

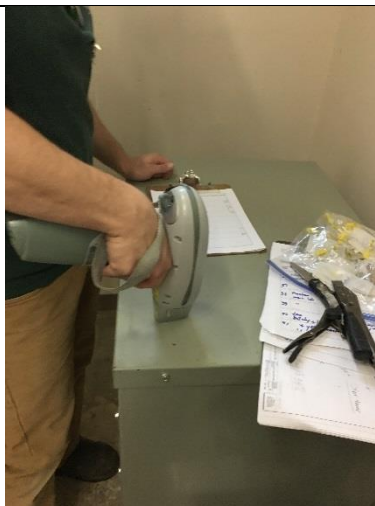
PHOTO 80 Transformer Box – D -20
<1mg/cm² lead

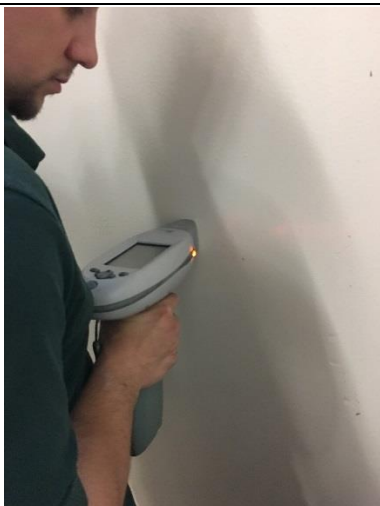
PHOTO 81 East Wall – D-20
<1mg/cm² lead

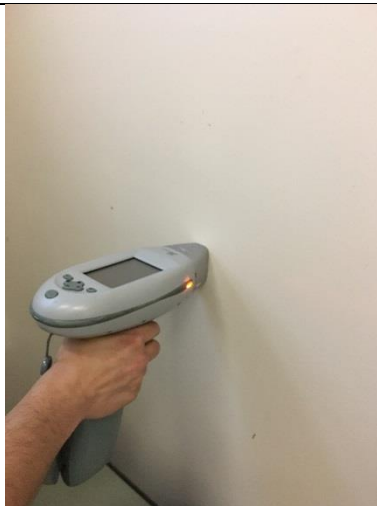
PHOTO 82 North Wall – D-20
<1mg/cm² lead

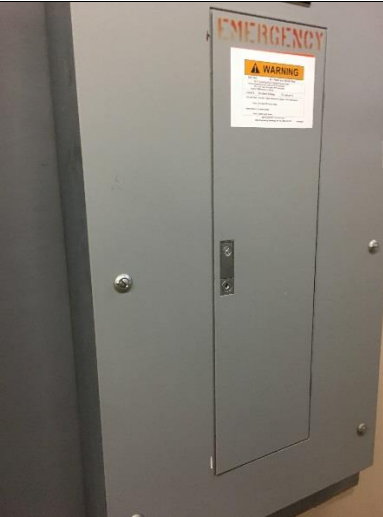
PHOTO 83 Breaker Box – D-20
<1mg/cm² lead

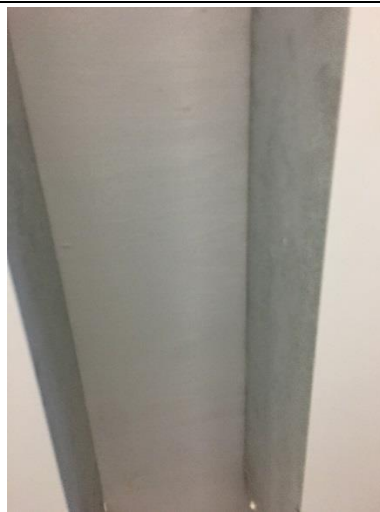
PHOTO 84 Panel behind Breaker Box – D-20
<1mg/cm² lead

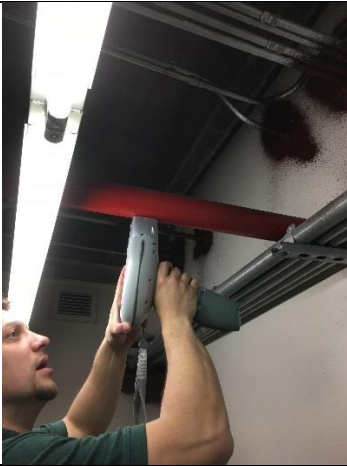
PHOTO 85 Red Metal Pipe – D-20
<1mg/cm² lead

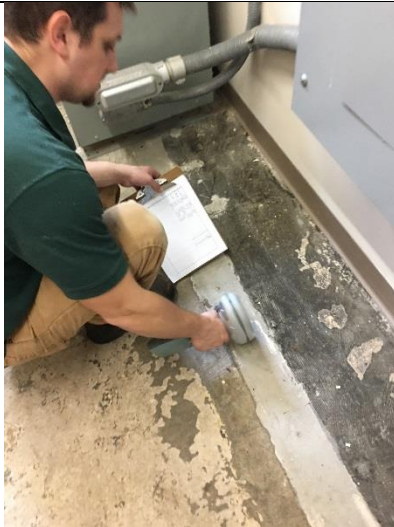
PHOTO 89

Gray Concrete Floor – D-20
<1mg/cm² lead
