4. SUMMARY OF INSPECTION FINDINGS

Location:		VA Medical Center, Sioux Falls, SD - Building 5 (Mech Rm, Tunnel, Lower Level)						
Inspector:		Jason Biggins, Prairie Environmental Consulting, LLC						
XRF Model: NITON XLp Series Lead Analyzer, serial #24794					Lead Paint ≥ 1.0 mg/cm²			
XRF #	Unit #	Substrate	Component	Color	Test Location	Condition	Results	Notes
1					Calibrate			Test
2					Calibrate			Test
3					Calibrate			Test
4					Calibrate			Test
5					Calibrate			Test
6					Calibrate			Test
7	Mech Rm	Metal	Electrical Panel	Grey	Mech Rm	Good	0.00	
8	Mech Rm	Concrete	Wall	White	Mech Rm	Fair	0.00	
9	Mech Rm	Concrete	Wall	Red	Mech Rm	Fair	0.00	
10	Mech Rm	Metal	Duct	Grey	Mech Rm	Fair	0.00	
11	Mech Rm	Metal	Frame	Red	Mech Rm	Fair	0.01	
12	Mech Rm	Concrete	Wall	Red	Mech Rm	Good	0.00	
13	Mech Rm	Metal	Tank	Silver	Mech Rm	Fair	0.01	
14	Mech Rm	Metal	Mixing Chamber	Red	Mech Rm	Fair	0.25	
15	Mech Rm	Wood	Panel	Grey	Mech Rm	Fair	0.00	
16	Mech Rm	Metal	Casing	Grey	Mech Rm	Good	0.01

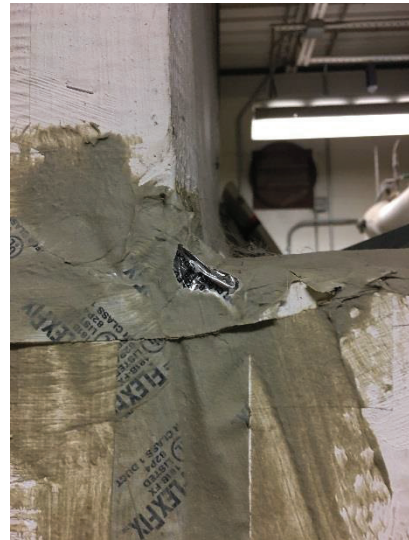
PHOTO 1 Gray Mastic – Duct in below grade mechanical room

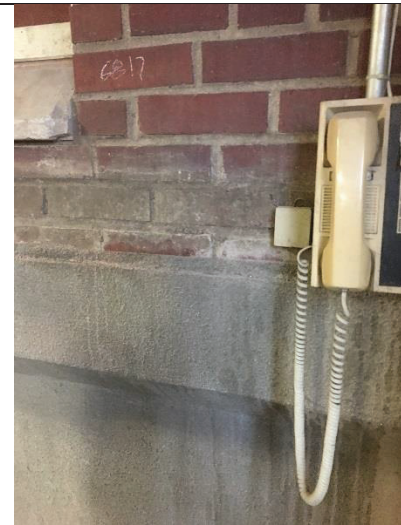
PHOTO 3 EFIS Surfacing – Mech. Room & Entry Area

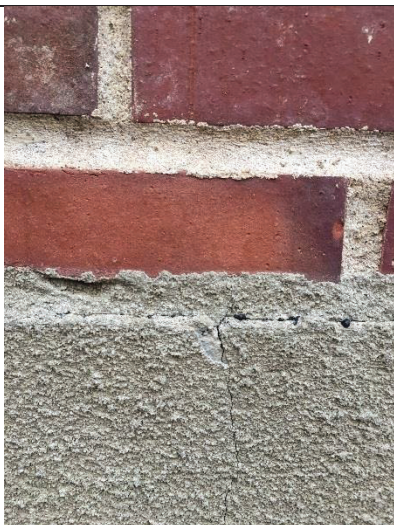
PHOTO 4 EFIS Surfacing – Mech. Room & Entry Area

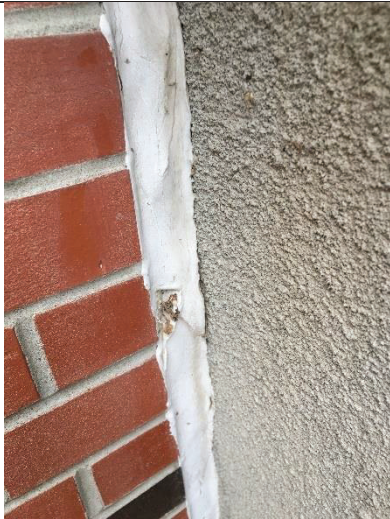
PHOTO 8 White Joint Caulk – Entry to Mech. Room

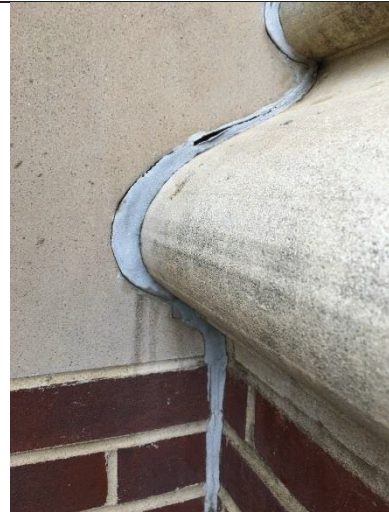
PHOTO 13 Gray Joint Caulk – Horizontal Concrete Pad

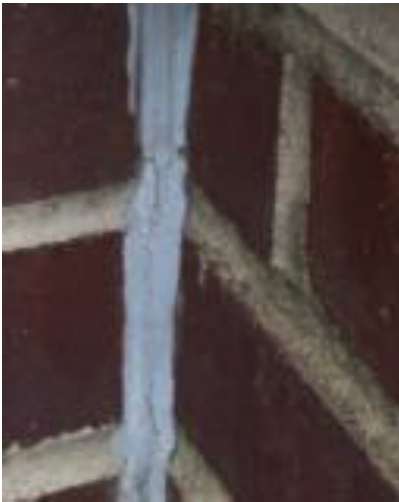
PHOTO 14 Gray Joint Caulk - Exterior

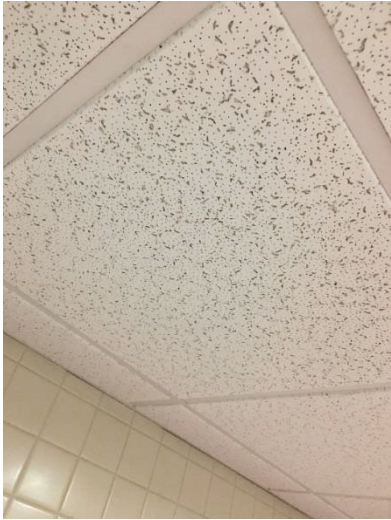
PHOTO 18 2' x 2' Ceiling Tile D-17

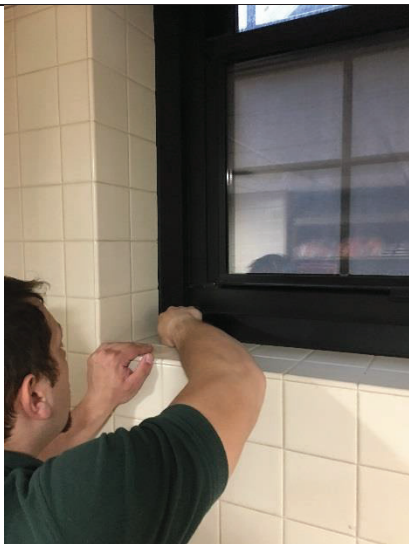
PHOTO 22 | Black Window Caulk – Windows Throughout

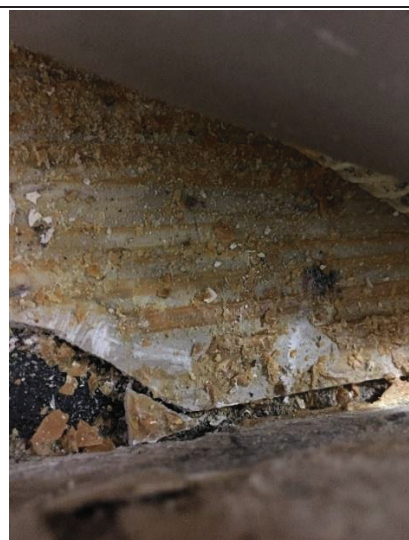
PHOTO 29 Beige VFT Black Mastic (under carpet) – D 21

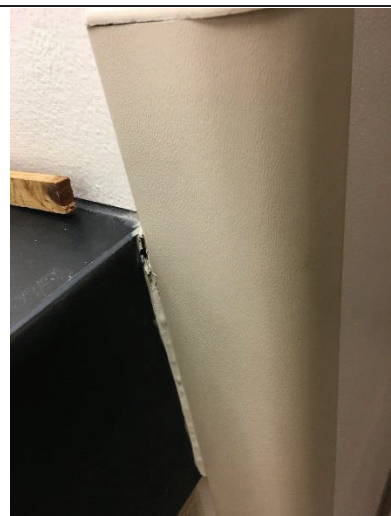
PHOTO 35 Epoxy Resin Bench Top - Lab

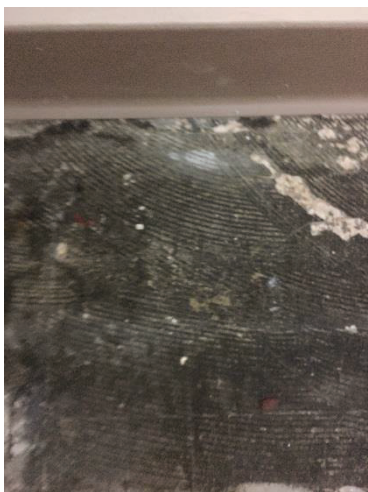
PHOTO 42 12" x 12" VFT Tan Blotchy/Mastic
Black Mastic 4% Chrysotile

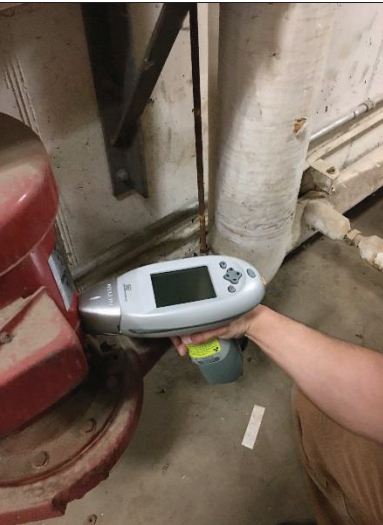
PHOTO 10 Gray Painted Casing – Below Grade Mechanical Room
<1mg/cm² lead

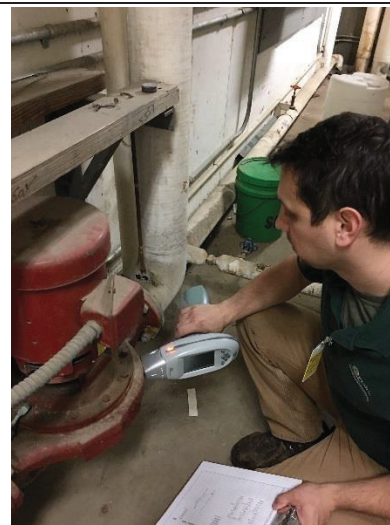
PHOTO 11 Red Painted Mixing Chamber – Below Grade Mech. Room
<1mg/cm² lead

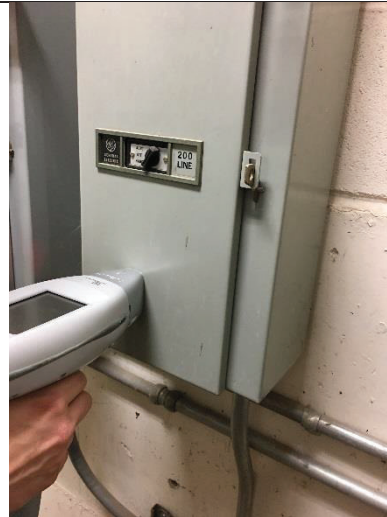
PHOTO 13 Gray Breaker Box – Below Grade Mech. Room
<1mg/cm² lead

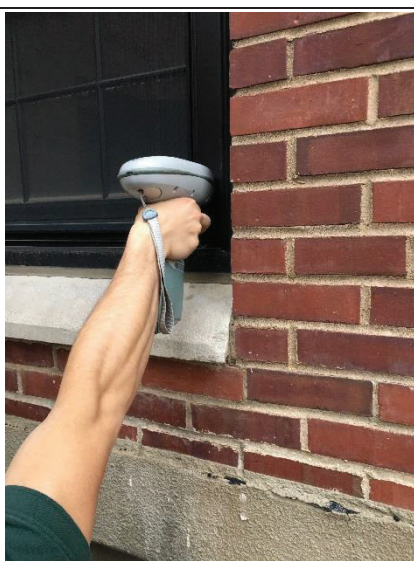
PHOTO 19 Black Window Frame - Exterior
<1mg/cm² lead

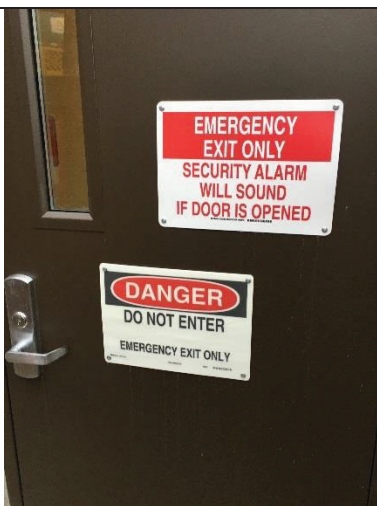
PHOTO 22 Black Mech. Room Door (Outside)
<1mg/cm² lead

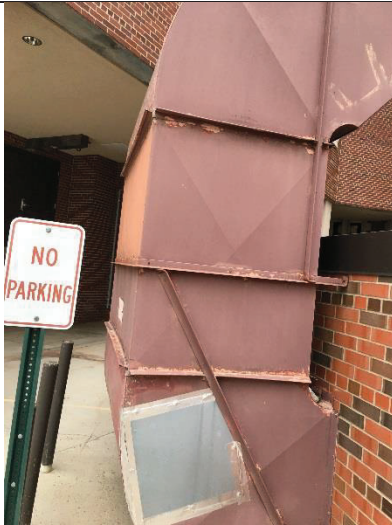
PHOTO 26 Black Flashing - Exterior
<1mg/cm² lead

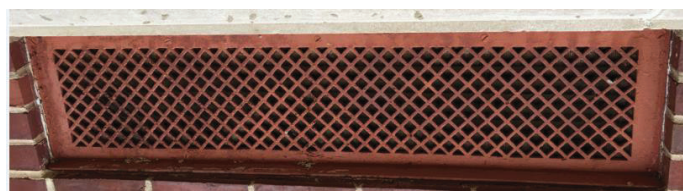
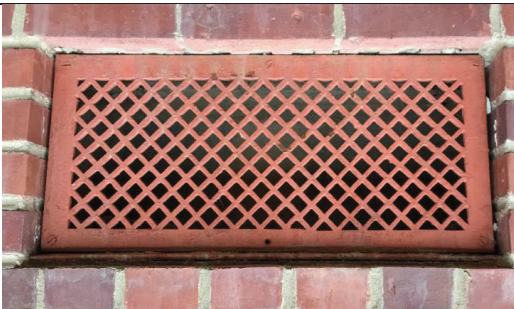
PHOTO 28 Brown Metal Panel – Exterior
<1mg/cm² lead

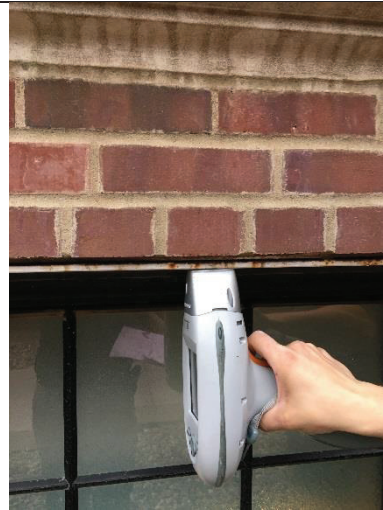
PHOTO 31 Silver Window Frame
<1mg/cm² lead

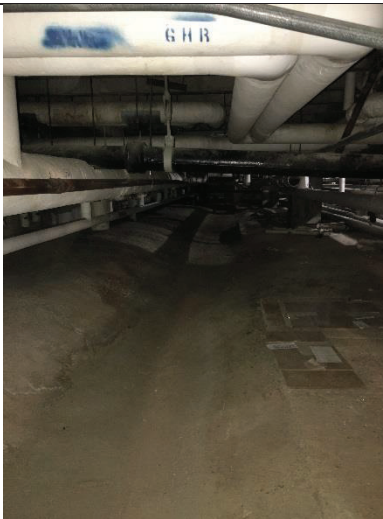
PHOTO 33 Black Pipe – Tunnel
<1mg/cm² lead

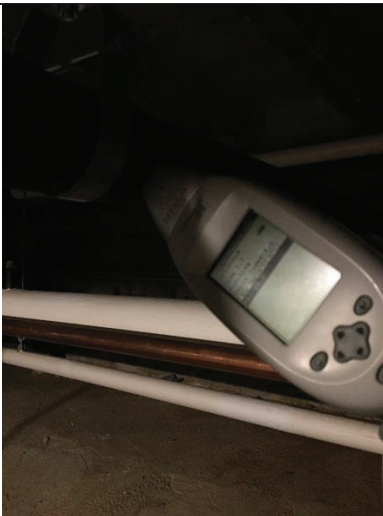
PHOTO 34 Black Pipe – Tunnel
<1mg/cm² lead

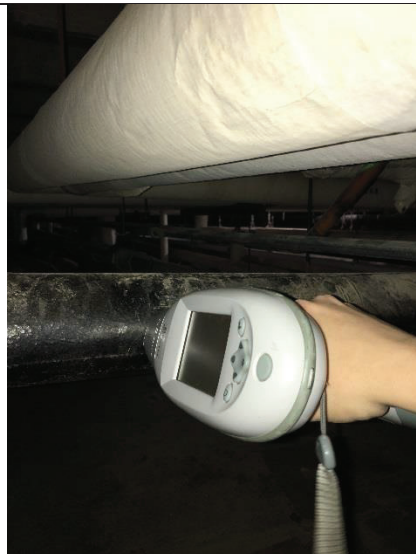
PHOTO 35 Black Pipe – Tunnel
<1mg/cm² lead

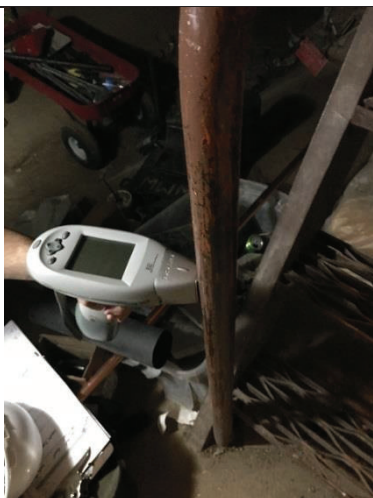
PHOTO 38 Black Pipe – Tunnel
 $<1\text{mg}/\text{cm}^2$ lead

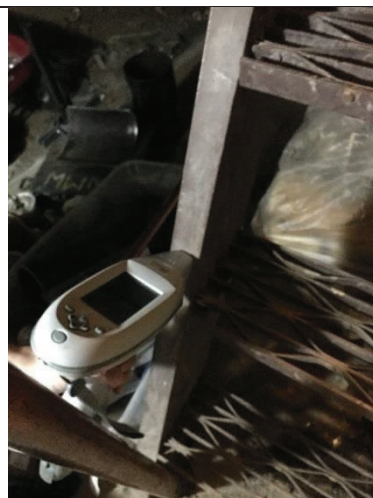
PHOTO 39 Brown Hand Railing-Stairs to Tunnel
 $3.8\text{ mg}/\text{cm}^2$ lead

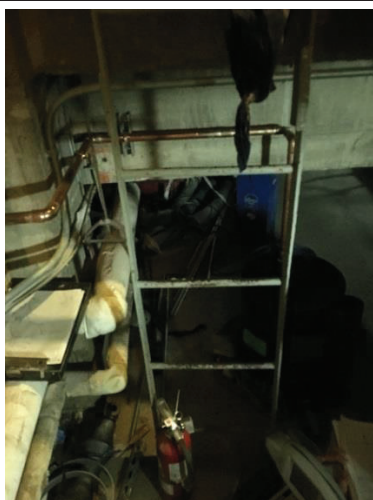
PHOTO 40 Brown Stairs to Tunnel
 $2.9\text{ mg}/\text{cm}^2$ lead

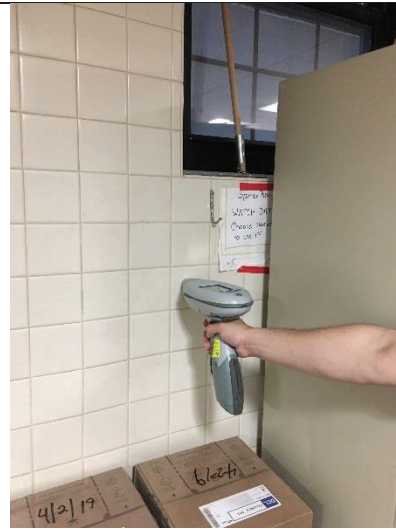
PHOTO 45

Metal Door Frame to East Stairwell Tower 3
<1mg/cm² lead

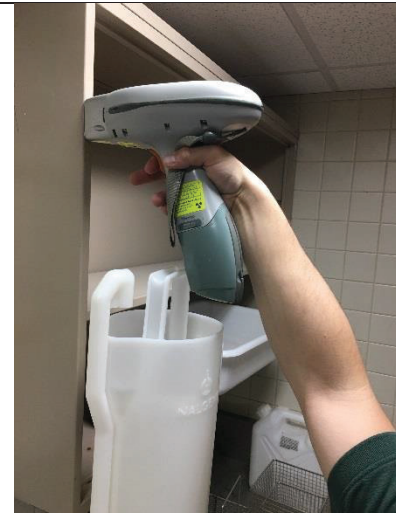
PHOTO 47

Beige Base Cabinet – D-17
<1mg/cm² lead

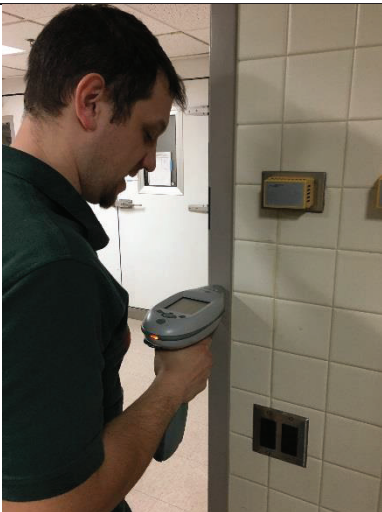
PHOTO 48

Beige Upper Cabinet – D-17
<1mg/cm² lead

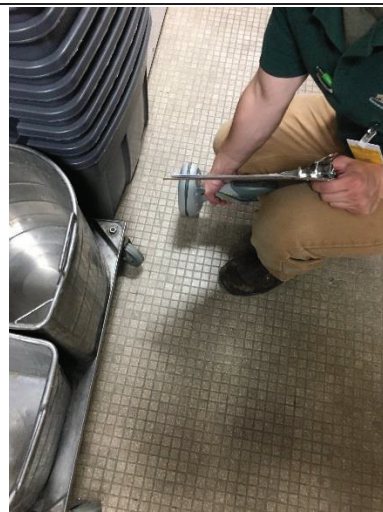
PHOTO 49 Beige Door Frame – D-17
<1mg/cm² lead

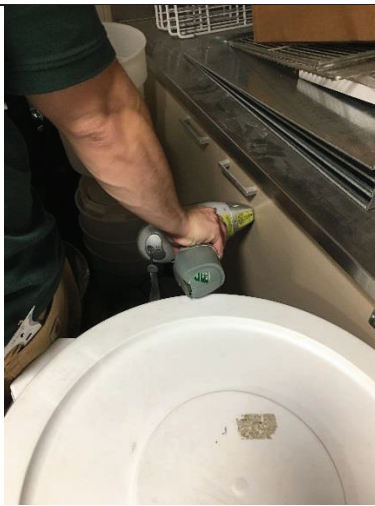
PHOTO 50 Beige Ceramic Tile Floor – D-17
<1mg/cm² lead

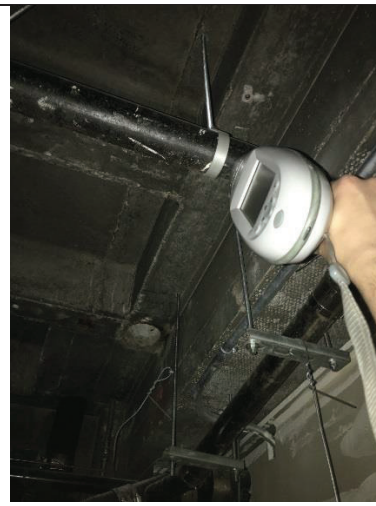
PHOTO 51 Beige Base Cabinet – D-17
<1mg/cm² lead

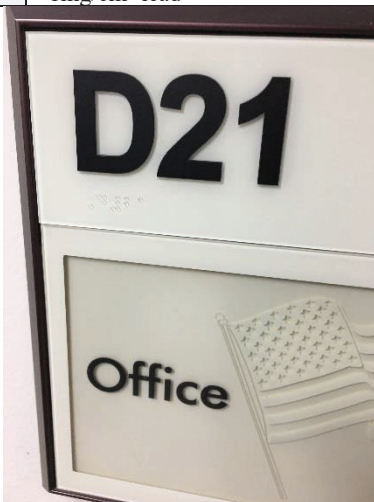
PHOTO 58 Black Pipe - Hallway
<1mg/cm² lead

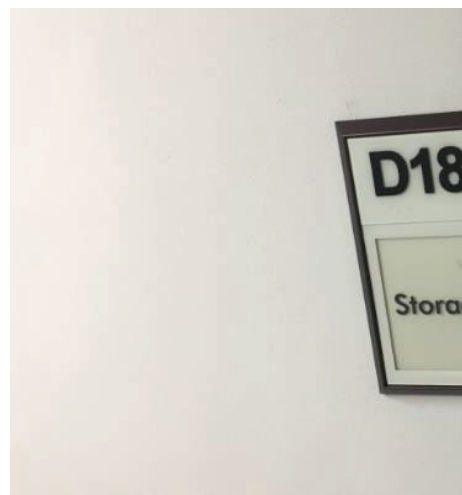
PHOTO 59 Cream Painted Sheetrock Wall – Room D-21
<1mg/cm² lead

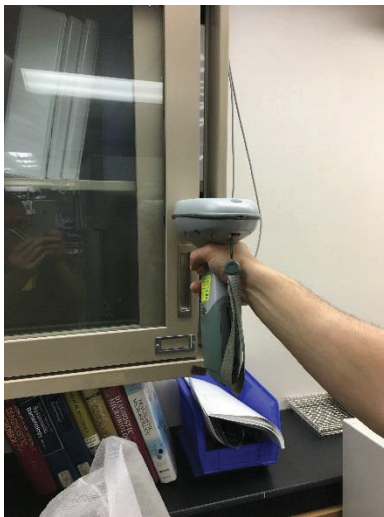
PHOTO 66 Cream Door Frame – S End
<1mg/cm² lead

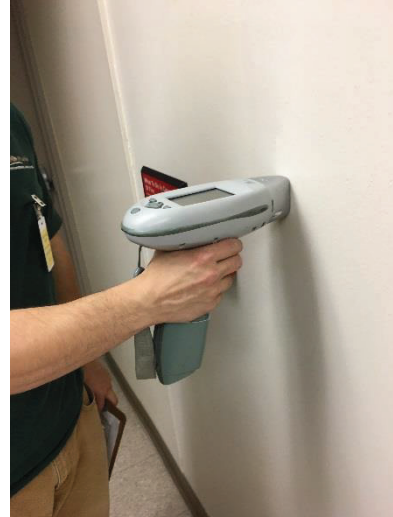
PHOTO 67 Beige Metal Cabinet – S End
<1mg/cm² lead

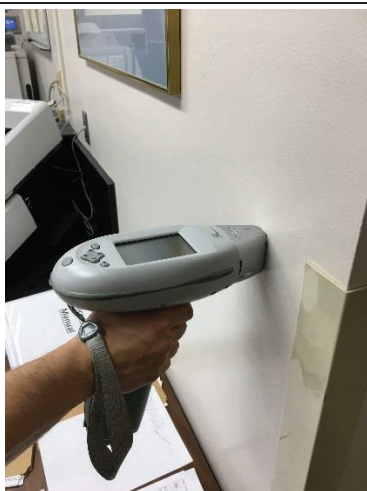
PHOTO 72 Non-Decorative Window Trim
<1mg/cm² lead

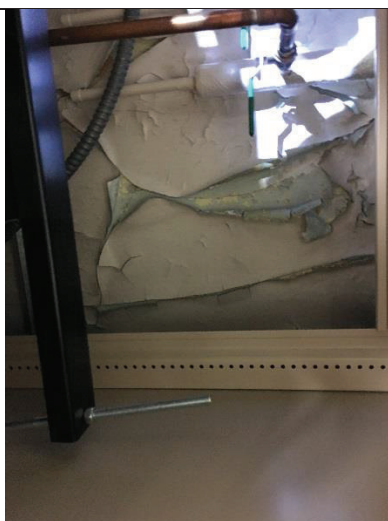
PHOTO 74 Black Metal surrounding sink basin
<1mg/cm² lead

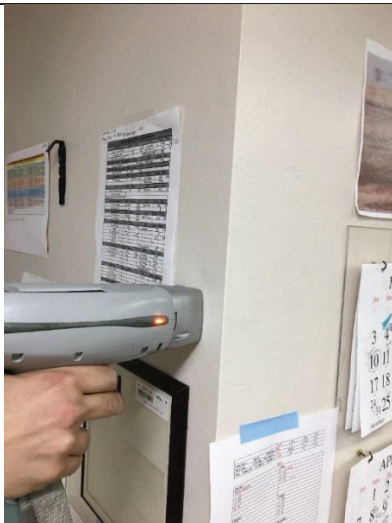
PHOTO 76 White Paint on Plaster
<1mg/cm² lead

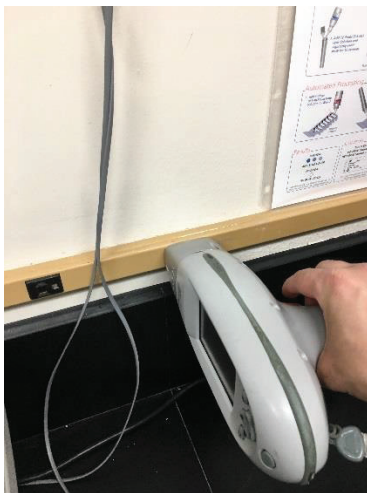
PHOTO 78 Plaster on column - Lab
<1mg/cm² lead

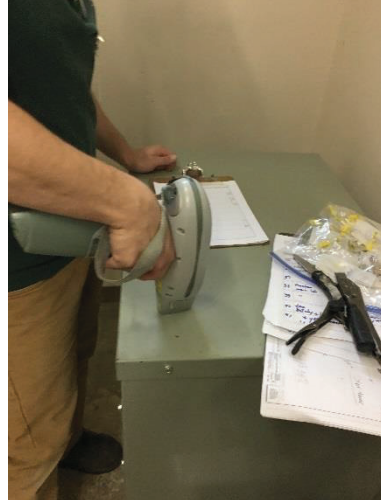
PHOTO 79 Metal Power Strip - Lab
<1mg/cm² lead

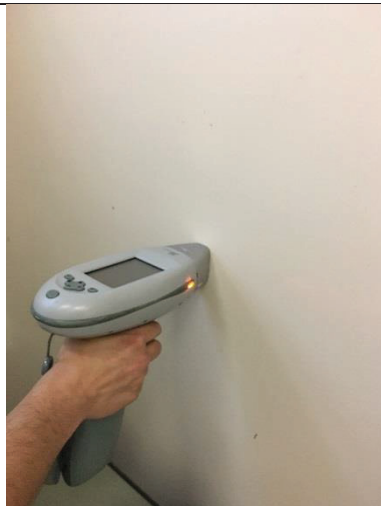
PHOTO 81 East Wall - D-20
<1mg/cm² lead

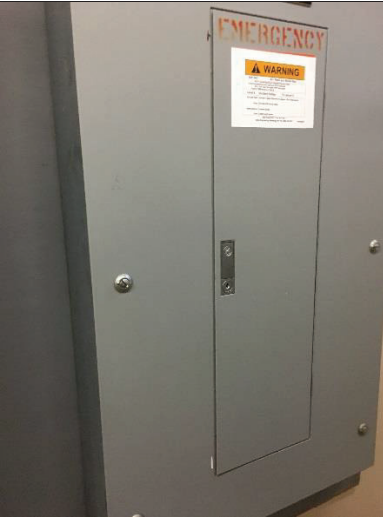
PHOTO 82 North Wall - D-20
<1mg/cm² lead

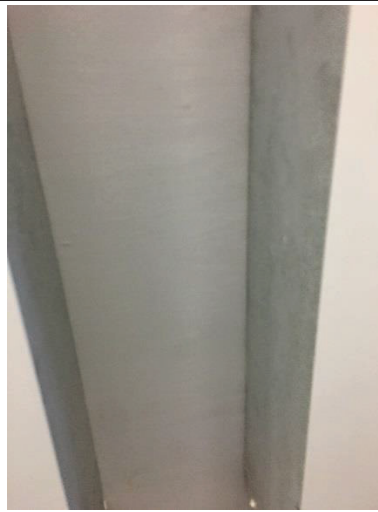
PHOTO 83 Breaker Box – D-20
<1mg/cm² lead
